City of Boise ADA  
Assessment

# Appendix A-Boise Depot

02/19/2021

Report #TO21-B020

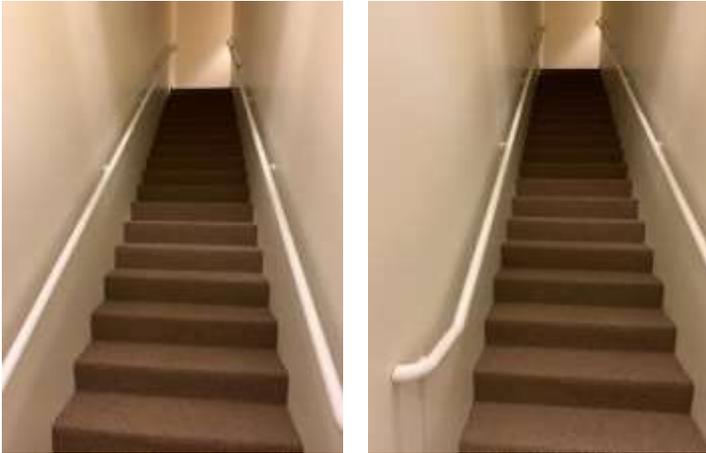
**2010 ADA Standards for Accessible Design Codes §505.4**  
Handrails are not located at a compliant height at 33" above the stair nosings.

Raise the handrails to a minimum height of 34" and a maximum of 38" above the stair nosings. Ensure that the handrails are at a consistent height along the stair treads.

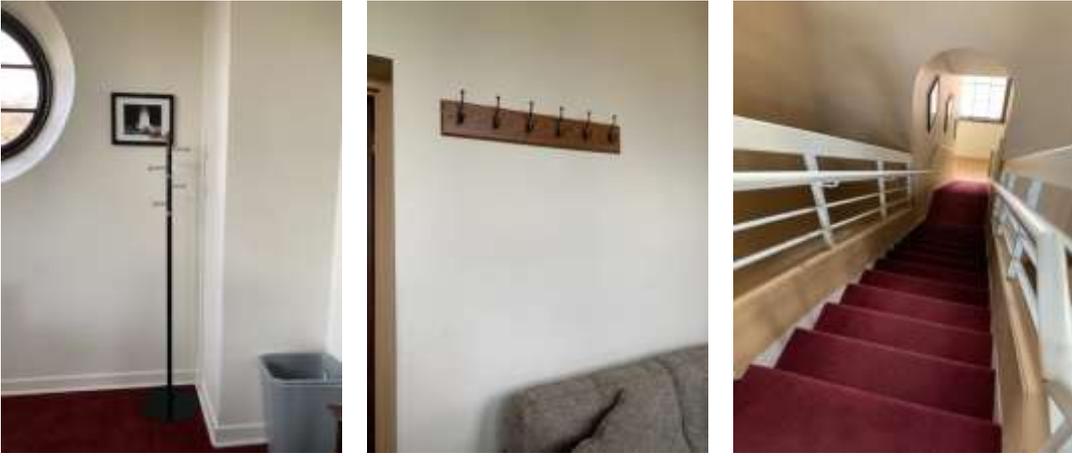
**2010 ADA Standards for Accessible Design Codes §308.2.1**  
The hooks are outside of the unobstructed forward reach range at 48.5" and 78" above the floor.

Lower the hooks by 0.5" to meet the accessible reach range of 48" maximum above the floor.

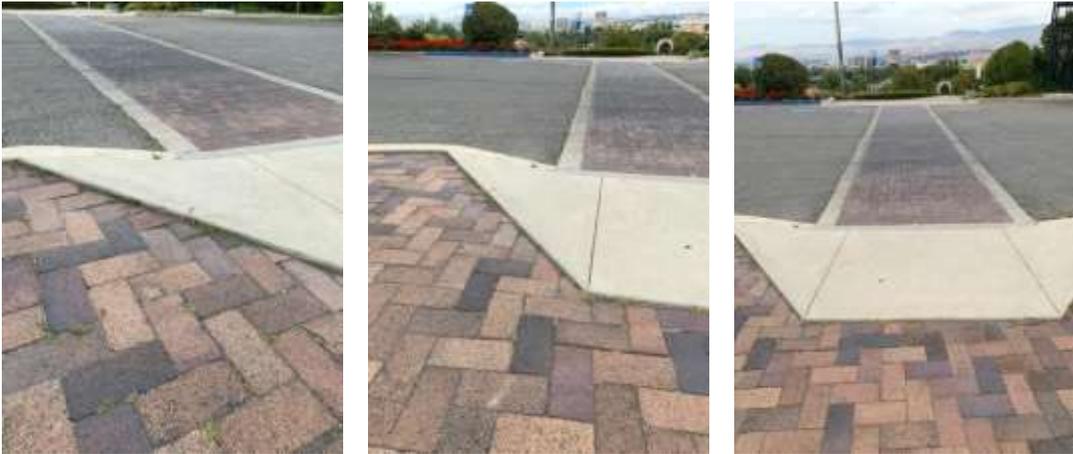
**2010 ADA Standards for Accessible Design Codes §303.2**  
There is a 1" change in level.

Resurface the pathway to reduce the change in level to less than 0.25" or 0.5" if beveled.

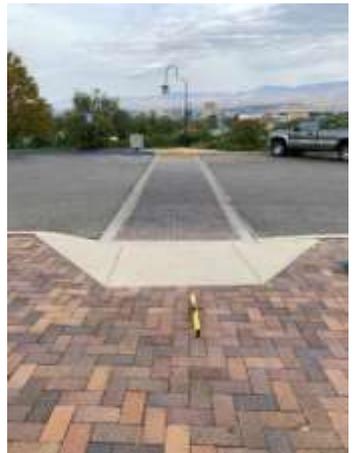
**2010 ADA Standards for Accessible Design Codes §705**  
The curb ramps do not have detectable warnings.

Install detectable warnings that contrast visually with the adjacent surface with either light-on-dark, or dark-on-light, are the width of the curb ramp, and have a depth of 24".

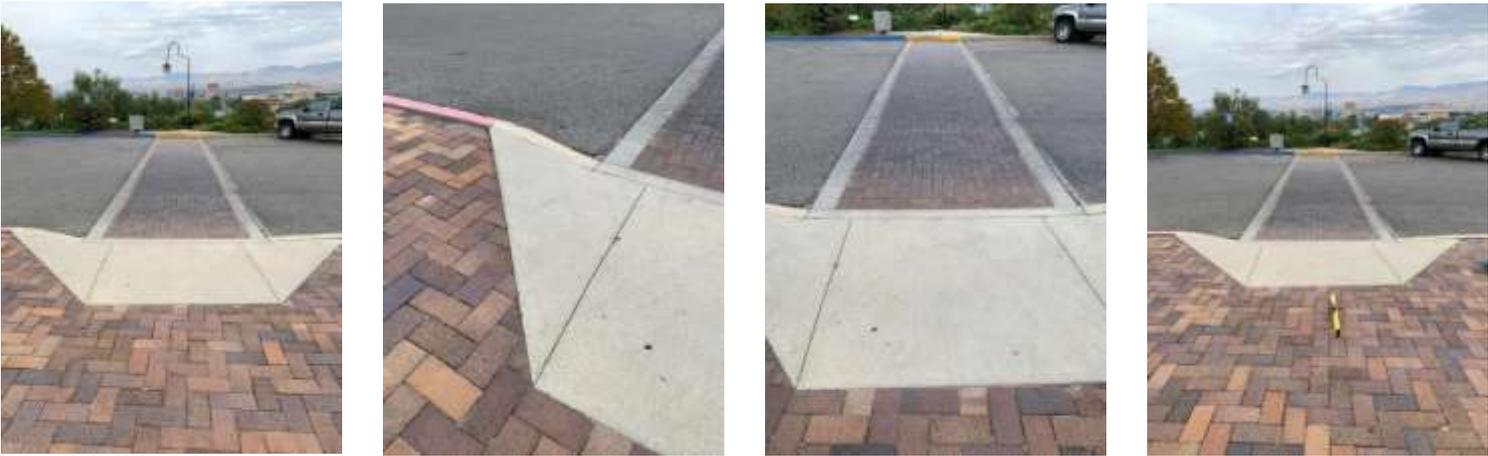
**2010 ADA Standards for Accessible Design Codes §406.3**  
The curb ramp flares have a 15.3% slope.

Resurface the curb ramp flares to ensure a maximum slope of 10%.

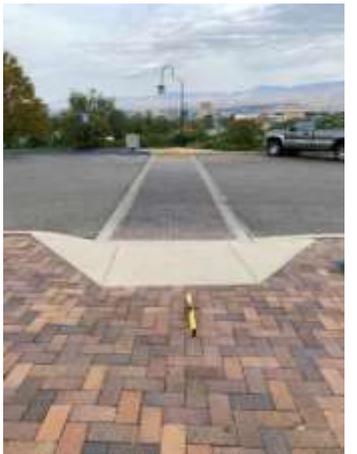
**2010 ADA Standards for Accessible Design Codes** §405.2  
The running slope of the curb ramp is 10.3%.

Reconstruct the curb ramp to reduce the running slope to a maximum of 8.3%.

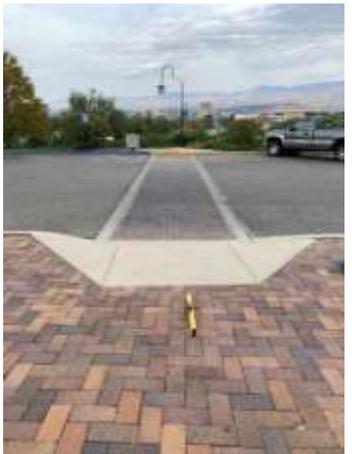
**2010 ADA Standards for Accessible Design Codes §405.7.1**  
The top landing has a 6.8% running slope.

Reconstruct the top landing to have a maximum slope of 2% in all directions.

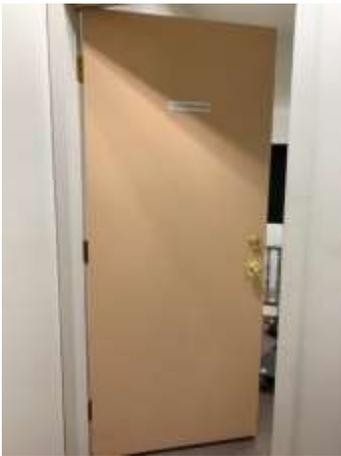
**2010 ADA Standards for Accessible Design Codes**    §309.4  
The door knob requires twisting of the wrist.

Replace the door knob with a lever handle that can be operated with a closed fist and without twisting the wrist.

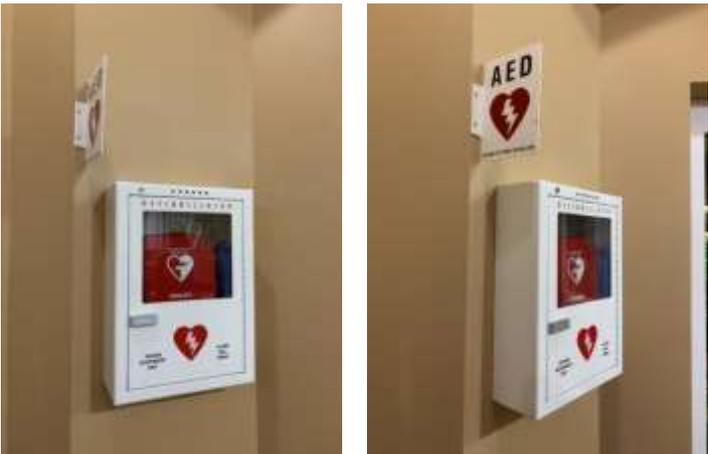
**2010 ADA Standards for Accessible Design Codes §307.2**  
The AED protrudes 6" into the circulation space at 43.25" above the floor.

Recess the AED so it protrudes a maximum of 4", lower it so the bottom edge is 27" maximum above the floor, or place a cane detectable object beneath it.

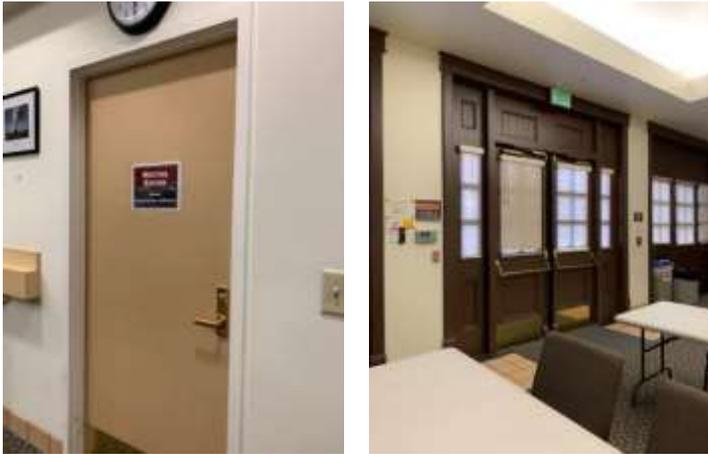
**2010 ADA Standards for Accessible Design Codes** §216.2, §703  
There are no tactile signs identifying 47 permanent rooms.

Install tactile signage on the latch side of the doorway at a height of 48" minimum to 60" maximum above the floor, identifying room by name or room number.  
Signs shall be Braille with raised lettering and should be placed on the wall in the center of an 18"x18" clear floor space.

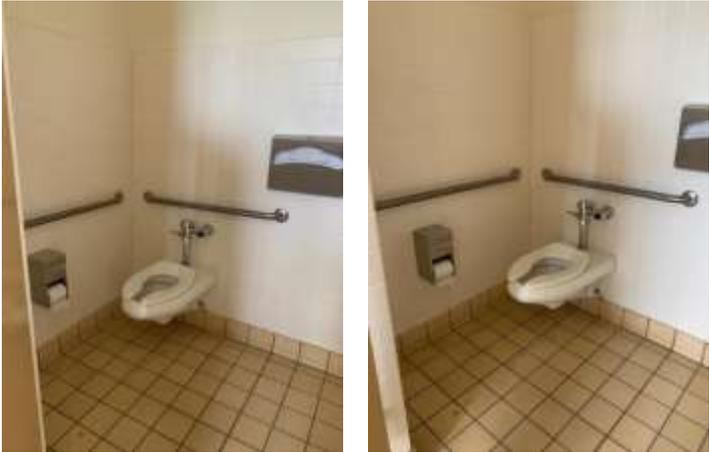
**2010 ADA Standards for Accessible Design Codes** §308.2.1, §609.3  
The space between the grab bar and the toilet seat covers is 6.25".  
The toilet seat covers are outside of the unobstructed forward reach range at 49" above the floor.

Relocate the toilet seat covers to a location that is at least a distance of 12" or greater above the grab bar.  
Lower the toilet seat covers by 1" to meet the accessible reach range of 15" minimum and 48" maximum above the floor.

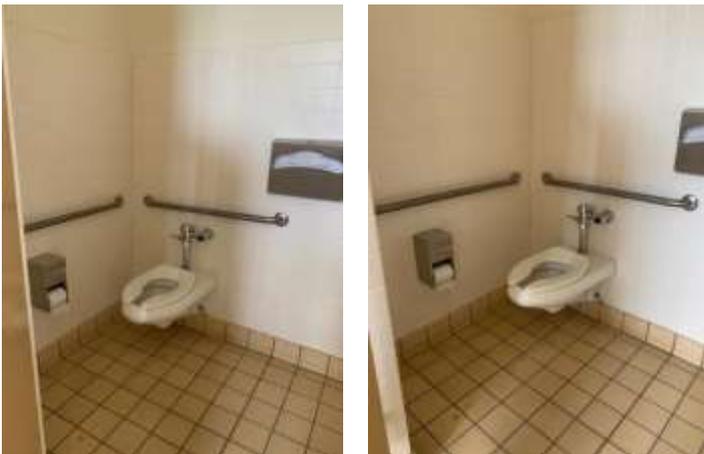
**2010 ADA Standards for Accessible Design Codes §604.5.2**

The rear grab bar is located 11.5" to the center of the toilet.

Remount the rear grab bar 12" from the centerline of the water closet minimum on one side and 24" minimum on the other.

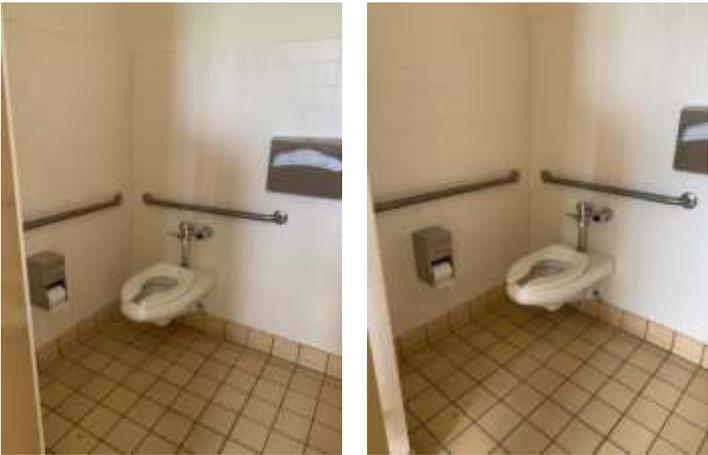
**2010 ADA Standards for Accessible Design Codes §604.5.1**  
The side grab bar is located 6" from the rear wall.

Remount the side grab bar 12" maximum from the rear wall and extending 54" minimum from the rear wall.
