City of Boise ADA
Assessment

Appendix A - Watershed Treatment Plant

05/05/2021

Report #TO21-B026

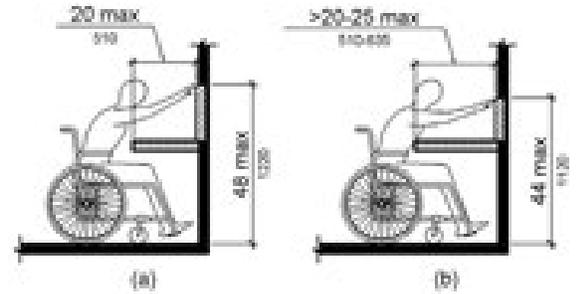
2010 ADA Standards for Accessible Design Codes §308.2.1

The paper towel dispenser is outside of the obstructed forward reach range at 58" above the floor.

Lower the paper towel dispenser by 10" to meet the accessible reach range of 48" maximum above the floor.

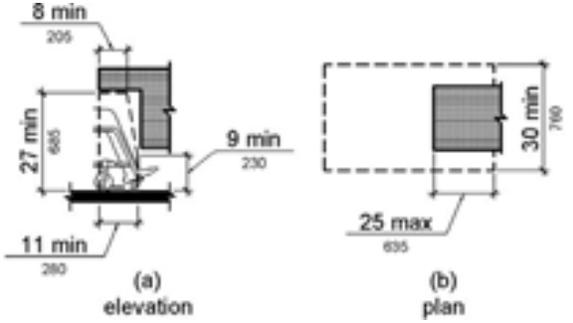
2010 ADA Standards for Accessible Design Codes §902.3, §306.3.3
There is no knee clearance underneath the sink.
The dining and work surface counter is 34.75" above the floor.

Provide knee clearance underneath the counter at the sink that is a minimum of 11" deep at 9" above the floor and 8" deep at 27" above the floor.
A portion of the dining and work surface must be no higher than 34" above the floor.

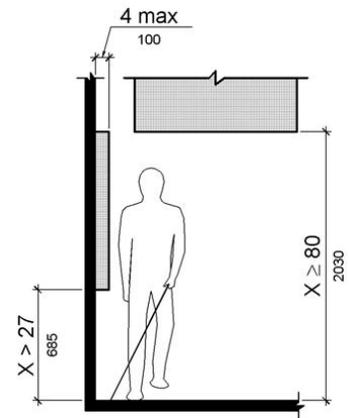
2010 ADA Standards for Accessible Design Codes §307.2

The TV protrudes 5.5" into the circulation space at 74" above the floor.

Recess the TV so it protrudes a maximum of 4", raise it so the bottom edge is 80" maximum above the floor, or place a cane detectable object beneath it.

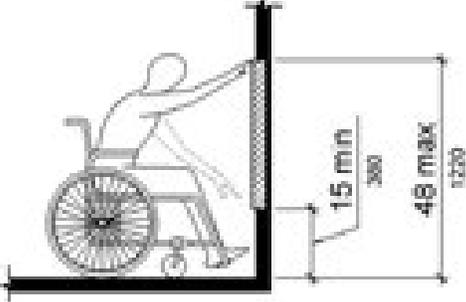
2010 ADA Standards for Accessible Design Codes §308.2.1
The toilet seat covers are outside of the obstructed forward reach range at 59" above the floor.

Lower the toilet seat covers container by 11" to meet the accessible reach range of 48" maximum above the floor and ensure it is at least 12" above the rear grab bar.

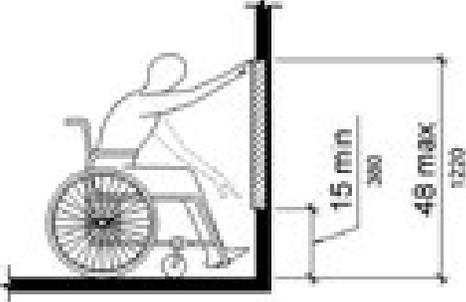
2010 ADA Standards for Accessible Design Codes §308.2.1
The paper towel dispenser is outside of the unobstructed forward reach range at 54" above the floor.

Lower the paper towel dispenser by 6" to meet the accessible reach range of 48" maximum above the floor.
This will require moving the changing table or the paper towel dispenser to another location.

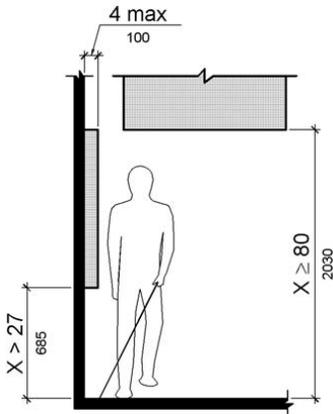
2010 ADA Standards for Accessible Design Codes §307.2
The first aid box protrudes 6.75" into the circulation space at 40.5" above the floor.

Recess the first aid box so it protrudes a maximum of 4" or place a cane detectable object beneath it.

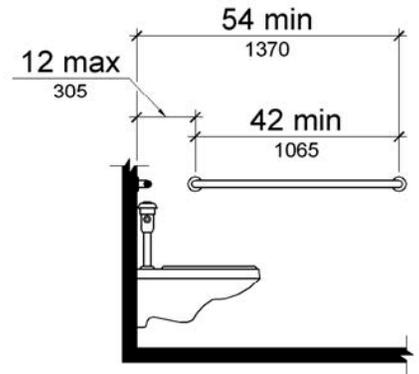
2010 ADA Standards for Accessible Design Codes §604.5.1

The side grab bar is located 11.5" from the rear wall.

Remount the side grab bar 12" maximum from the rear wall and extending 54" minimum from the rear wall.

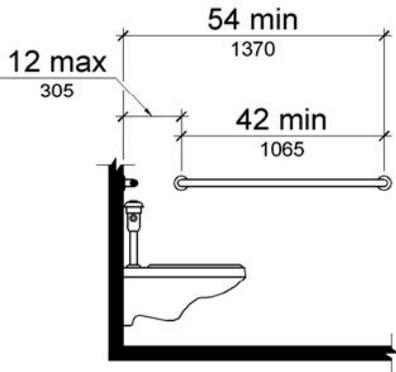
2010 ADA Standards for Accessible Design Codes §604.5.1
The side grab bar is located 11.5" from the rear wall.

Remount the side grab bar 12" maximum from the rear wall and extending 54" minimum from the rear wall.
