City of Boise ADA  
Assessment

# Appendix A-Fairmont Pool House

12/4/2020

Report #TO20-B007

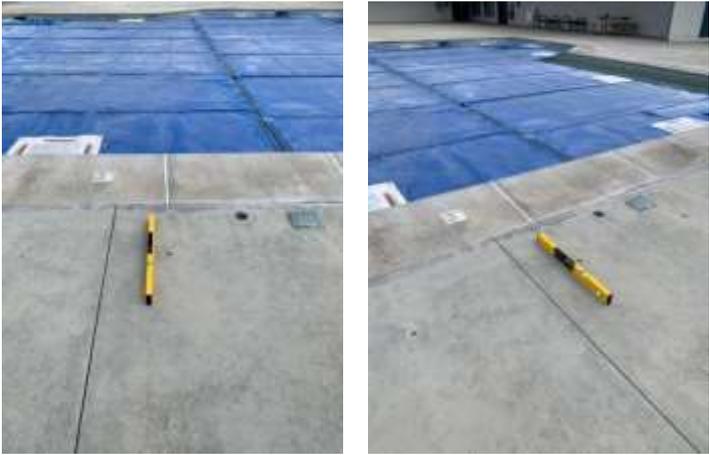
**ID:** 2087      **Facility:** Fairmont Pool House

**2010 ADA Standards for Accessible Design Codes: §305.2**  
The clear floor space for the pool lift has a 3.1% slope.

Resurface the 30"x48" clear floor space to have a maximum slope of 2% slope.

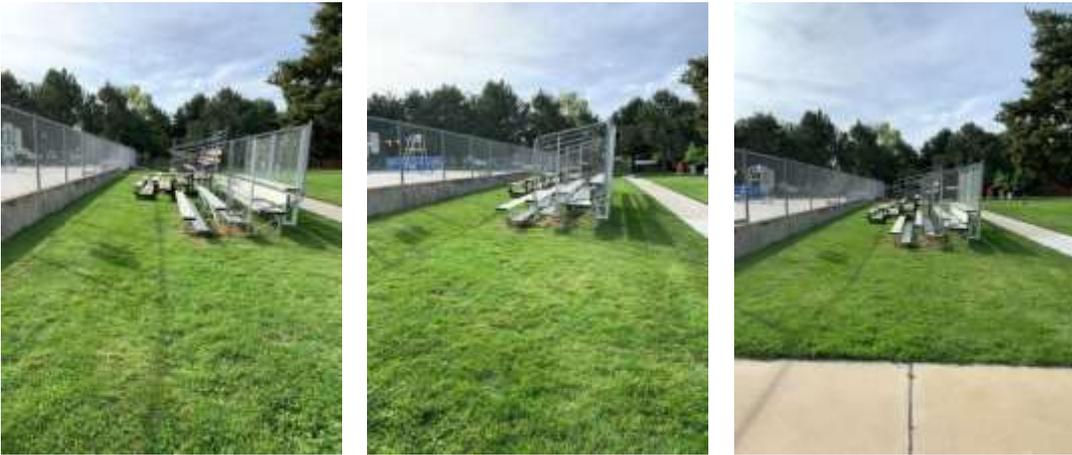
**ID:** 2048      **Facility:** Fairmont Pool House

**2010 ADA Standards for Accessible Design Codes:** §302.1, §305  
There is not a firm, stable, and slip resistant route to the bleachers.

Construct a firm, stable, and slip resistant accessible route with a maximum cross slope of 2% and maximum running slope of 5%.

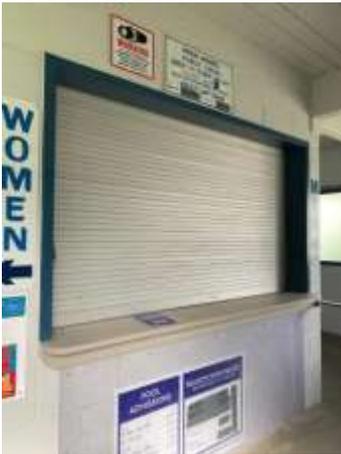
**ID:** 2068      **Facility:** Fairmont Pool House

**2010 ADA Standards for Accessible Design Codes: §904.4.1**  
The check-in counter is 37.75" above the floor.

A 36" wide portion of the service counter must be no higher than 36" above the floor.

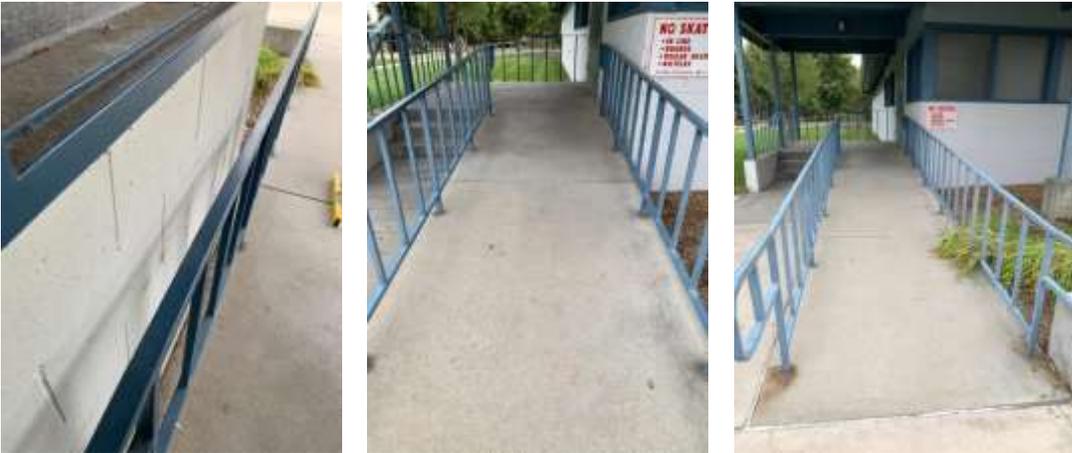
**ID:** 2395      **Facility:** Fairmont Pool House

**2010 ADA Standards for Accessible Design Codes: §505.4**  
Handrails are not at a compliant height at 32" above the floor.

Raise the handrails to a minimum height of 34" and a maximum of 38" above the ground. Ensure that the handrails are at a consistent height along the walking surface.

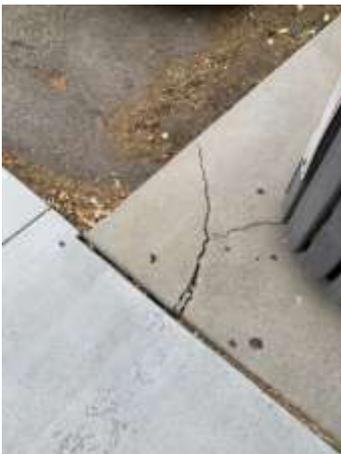
**ID:** 2396      **Facility:** Fairmont Pool House

**2010 ADA Standards for Accessible Design Codes: §302.3**  
There is a 1.25" gap causing a tripping hazard and uneven surface.

Fill in the gap to ensure that openings in the accessible route does not exceed 1/2".

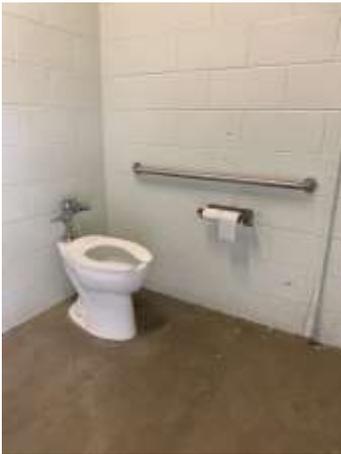
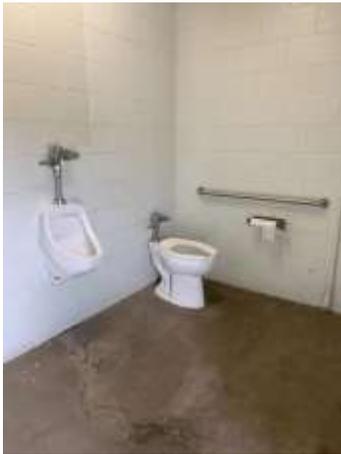
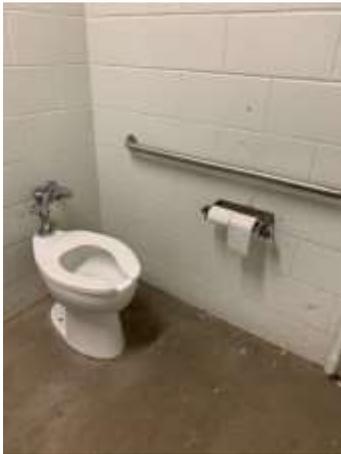
**ID:** 2060      **Facility:** Fairmont Pool House

**2010 ADA Standards for Accessible Design Codes: §604.5**  
There is no rear grab bar.

Install a rear grab bar at a minimum height of 33" and maximum height of 36" above the finish floor.

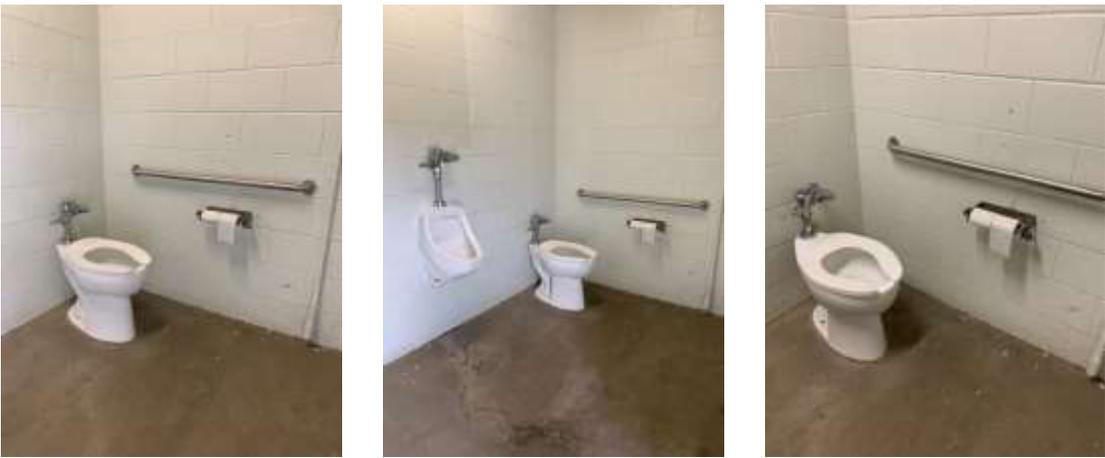
**ID:** 2061      **Facility:** Fairmont Pool House

**2010 ADA Standards for Accessible Design Codes: ICC A117.1 §604.5.1**  
The accessible water closet does not have a vertical grab bar.

Install an 18" long (minimum) vertical grab bar, mounted with the bottom located at 39" minimum and 41" maximum above the floor.  
The centerline of the vertical grab bar shall be located 39" minimum and 41" maximum from the rear wall.

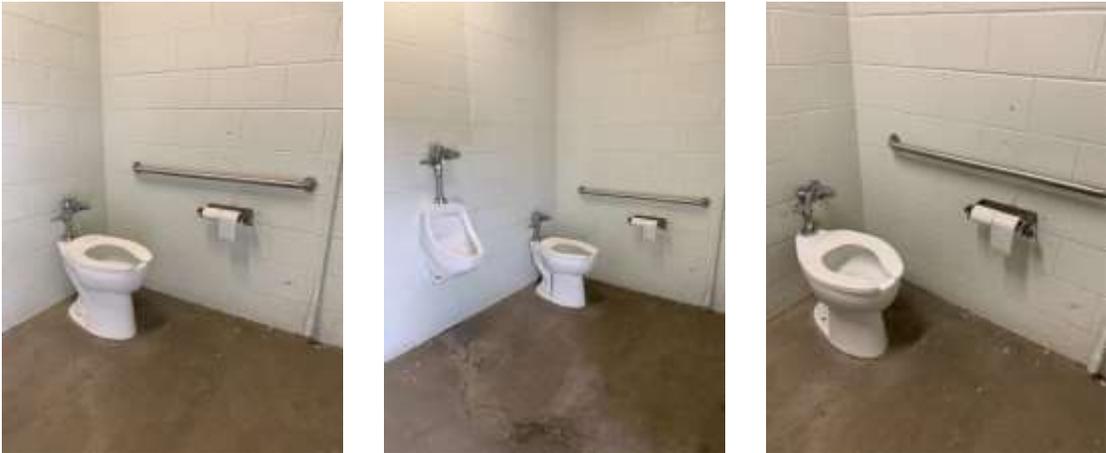
**ID:** 2062      **Facility:** Fairmont Pool House

**2010 ADA Standards for Accessible Design Codes: §604.2**  
The toilet is located 20" from the sidewall.

Reposition the toilet to be within 16" minimum and 18" maximum from the sidewall.

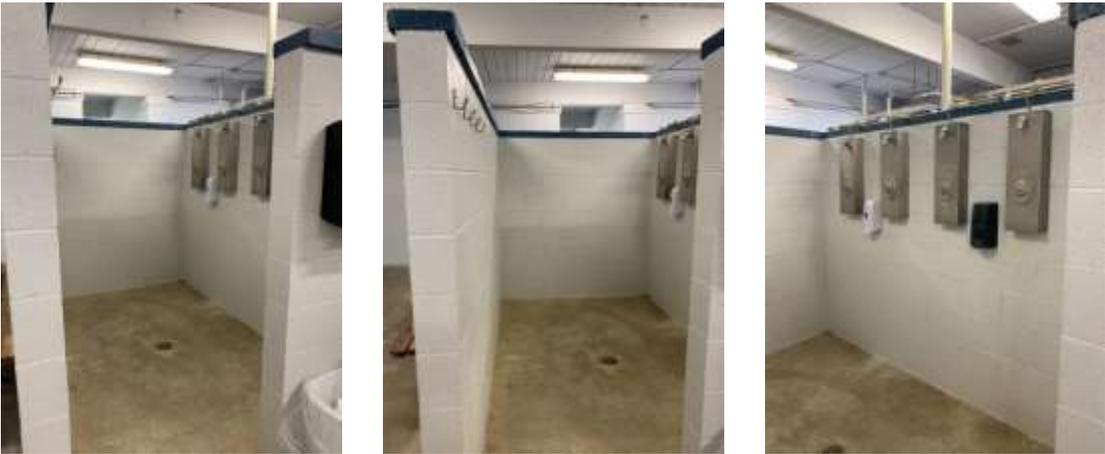
**ID:** 2110      **Facility:** Fairmont Pool House

**2010 ADA Standards for Accessible Design Codes: §308.2.1**  
The hooks are outside of the unobstructed forward reach range at 65" above the floor.

Lower at least one hook by 17" to meet the accessible reach range of 15" minimum and 48" maximum above the floor.

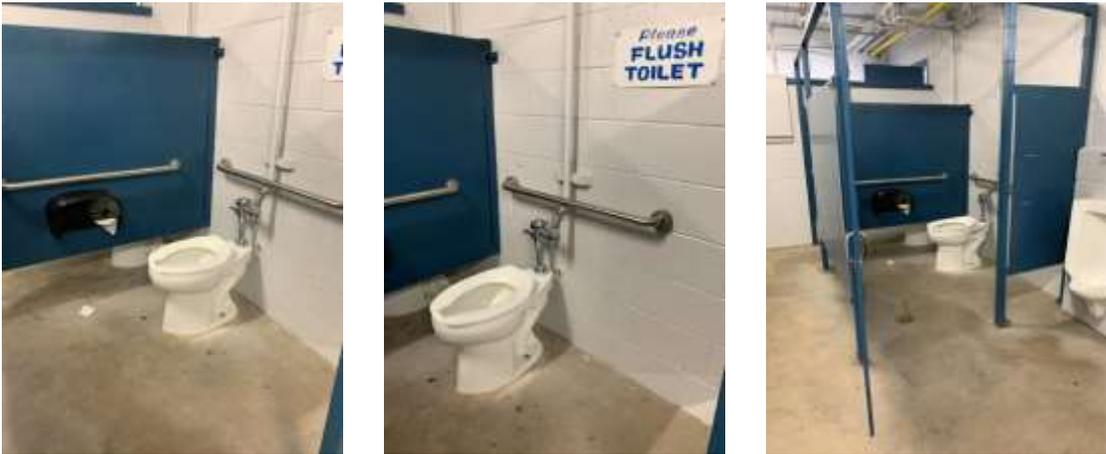
**ID:** 2100      **Facility:** Fairmont Pool House

**2010 ADA Standards for Accessible Design Codes: §604.7**  
The toilet paper dispenser is not located in an accessible position.

Remount the toilet paper dispenser so that it is located 7" minimum to 9" maximum in front of the toilet. Ensure that the height is within the accessible reach range of 15" minimum to 48" maximum above the floor.

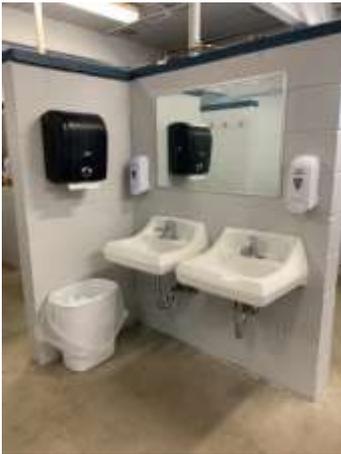
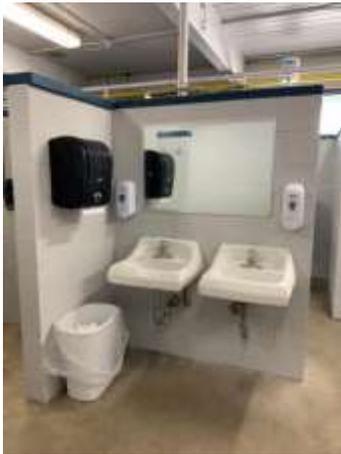
**ID:** 2112      **Facility:** Fairmont Pool House

**2010 ADA Standards for Accessible Design Codes: §603.3**  
The mirror is too high to be accessible at 43.5" above the floor.

Lower the mirror its bottom edge is a maximum height of 40" above the floor.

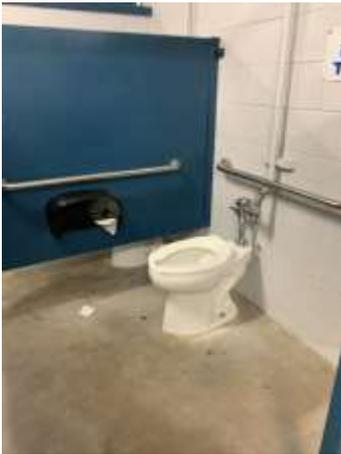
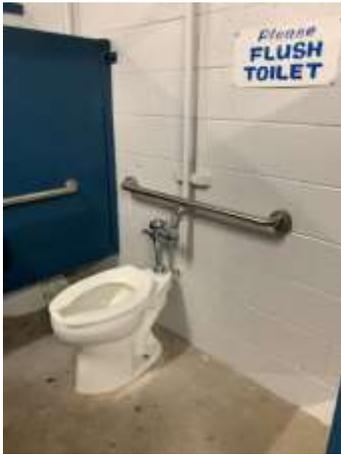
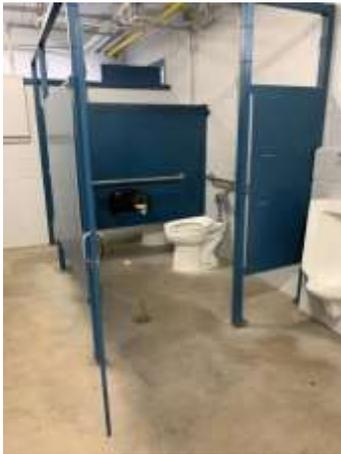
**ID:** 2098      **Facility:** Fairmont Pool House

**2010 ADA Standards for Accessible Design Codes: §604.6**  
The flush control is located on the wall side of the toilet.

Either make the toilet flush automatically or relocate the flush control to be operated on the open side of the toilet.

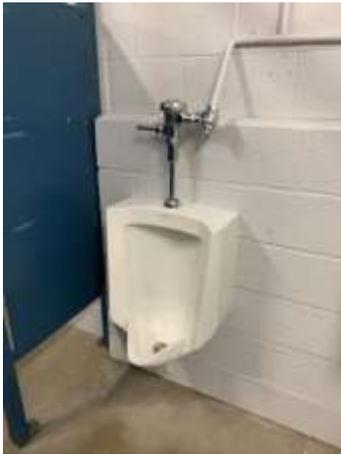
**ID:** 2102      **Facility:** Fairmont Pool House

**2010 ADA Standards for Accessible Design Codes: §605.2**  
The urinal is 18.5" above the floor.

Lower at least one of the urinals to a maximum height of 17" above the floor.
