City of Boise
ADA Assessment

Appendix A - Fire Training Center

03/26/2021

Report # TO21-B024

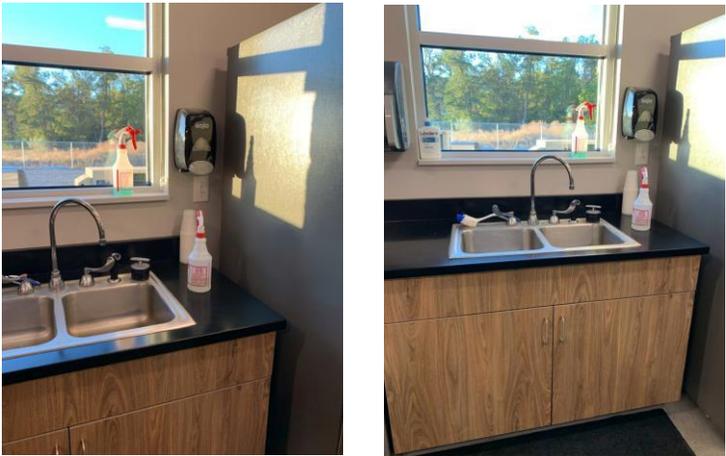
ID: 1359 **Facility:** Fire Training/Safety Building

2010 ADA Standards for Accessible Design Codes §308.2.2
The soap dispenser is outside of the obstructed forward reach range at 48.5" above the floor.

Lower the soap dispenser by 0.5" to meet the accessible reach range of 48" maximum above the floor.

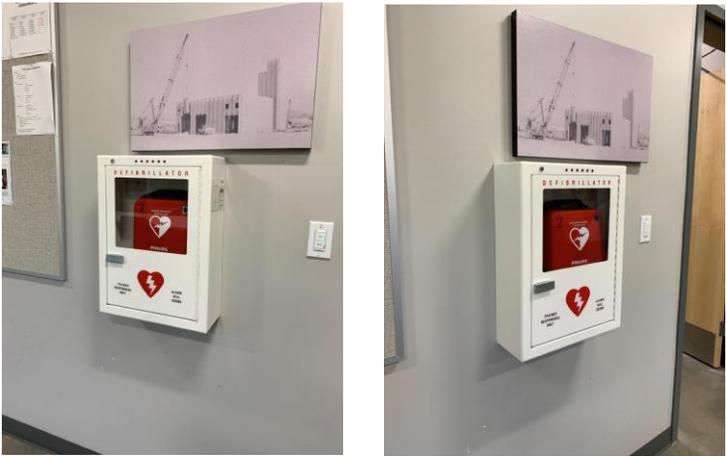
ID: 1360 **Facility:** Fire Training/Safety Building

2010 ADA Standards for Accessible Design Codes §307.2
The AED protrudes 6" into the circulation space at 34" above the floor.

Recess the AED so it protrudes a maximum of 4", lower it so the bottom edge is 27" maximum above the floor, or place a cane detectable object beneath it.

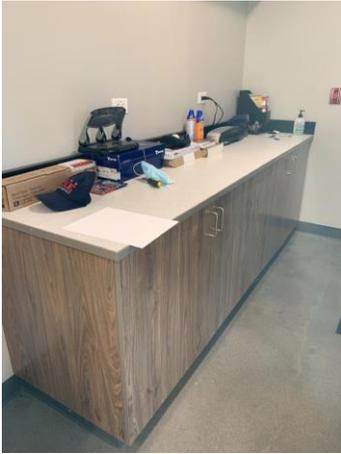
ID: 1317 **Facility:** Fire Training/Safety Building

2010 ADA Standards for Accessible Design Codes §902.3
 The dining and work surface counter is 34.5" above the floor.

A 30" portion of the dining and work surface must be no higher than 34" above the floor.

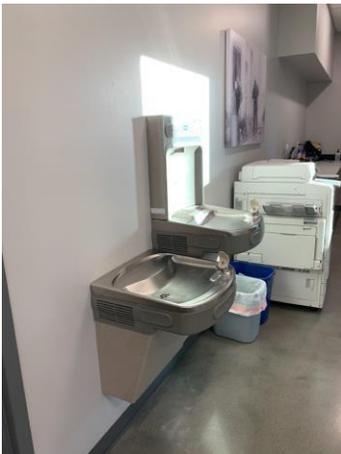
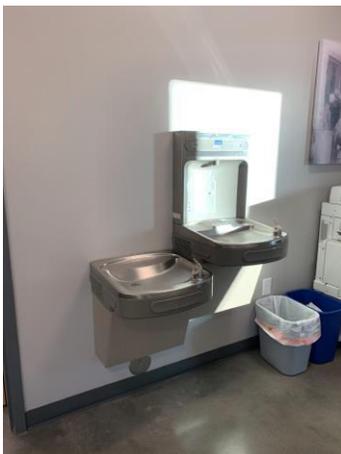
ID: 1318 **Facility:** Fire Training/Safety Building

2010 ADA Standards for Accessible Design Codes §602.4, §602.7
The height of the tall drinking fountain is not compliant at 37" above the floor.

Raise the existing drinking fountain in order to comply with the 38" minimum and 43" maximum spout height above the floor.

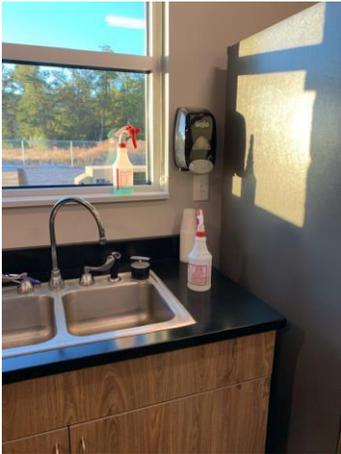
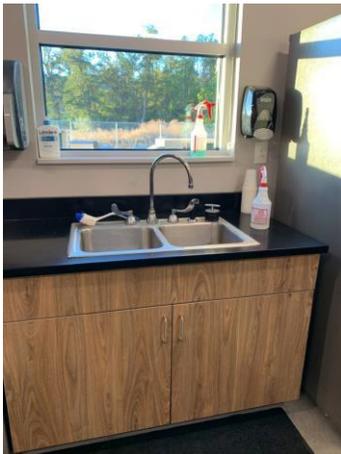
ID: 1357 **Facility:** Fire Training/Safety Building

2010 ADA Standards for Accessible Design Codes §306.3.3
There is no knee clearance underneath the sink.

Provide knee clearance underneath the counter at the sink that is a minimum of 11" deep at 9" above the floor and 8" deep at 27" above the floor.

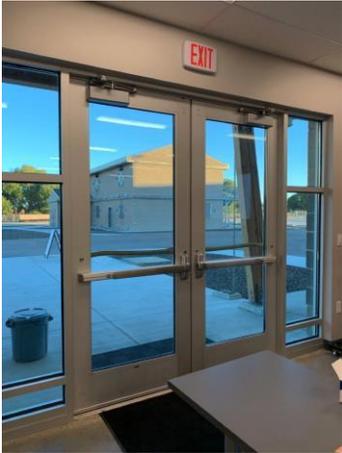
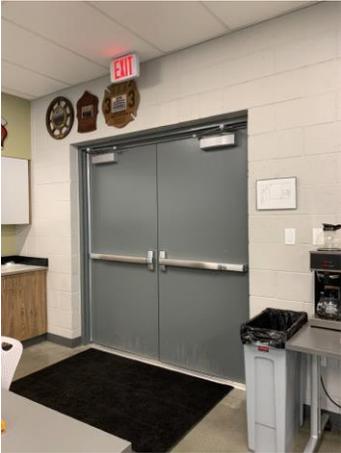
ID: 1361 **Facility:** Fire Training/Safety Building

2010 ADA Standards for Accessible Design Codes §216.4, §703
Doors serving as exits are not marked by tactile signage.

Place a tactile exit sign, that complies with §703.1, §703.2 and §703.5, identifying the exit doors.
Install missing signage at 48" minimum above the floor measured from the baseline of the lowest character and 60" maximum measured from the baseline of the highest character.

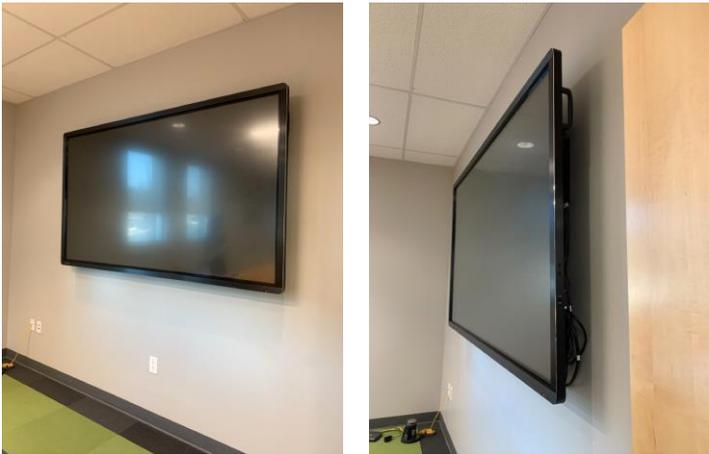
ID: 1300 **Facility:** Fire Training/Safety Building

2010 ADA Standards for Accessible Design Codes §307.2
The TV protrudes 6" into the circulation space at 45.5" above the floor.

Recess the TV so it protrudes a maximum of 4" or place a cane detectable object beneath it.

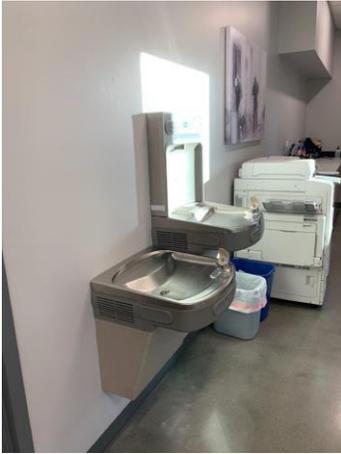
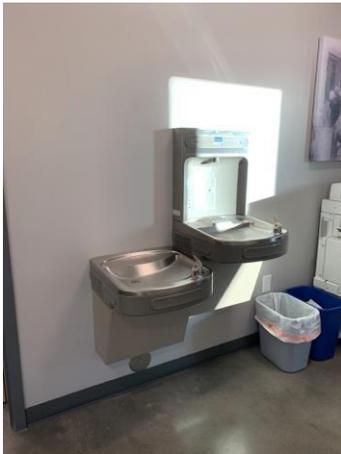
ID: 1302 **Facility:** Fire Training/Safety Building

2010 ADA Standards for Accessible Design Codes §602.4, §602.7
The height of the tall drinking fountain is not compliant at 37" above the floor.

Raise the existing drinking fountain in order to comply with the 38" minimum and 43" maximum spout height above the floor.

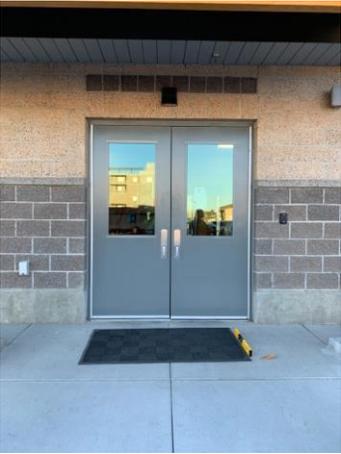
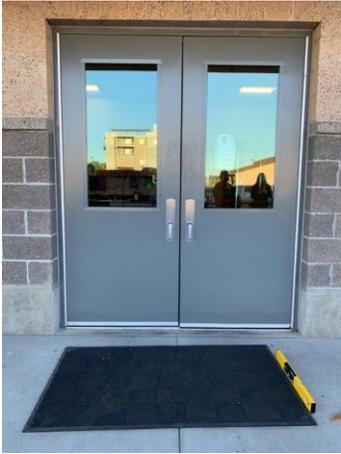
ID: 1294 **Facility:** Fire Training/Safety Building

2010 ADA Standards for Accessible Design Codes §404.2.4.4
The entrance has a 3%.

Resurface the entryway to reduce the running slope to a maximum of 2% in all directions.

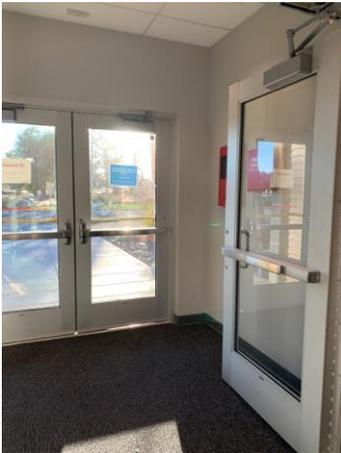
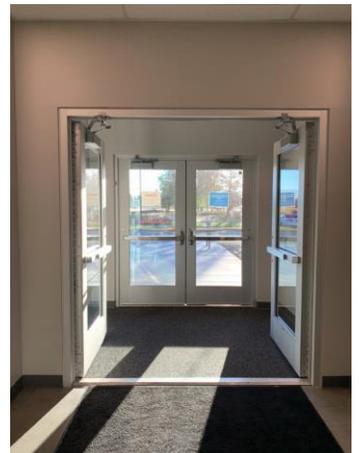
ID: 1295
Facility: Fire Training/Safety Building

2010 ADA Standards for Accessible Design Codes §404.2.6

Between the two hinged or pivoted doors, the width is 46".

Remove the inside set of doors or reverse the swing of the inside set of doors.

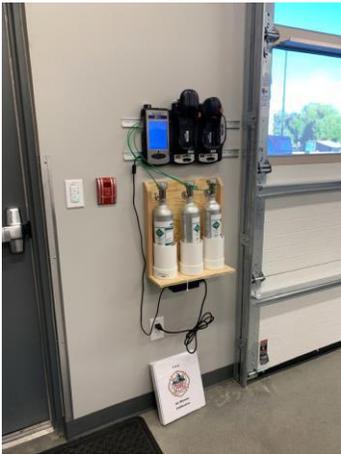
ID: 1299 **Facility:** Fire Training/Safety Building

2010 ADA Standards for Accessible Design Codes §307.2
The gas tanks protrude 6.5" into the circulation space at 28" above the floor.

Recess the gas tanks so they protrude a maximum of 4", lower them so the bottom edge is 27" maximum above the floor, or place a cane detectable object beneath them.

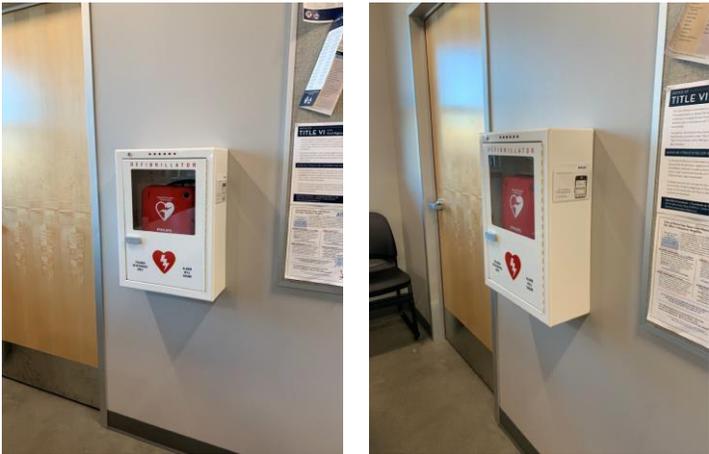
ID: 1315 **Facility:** Fire Training/Safety Building

2010 ADA Standards for Accessible Design Codes §307.2
The AED protrudes 6" into the circulation space at 34" above the floor.

Recess the AED so it protrudes a maximum of 4", lower it so the bottom edge is 27" maximum above the floor, or place a cane detectable object beneath it.

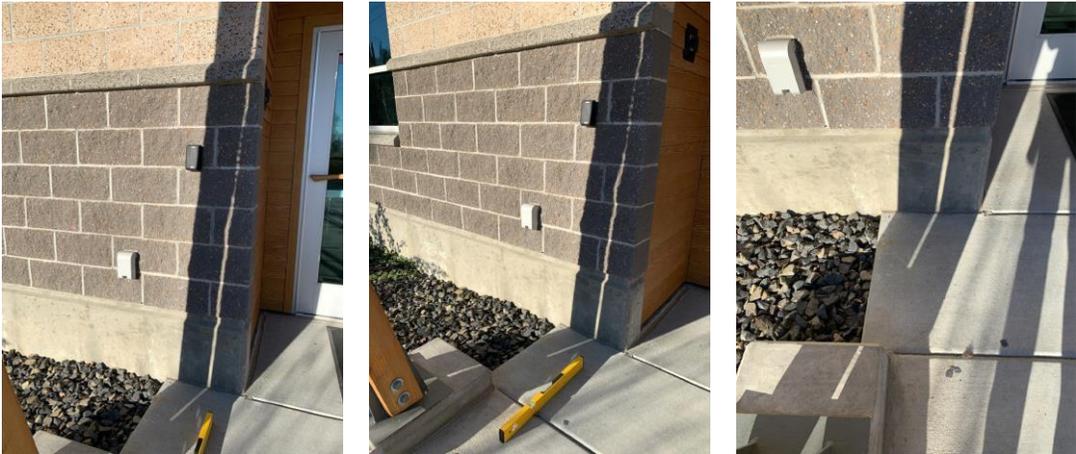
ID: 1279 **Facility:** Fire Training/Safety Building

2010 ADA Standards for Accessible Design Codes §308.2.1
The badge scanner is outside of the unobstructed forward reach range at 52" above the floor.

Lower the badge scanner by 4" to meet the accessible reach range of 48" maximum above the floor.

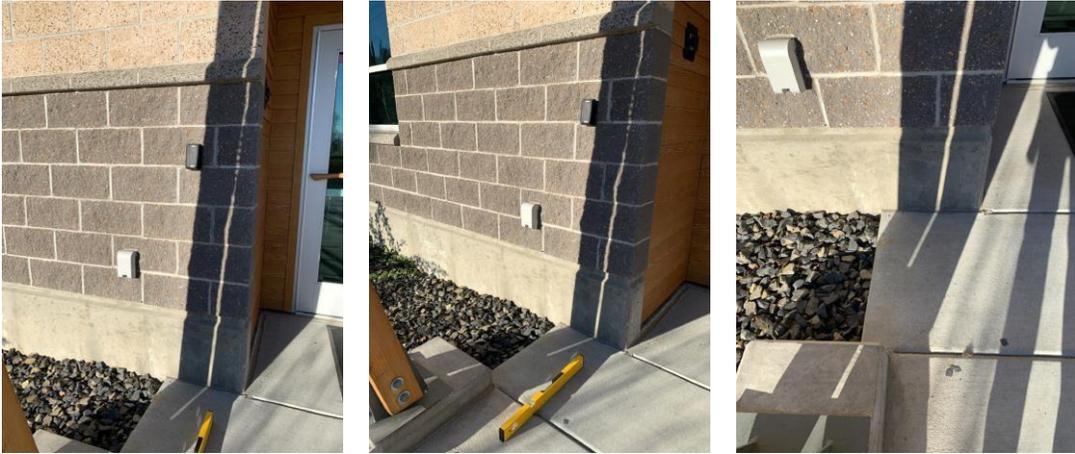
ID: 1280 **Facility:** Fire Training/Safety Building

2010 ADA Standards for Accessible Design Codes §305.2

The clear floor space to access the card scanner at the main entrance is not large enough.

Expand the clear floor space to be 30"x48" with a maximum slope of 2% in all directions.

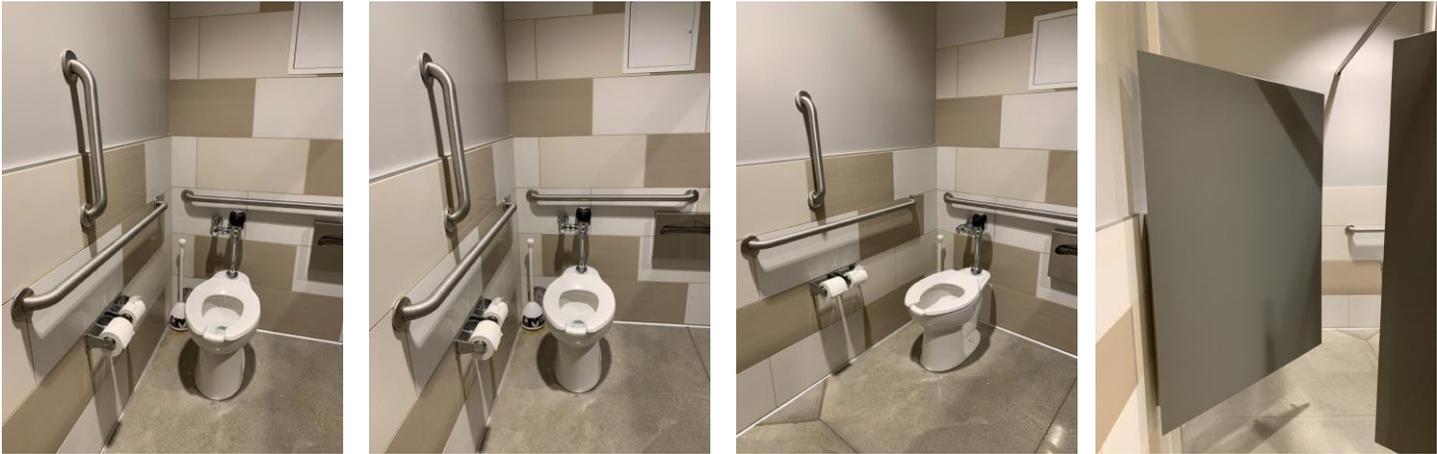
ID: 1309 **Facility:** Fire Training/Safety Building

2010 ADA Standards for Accessible Design Codes §604.8.1.2
The door to the accessible water closet is not self closing. Either self-closing hinges are not installed on the door or if installed, they are defective.

Install or reinstall self-closing hinges on the door to ensure that the door is self-closing per the ADA requirements.

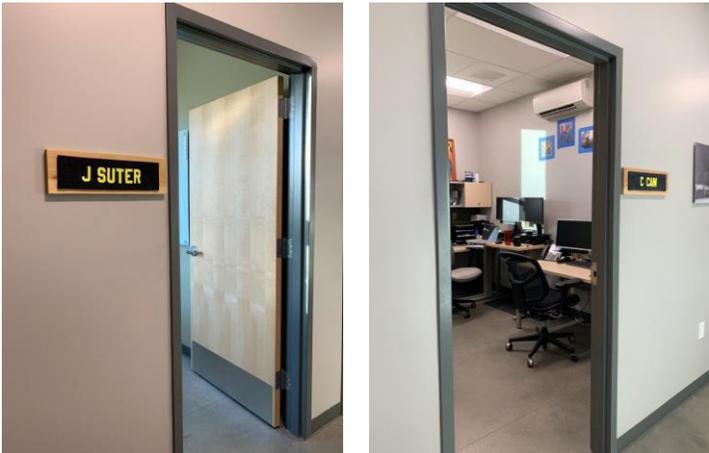
ID: 1316 **Facility:** Fire Training/Safety Building

2010 ADA Standards for Accessible Design Codes §216.2, §703
Throughout the Fire Department buildings, there are no tactile signs identifying 36 permanent rooms.

Install tactile signage on the latch side of the doorway at a height of 48” minimum to 60” maximum above the floor, identifying room by name or room number.
Signs shall be Braille with raised lettering and should be placed on the wall in the center of an 18"x18" clear floor space.

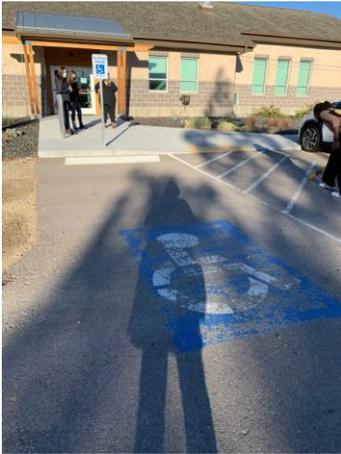
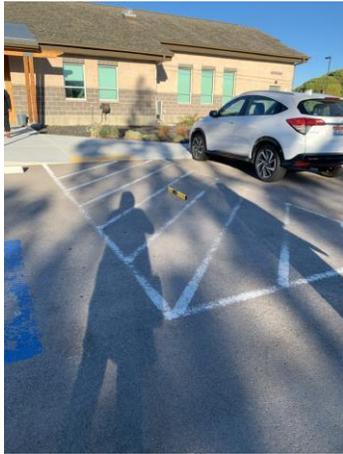
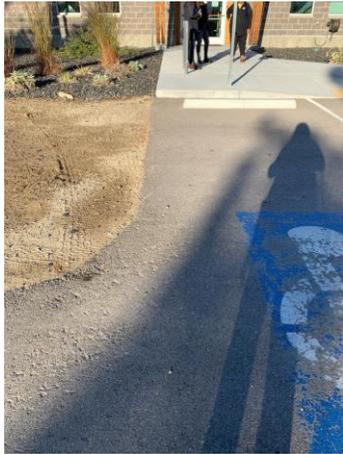
ID: 1277 **Facility:** Fire Training/Safety Building

2010 ADA Standards for Accessible Design Codes §216.5
The parking sign identifying the accessible parking space does not meet the minimum height requirement of 60" from the ground.

Remount the accessible parking sign to ensure 60" minimum height from the ground.

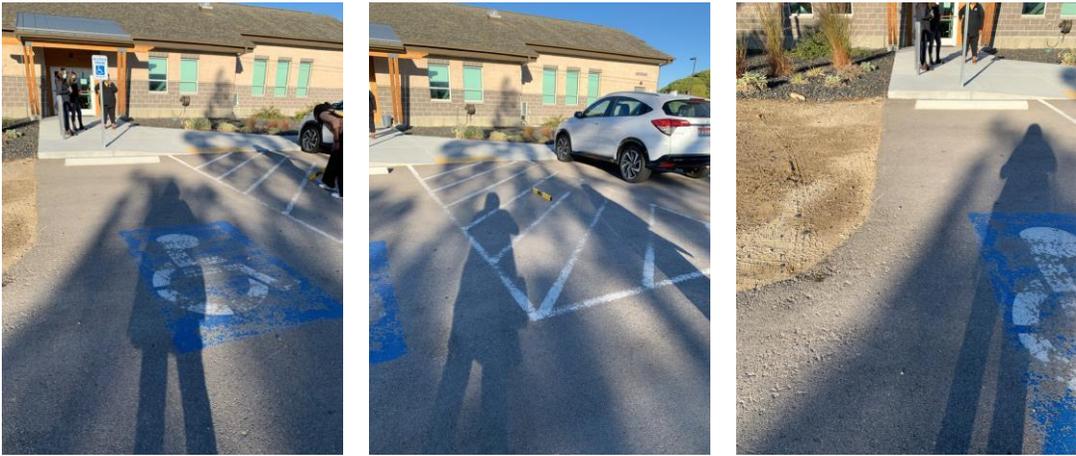
ID: 1276 **Facility:** Fire Training/Safety Building

2010 ADA Standards for Accessible Design Codes §208.2.4, §502
There are no painted lines on the left side of the accessible parking space and ISA symbols are fading.

Stripe the left side of the accessible parking space and repaint the ISA symbols.

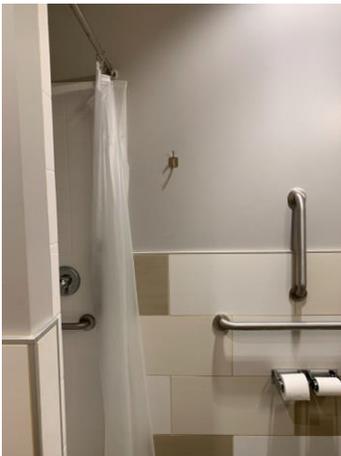
ID: 1343 **Facility:** Fire Training/Safety Building

2010 ADA Standards for Accessible Design Codes §308.2.1
The hook is outside of the unobstructed forward reach range at 64" above the floor.

Lower the hook by 16" to meet the accessible reach range of 48" maximum above the floor.

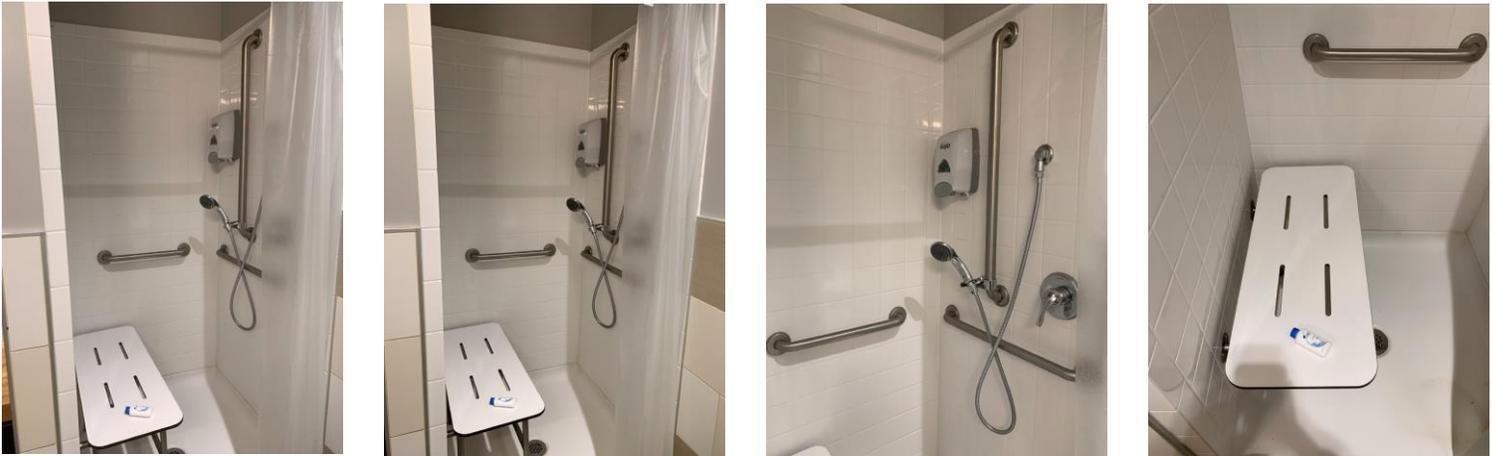
ID: 1348 **Facility:** Fire Training/Safety Building

2010 ADA Standards for Accessible Design Codes §308.2.1
The soap dispenser is outside of the unobstructed forward reach range at 54" above the floor.

Lower the soap dispenser by 6" to meet the accessible reach range of 48" maximum above the floor.

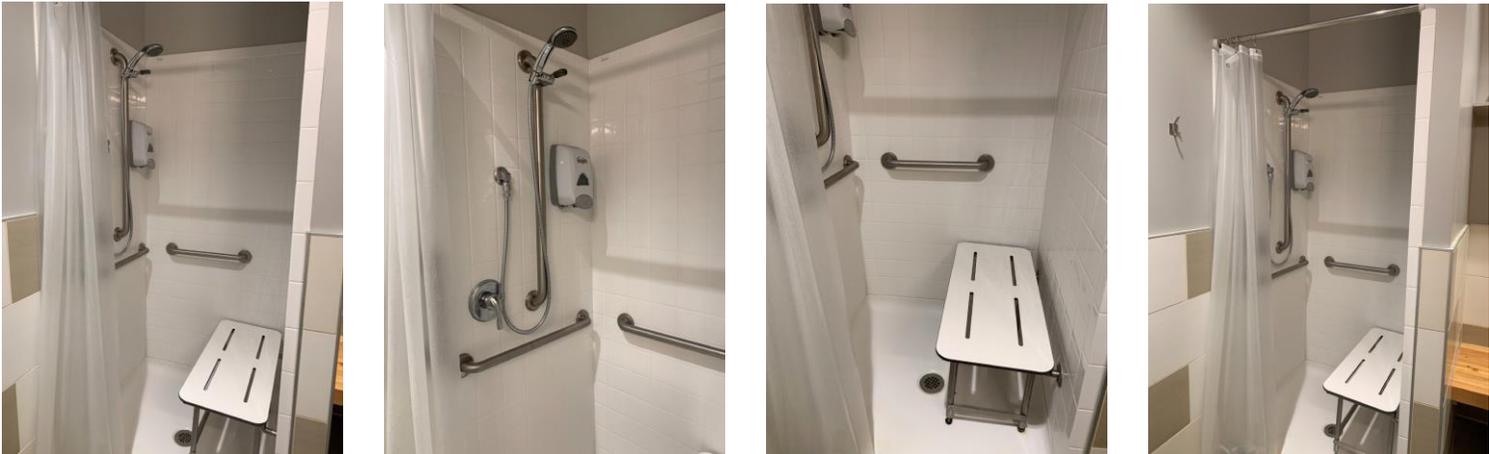
ID: 1336 **Facility:** Fire Training/Safety Building

2010 ADA Standards for Accessible Design Codes §308.2.1
The soap dispenser is outside of the unobstructed forward reach range at 54" above the floor.

Lower the soap dispenser by 6" to meet the accessible reach range of 48" maximum above the floor.

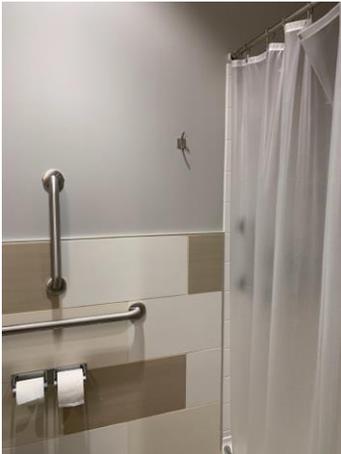
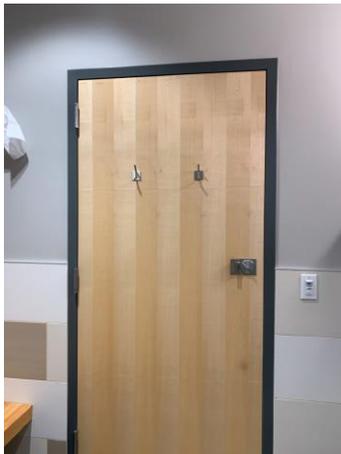
ID: 1338 **Facility:** Fire Training/Safety Building

2010 ADA Standards for Accessible Design Codes §308.2.1

The hooks are outside of the unobstructed forward reach range at 64" above the floor.

Lower at least one of the hooks by 16" to meet the accessible reach range of 48" maximum above the floor.

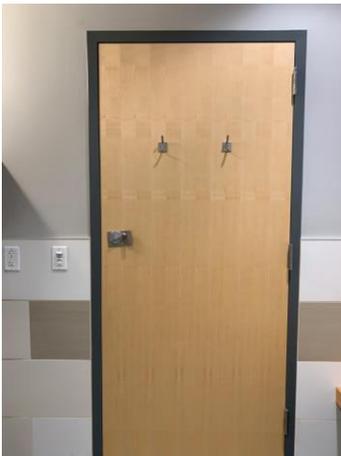
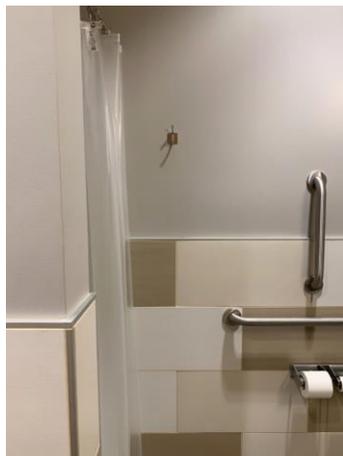
ID: 1321 **Facility:** Fire Training/Safety Building

2010 ADA Standards for Accessible Design Codes §308.2.1

The hooks are outside of the unobstructed forward reach range at 64" above the floor.

Lower at least one of the hooks by 16" to meet the accessible reach range of 48" maximum above the floor.

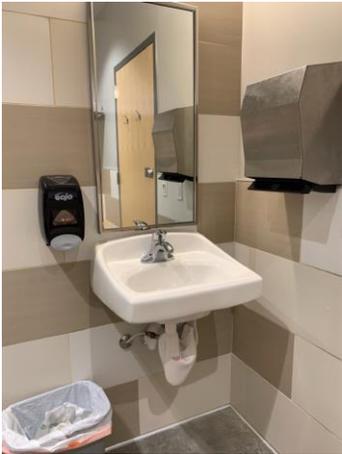
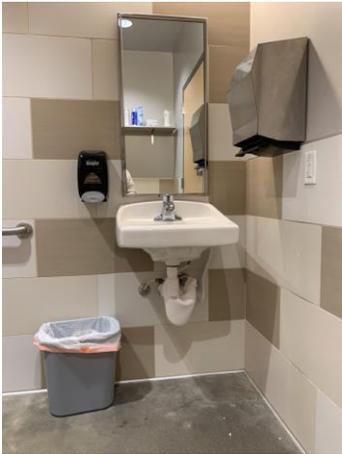
ID: 1326 **Facility:** Fire Training/Safety Building

2010 ADA Standards for Accessible Design Codes §606.3
The sink is 35" above the floor.

Lower the sink to the maximum height of 34" above the floor.

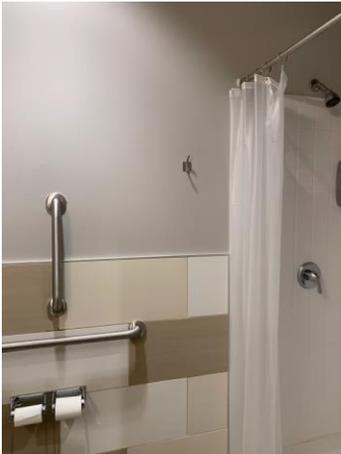
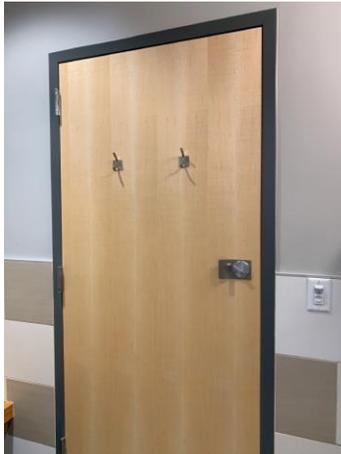
ID: 1289 **Facility:** Fire Training/Safety Building

2010 ADA Standards for Accessible Design Codes §308.2.1

The hooks are outside of the unobstructed forward reach range at 64" above the floor.

Lower at least one of the hooks by 16" to meet the accessible reach range of 48" maximum above the floor.

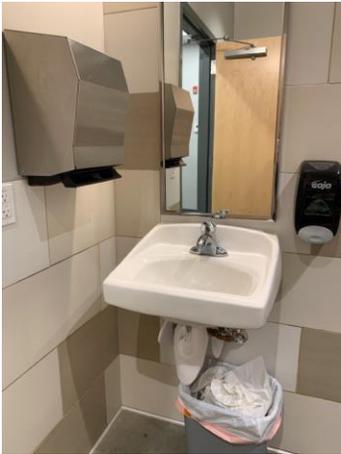
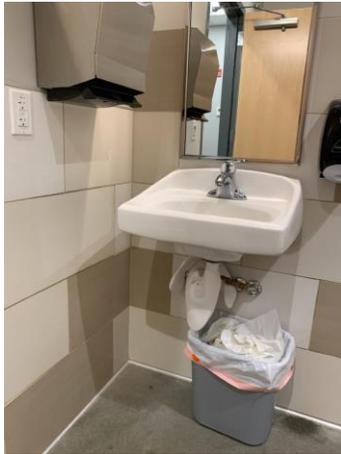
ID: 1293 **Facility:** Fire Training/Safety Building

2010 ADA Standards for Accessible Design Codes §606.3
The sink is 34.75" above the floor.

Lower the sink to the maximum height of 34" above the floor.

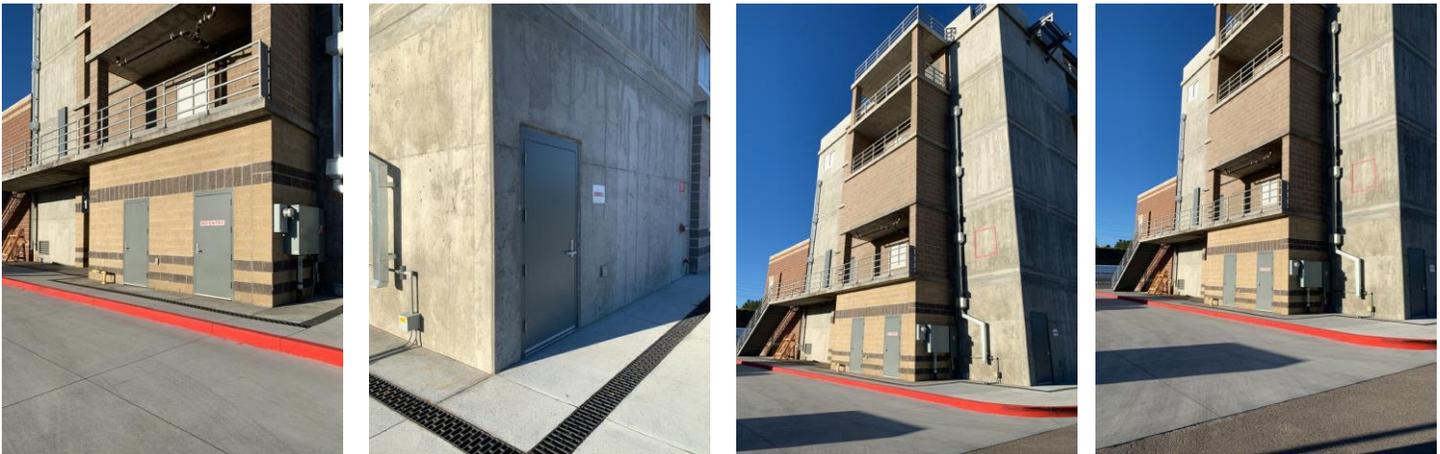
ID: 1283 **Facility:** Fire Training CMRCL Tower Burn

2010 ADA Standards for Accessible Design Codes §216.2, §703

There are no tactile signs identifying twelve permanent rooms.

Since the Fire Training CMRCL Tower Burn is used for firefighter training purposes only, there are no recommendations at this time.

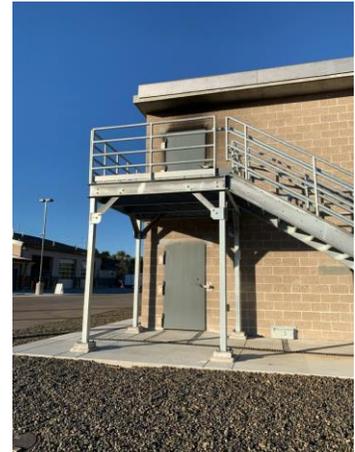
ID: 1284 **Facility:** Fire Training CLSS A Burn Building

2010 ADA Standards for Accessible Design Codes §216.2, §703

There is no tactile sign identifying four permanent rooms.

Since the CLSS A Burn Building is used for firefighter training purposes only, there are no recommendations at this time.

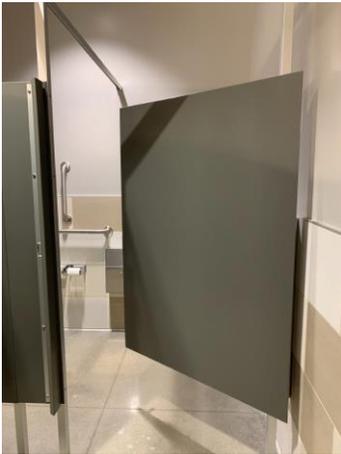
ID: 1303 **Facility:** Fire Training Admin Building

2010 ADA Standards for Accessible Design Codes §604.8.1.2
The door to the accessible water closet is not self closing. Either self-closing hinges are not installed on the door or if installed, they are defective.

Install or reinstall self-closing hinges on the door to ensure that the door is self-closing per the ADA requirements. Ensure that there is adequate maneuvering clearance to operate the door.

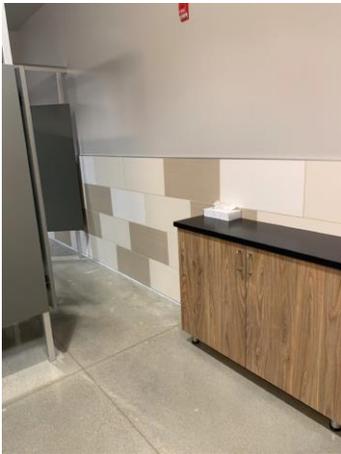
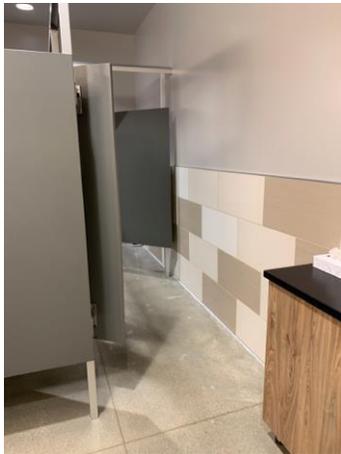
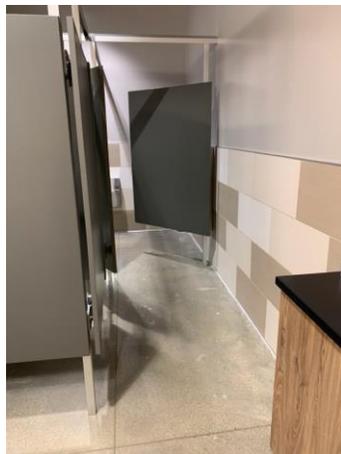
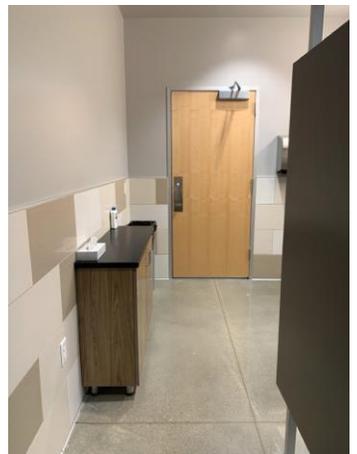
ID: 1308 **Facility:** Fire Training Admin Building

2010 ADA Standards for Accessible Design Codes §403.5.1

There is not a clear 36" width for wheelchairs to pass between the counter and the restroom door. When the restroom door is closed, the width is 29.5". When the restroom door is open, the width is 27.75".

Remove the counter from the restroom to ensure that there is a minimum clear width of 36".

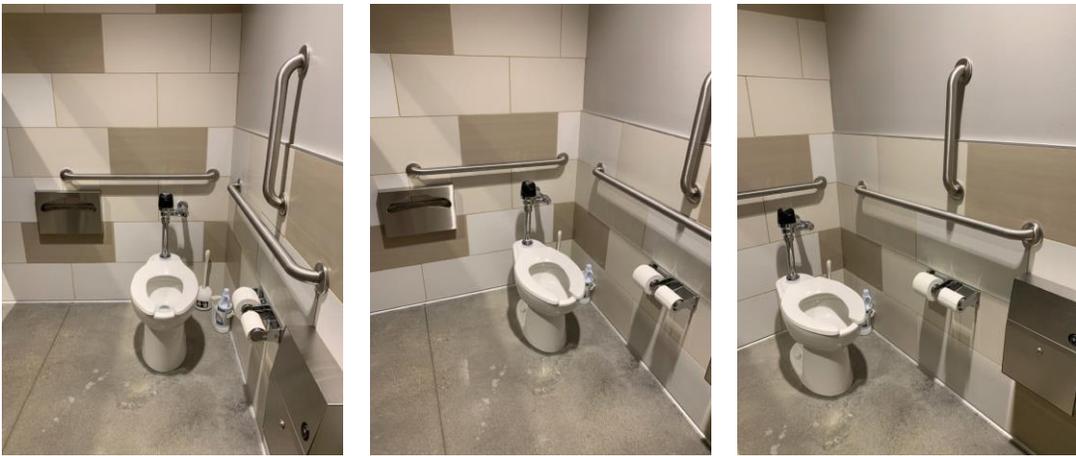
ID: 1305 **Facility:** Fire Training Admin Building

2010 ADA Standards for Accessible Design Codes §604.5.1
The side grab bar is located 11" from the rear wall, is 33" long, and extends 44.5" from the rear wall.

Replace the side grab bar with one that is a minimum of 42" long minimum, located 12" maximum from the rear wall and extending 54" minimum from the rear wall.
