City of Boise ADA  
Assessment

# Appendix A-Ivywild Pool House

12/4/2020

Report #TO20-B005

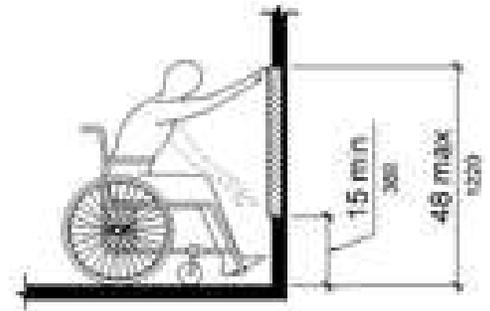
**2010 ADA Standards for Accessible Design Codes: §308.2.1**

The paper towel dispenser is outside of the unobstructed forward reach range at 61.5" above the floor.

Lower the paper towel dispenser by 13.5" to meet the accessible reach range of 15" minimum and 48" maximum above the floor.

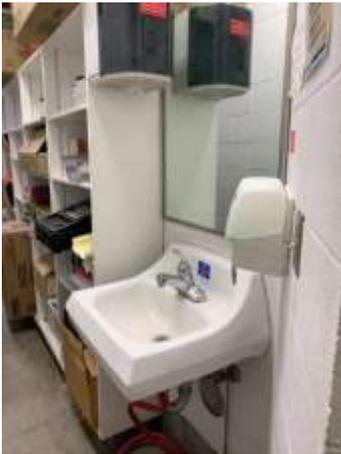
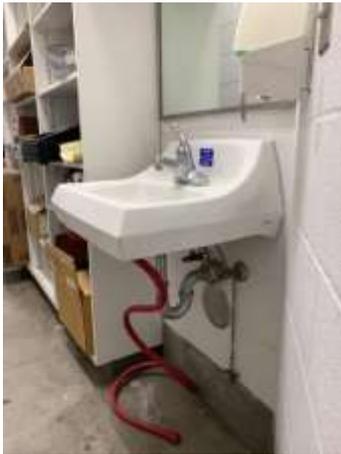
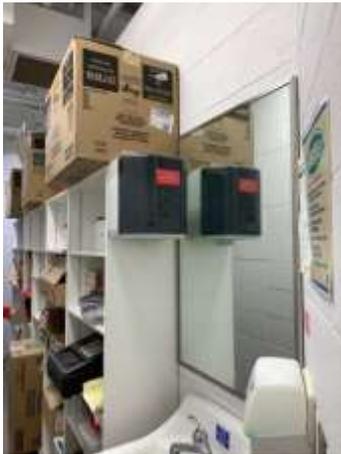
**2010 ADA Standards for Accessible Design Codes: §603.3**  
The mirror is too high to be accessible at 42" above the floor.

Lower the mirror its bottom edge is a maximum height of 40" above the floor.

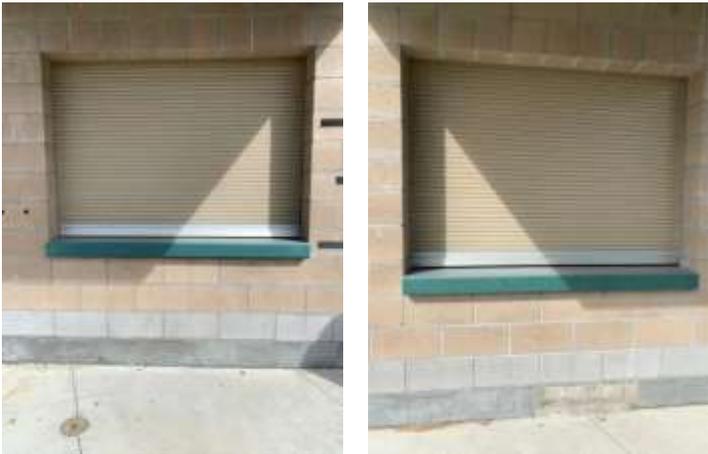
**2010 ADA Standards for Accessible Design Codes: §904.4.1**  
The counter is 36.75" above the ground.

A portion of the service counter must be no higher than 36" above the floor for a horizontal distance of 36".

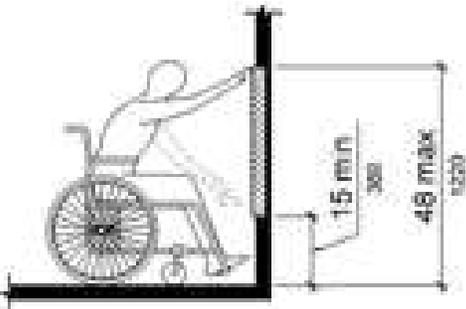
**2010 ADA Standards for Accessible Design Codes: §308.2.1**  
The hooks are outside of the unobstructed forward reach range at 55" above the floor.

Lower the hooks by 7" to meet the accessible reach range of 15" minimum and 48" maximum above the floor.

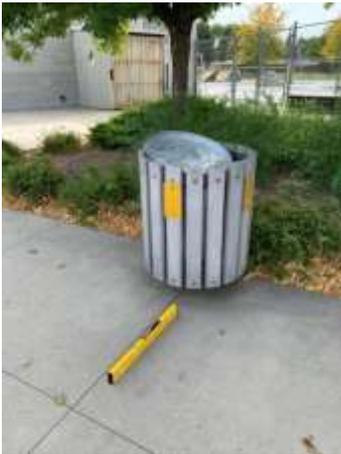
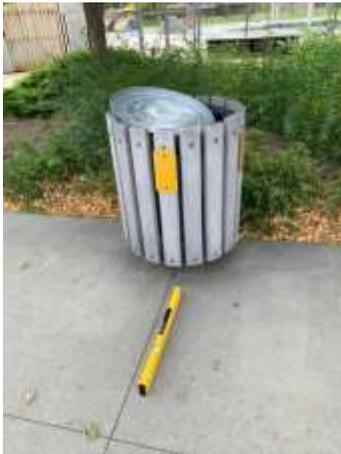
**2010 ADA Standards for Accessible Design Codes: §305.2**  
The clear floor space at the garbage can has a 2.2% slope.

Resurface the 30"x48" clear floor space to have a maximum slope of 2% slope.

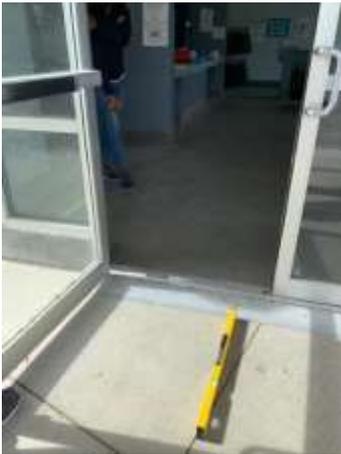
**2010 ADA Standards for Accessible Design Codes: §404.2.4.4**  
The main entrance's maneuvering clearance has a 2.4% slope.

Resurface the entryway to reduce the slope to a maximum of 2% in all directions.

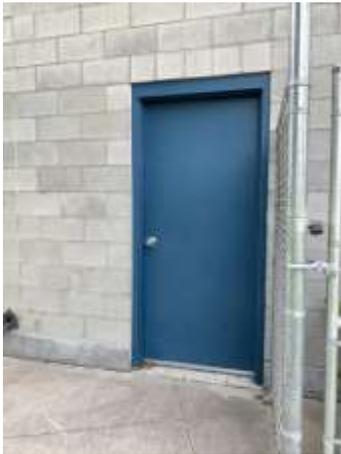
**2010 ADA Standards for Accessible Design Codes:** §216.2, §703  
There is no tactile sign identifying the permanent room.

Install tactile signage on the latch side of the doorway at a height of 48” minimum to 60” maximum above the floor, identifying room by name or room number.  
Signs shall be Braille with raised lettering and should be placed on the wall in the center of an 18"x18" clear floor space.

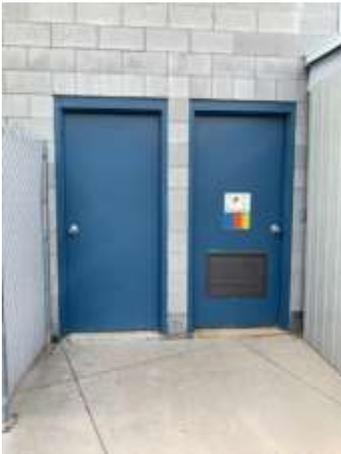
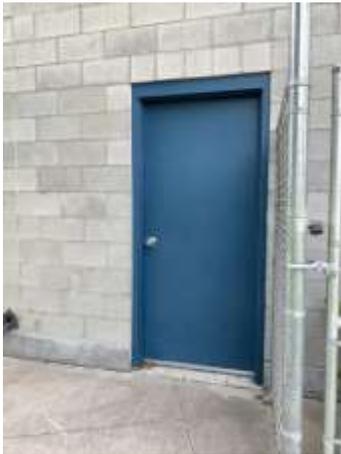
**2010 ADA Standards for Accessible Design Codes: §309.4**  
The door knob requires twisting of the wrist.

Replace the door knob with a lever handle that can be operated with a closed fist and without twisting the wrist.

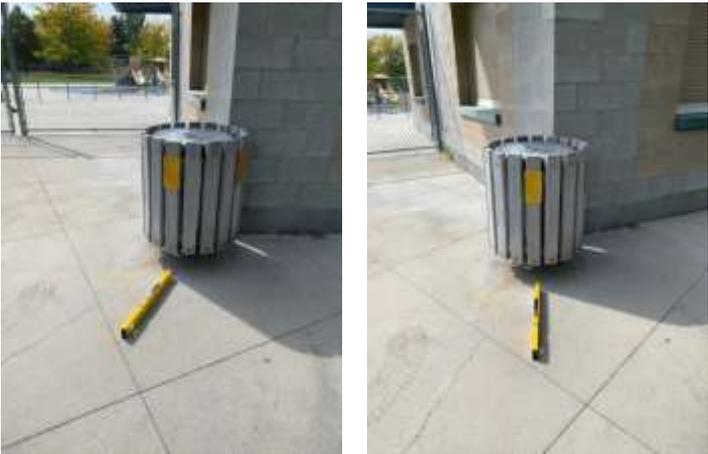
**2010 ADA Standards for Accessible Design Codes: §305.2**  
The clear floor space at the garbage can has a 2.8% slope.

Resurface the 30"x48" clear floor space to have a maximum slope of 2% slope.

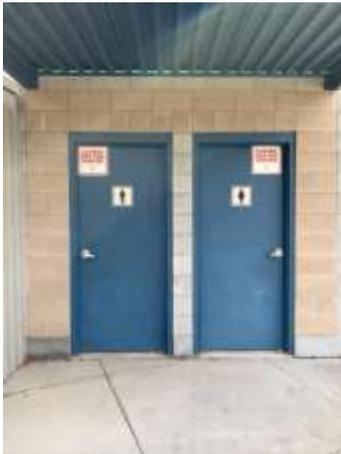
**2010 ADA Standards for Accessible Design Codes: §703.4**  
The tactile signs identifying the rooms are not in the correct locations.

Reinstall the sign on the latch side of the doors at 48" minimum above the floor measured from the baseline of the lowest character and 60" maximum measured from the baseline of the highest character.

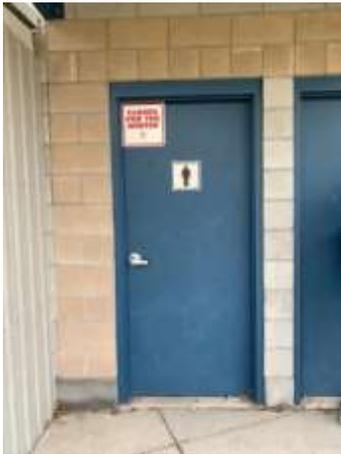
**2010 ADA Standards for Accessible Design Codes: §404.2.5**  
The threshold at the restroom doorway is 0.75" high.

Reduce the metal lip on the door to no more than 0.5" to 0.75" if beveled on each side.

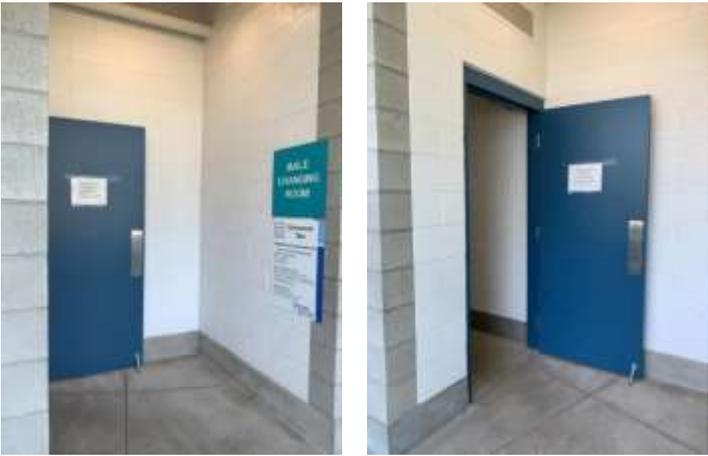
**2010 ADA Standards for Accessible Design Codes: §703.4**  
The tactile sign identifying the room is not in the correct location.

Reinstall the sign on the latch side of the door at 48" minimum above the floor measured from the baseline of the lowest character and 60" maximum measured from the baseline of the highest character.

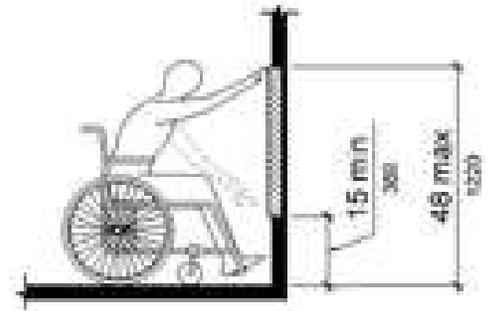
**2010 ADA Standards for Accessible Design Codes: §308.2.1**

The hooks are outside of the unobstructed forward reach range at 55" above the floor.

Lower the hooks by 7" to meet the accessible reach range of 15" minimum and 48" maximum above the floor.

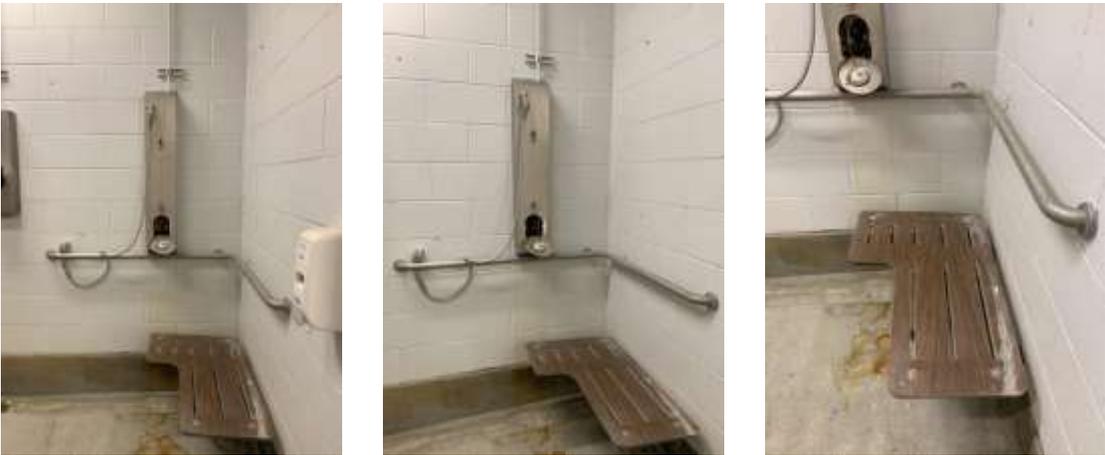
**2010 ADA Standards for Accessible Design Codes: §609.3, §607.6**  
The adjustable shower head bar is missing and the top part of the bar is broken.

Install a new shower head with a 59" long minimum hose to allow for a user to sit or stand.  
Ensure that the shower head is located at least a distance of 12" or greater away from the grab bar.

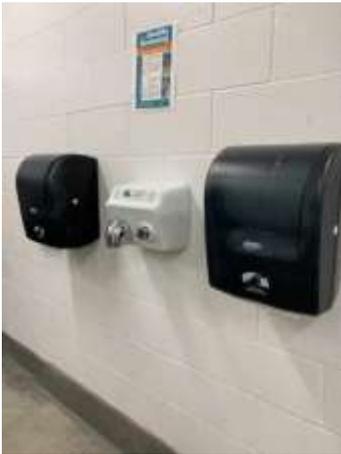
**2010 ADA Standards for Accessible Design Codes: §307.2**  
The paper towel dispensers protrude 8" into the circulation space at 41" above the floor.

Recess the paper towel dispensers so they protrude a maximum of 4", lower them so the bottom edge is 27" maximum above the floor, or place a cane detectable object beneath them.

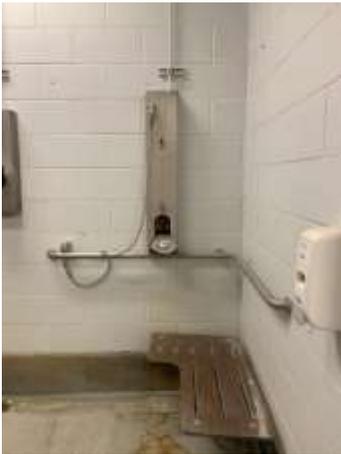
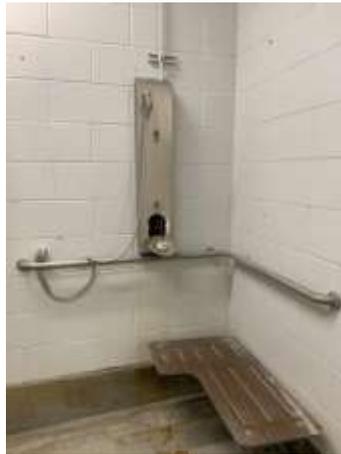
**2010 ADA Standards for Accessible Design Codes: §608.5.1**

The shower controls are 70" above the floor.

Adjust the height of shower controls to a minimum height of 38" and a maximum height of 48" above the floor.

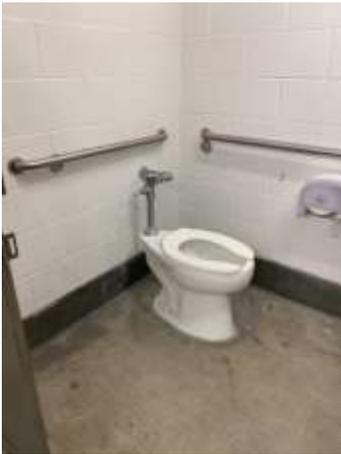
**2010 ADA Standards for Accessible Design Codes: §604.5.1**  
The side grab bar is located 7.5" from the rear wall.

Remount the side grab bar 12" maximum from the rear wall and extending 54" minimum from the rear wall.

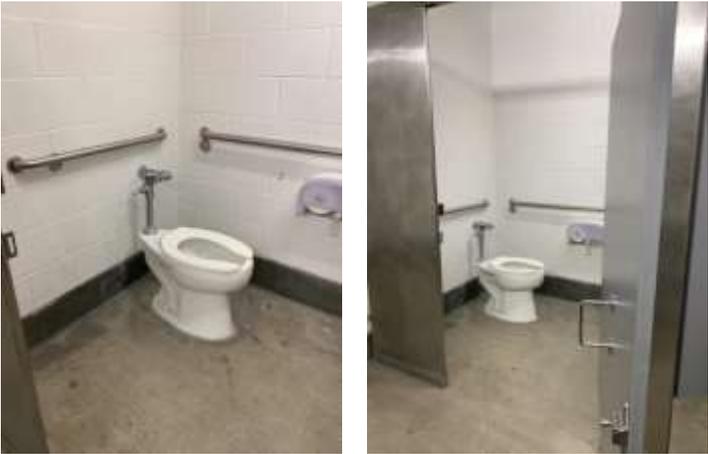
**2010 ADA Standards for Accessible Design Codes: §604.5.2**  
The rear grab bar is located 7" from the side wall.

Replace the rear grab bar with one that is a minimum of 36" long minimum and extends from the centerline of the water closet 12" minimum on one side and 24" minimum on the other.

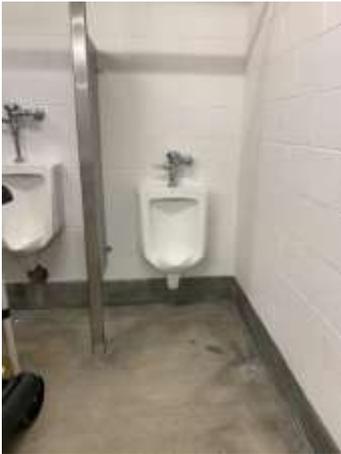
**2010 ADA Standards for Accessible Design Codes: §605.2**  
The urinal is 17.5" above the floor.

Lower the urinal to a maximum height of 17" above the floor.

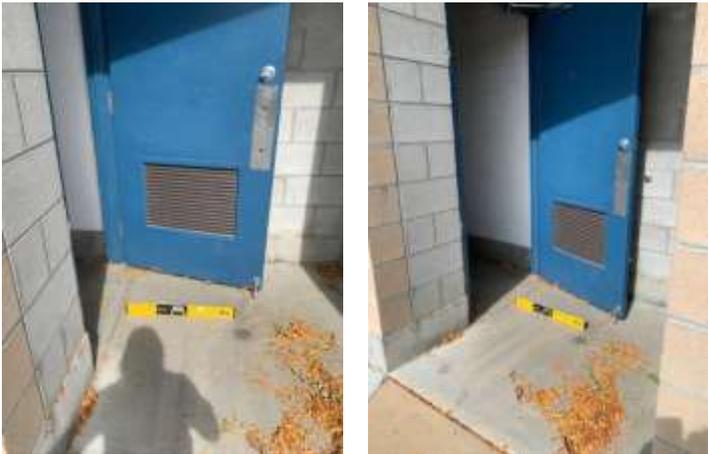
**2010 ADA Standards for Accessible Design Codes: §404.2.4.4**  
The maneuvering clearance at the entrance has a 4.8% cross slope and 3% running slope.

Resurface the entryway to reduce the slope to a maximum of 2% in all directions.

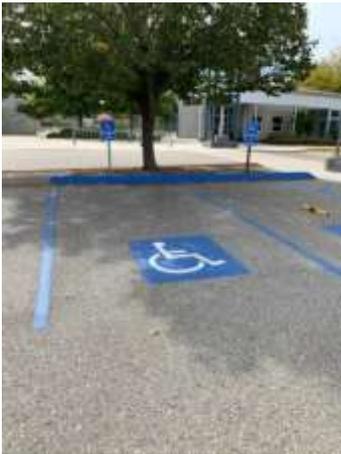
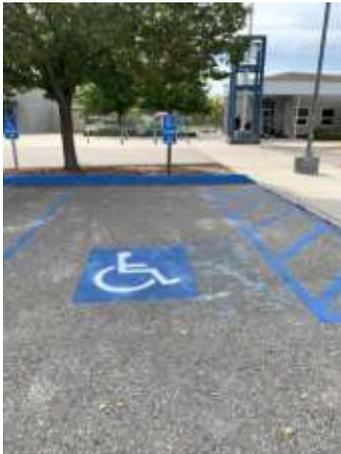
**2010 ADA Standards for Accessible Design Codes: §502.6**  
The accessible parking space signs are 37" and 33" above the ground.

Remount the accessible parking signs at each accessible space at a minimum height of 60" above the ground.

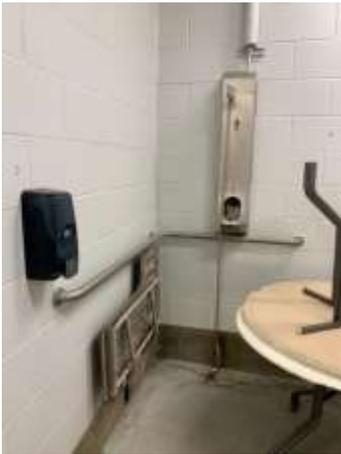
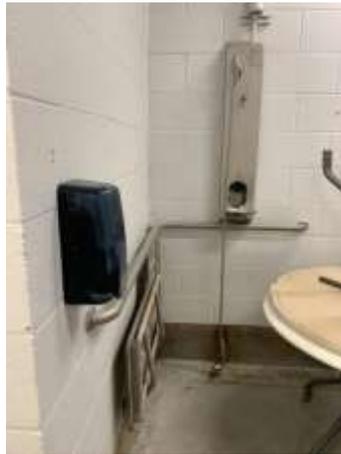
The adjustable shower head is broken.

Replace the adjustable shower head. Ensure that there is a 59" long hose to allow for a user to sit or stand.
