City of Boise
ADA Assessment

Appendix A – Library! At Bown Crossing

01/27/2021

Report # TO21-B014

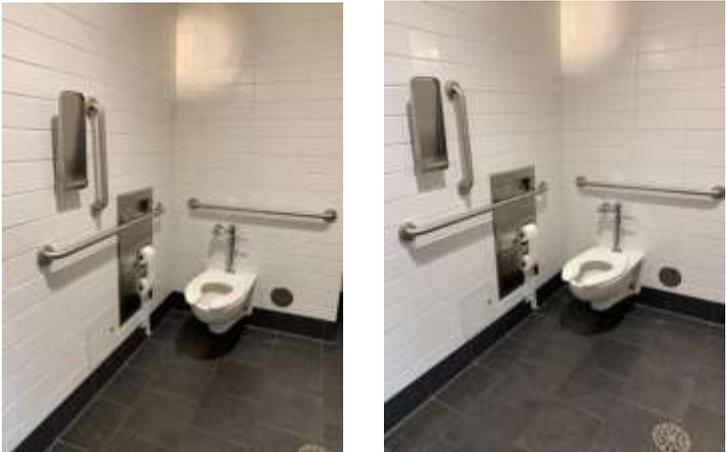
2010 ADA Standards for Accessible Design Codes §604.7
The toilet paper dispenser is located out of the accessible reach range.

Remount the toilet paper dispenser to 7" minimum and 9" maximum in front of the water closet measured to the centerline of the dispenser.
The outlet of the dispenser shall be 15" minimum and 48" maximum above the floor and shall not be located behind.

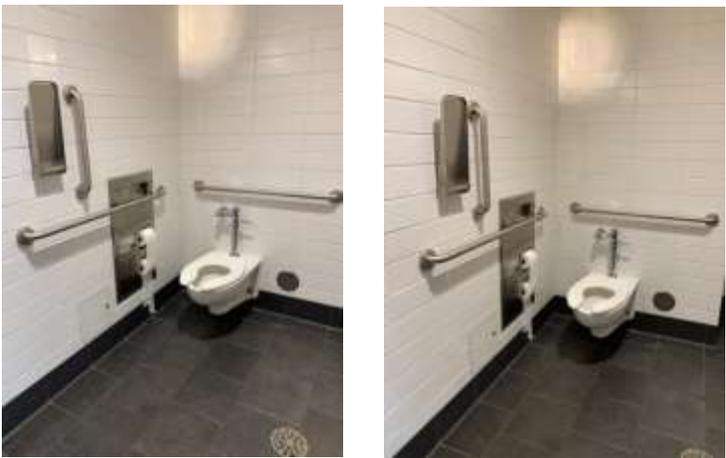
2010 ADA Standards for Accessible Design Codes §609.3
The space between the grab bar and the shelf is 9.5".

Relocate the shelf to a location that is at least a distance of 12" or greater above the grab bar. Ensure that the shelf is not greater than 48" above the floor.

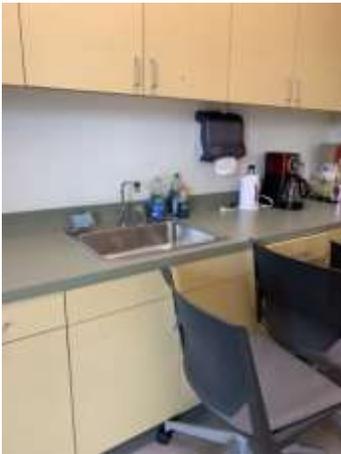
2010 ADA Standards for Accessible Design Codes §308.2.2
The paper towel dispenser is outside of the obstructed forward reach range at 46" above the floor.

Lower the paper towel dispenser by 2" to meet the accessible reach range of 44" maximum above the floor.

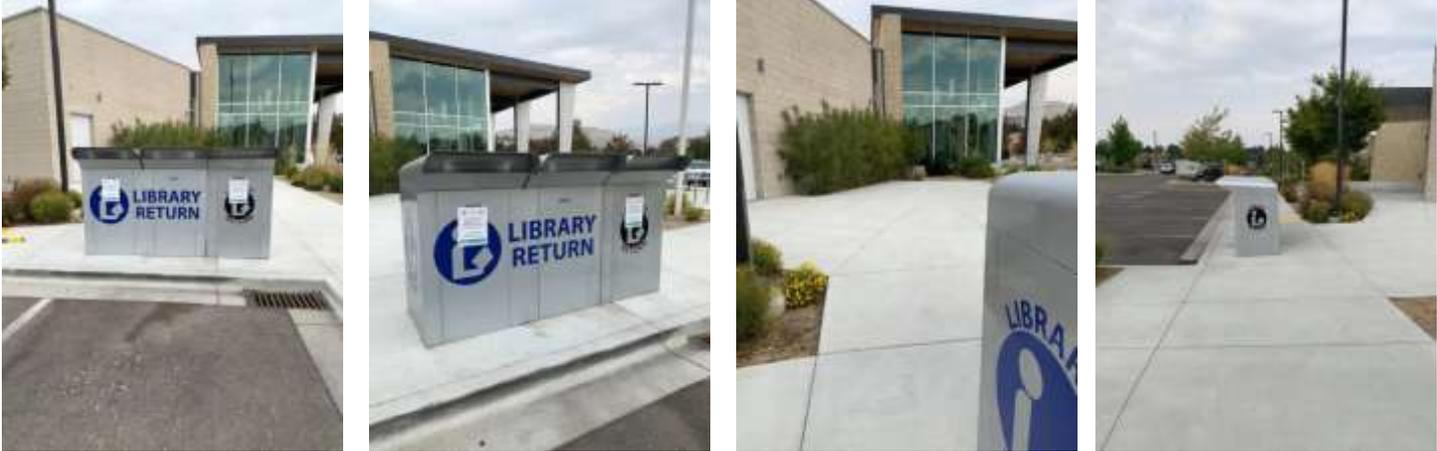
2010 ADA Standards for Accessible Design Codes §305.2
There is a 24" clear floor space to the book return boxes.

Relocate the book return boxes closer to the library to allow for a 30"x48" clear floor space.
Ensure the clear floor space has a maximum of 2% slope in all directions.

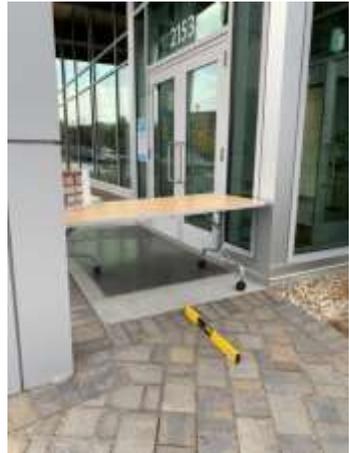
2010 ADA Standards for Accessible Design Codes §403.3, §303.2

There is a 1" change in level. The running slope is 8.1%.

Reconstruct the bricks on the right side of the door to ensure that the slope does not exceed 5%.

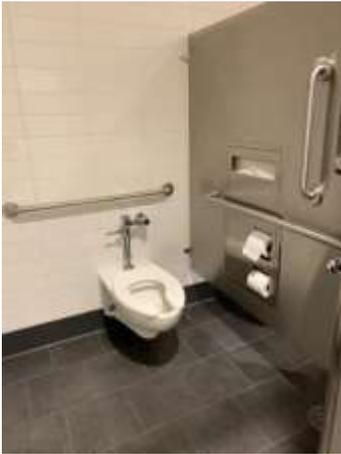
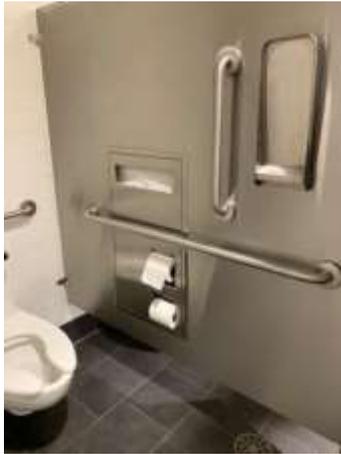
2010 ADA Standards for Accessible Design Codes §604.8.1.2

The door to the accessible water closet is not self closing. Either self-closing hinges are not installed on the door or if installed, they are defective.

Install or reinstall self-closing hinges on the door to ensure that the door is self-closing per the ADA requirements.

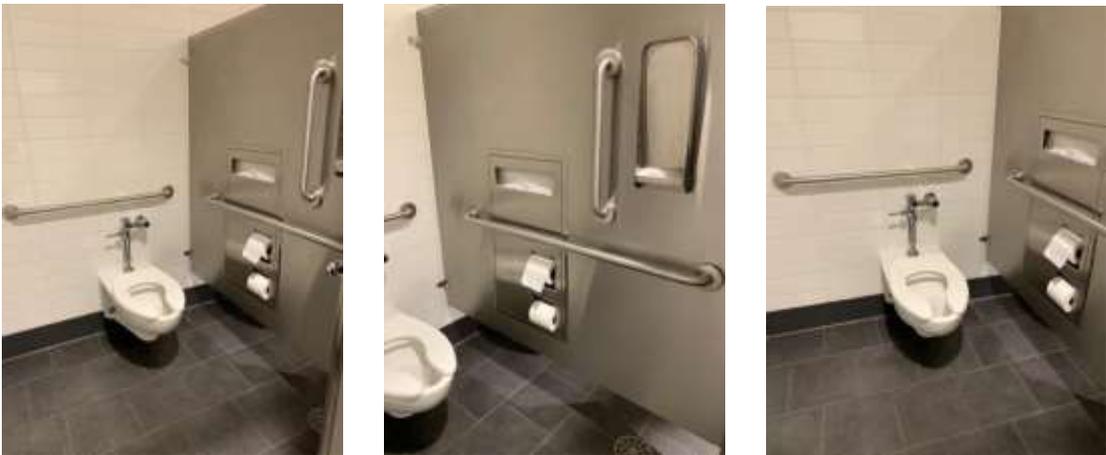
2010 ADA Standards for Accessible Design Codes §609.3
The space between the grab bar and the shelf is 9.5".

Relocate the shelf to a location that is at least a distance of 12" or greater above the grab bar. Ensure that the shelf is not greater than 48" above the floor.

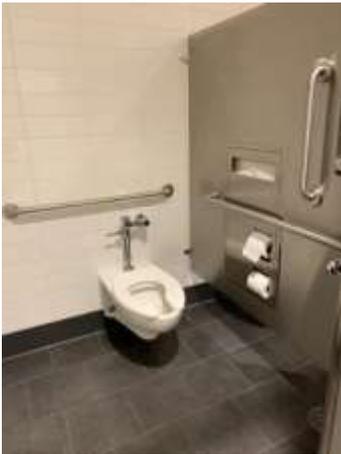
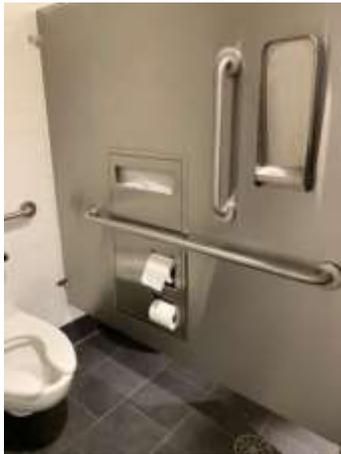
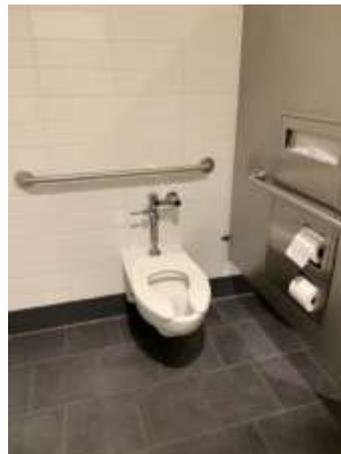
2010 ADA Standards for Accessible Design Codes §604.7

The toilet paper dispenser is located out of the accessible reach range.

Remount the toilet paper dispenser to 7" minimum and 9" maximum in front of the water closet measured to the centerline of the dispenser.

The outlet of the dispenser shall be 15" minimum and 48" maximum above the floor and shall not be located behind.

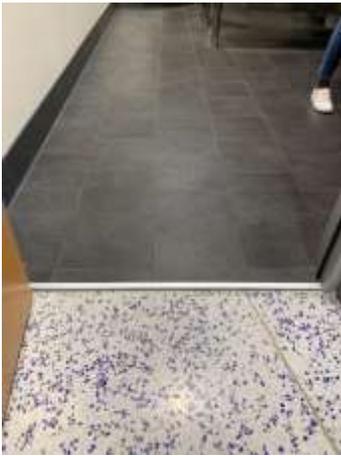
2010 ADA Standards for Accessible Design Codes §303.2
There is a 0.75" change in level.

Resurface the pathway to reduce the change in level to less than 0.25".

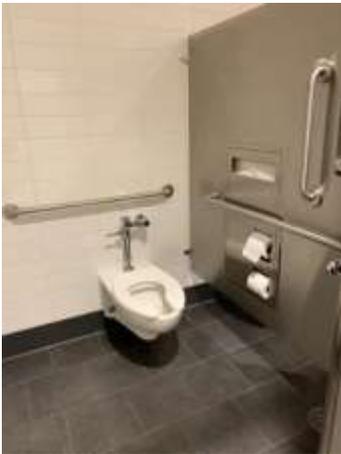
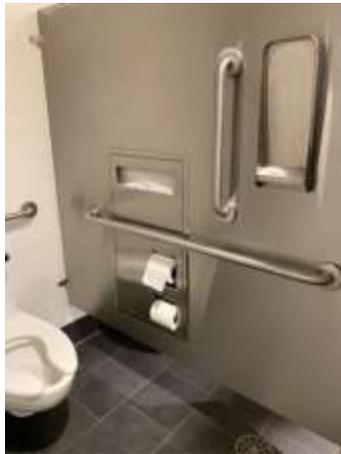
2010 ADA Standards for Accessible Design Codes §604.2

The centerline of the toilet is located 19" from the sidewall

Reposition the centerline of the toilet to be within 16" minimum and 18" maximum from the sidewall.

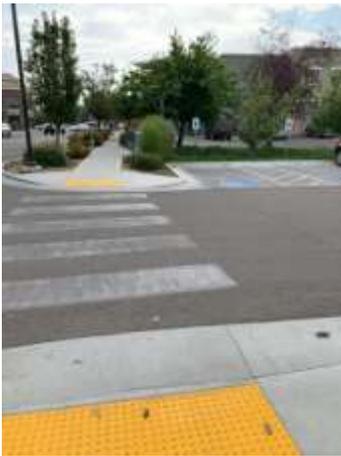
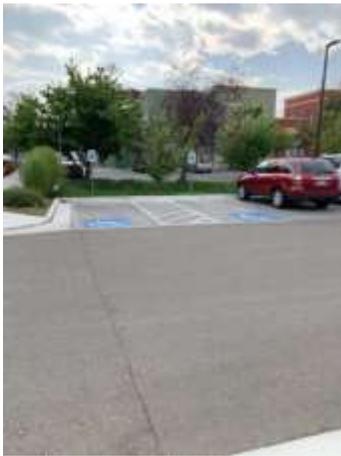
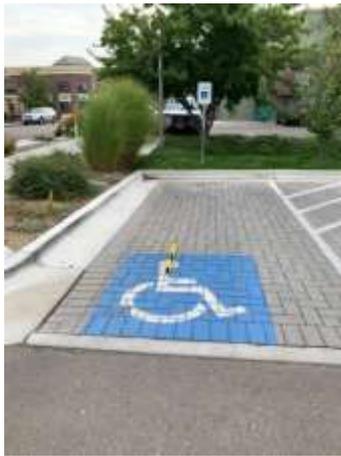
2010 ADA Standards for Accessible Design Codes §216.5
The parking signs identifying the accessible parking space do not meet the minimum height requirement of 60" from the ground.

Remount the accessible parking signs to ensure 60" minimum height from the ground.

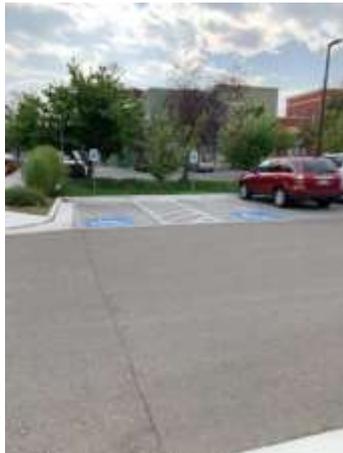
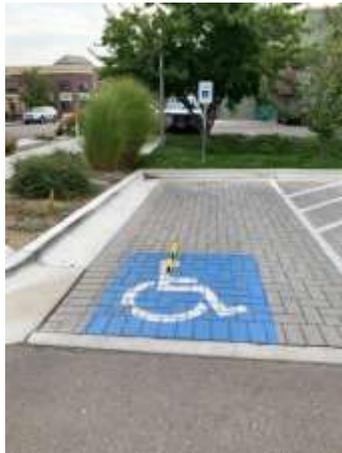
2010 ADA Standards for Accessible Design Codes §502.4
The parking space has a 2.6% slope.

Resurface the parking space to reduce the slope to a maximum of 2% in all directions.

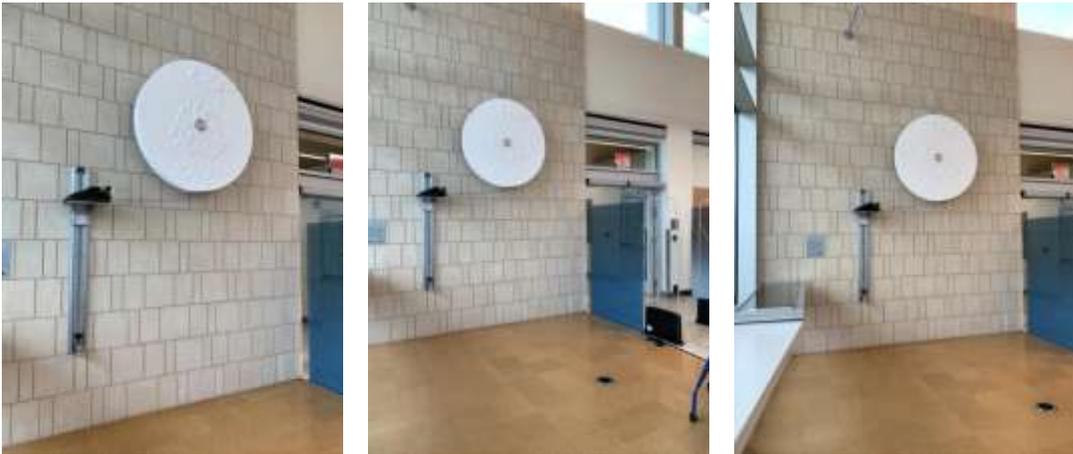
2010 ADA Standards for Accessible Design Codes §307.2
The Vox Poplar art protrudes 14" into the circulation space at 71.5" above the floor.

Recess the Vox Poplar art so it protrudes a maximum of 4", lower it so the bottom edge is 27" maximum above the floor, or place a cane detectable object beneath it.

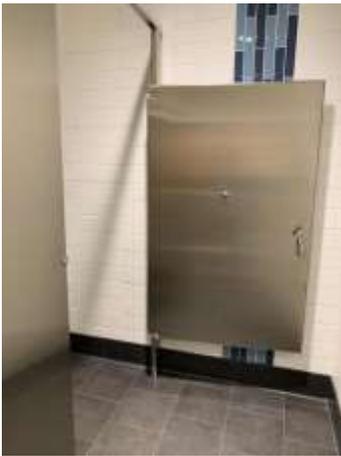
2010 ADA Standards for Accessible Design Codes §604.8.1.2
The door to the accessible water closet is not self closing. Either self-closing hinges are not installed on the door or if installed, they are defective.

Install or reinstall self-closing hinges on the door to ensure that the door is self-closing per the ADA requirements.

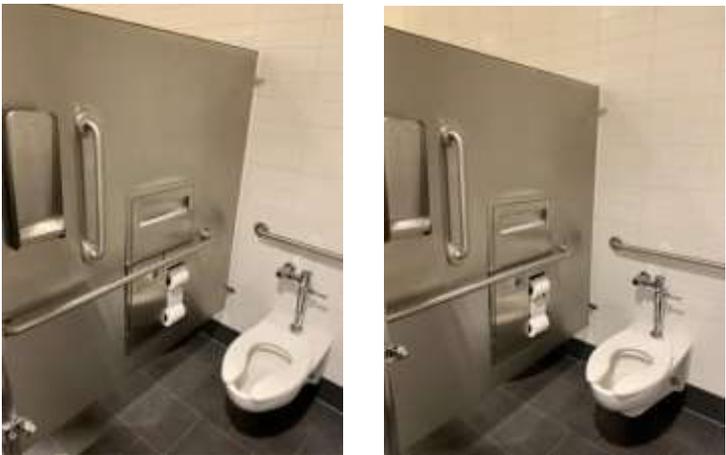
2010 ADA Standards for Accessible Design Codes §609.3
The space between the grab bar and shelf is 9.75".

Relocate the shelf to a location that is at least a distance of 12" or greater above the grab bar. Ensure that the shelf is not greater than 48" above the floor.

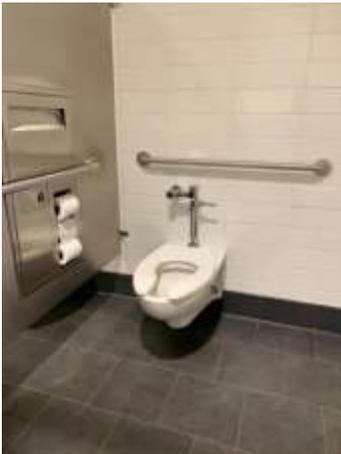
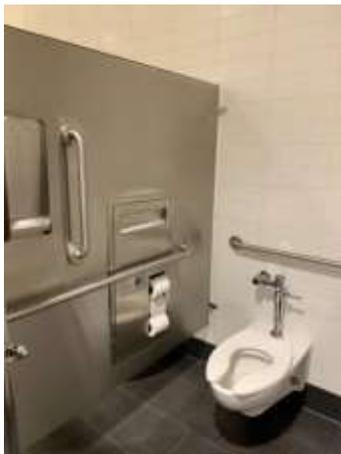
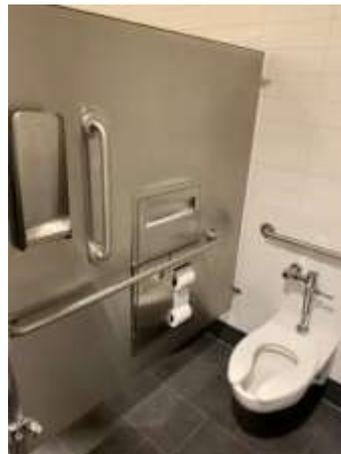
2010 ADA Standards for Accessible Design Codes §604.7

The toilet paper dispenser is located out of the accessible reach range.

Remount the toilet paper dispenser to 7" minimum and 9" maximum in front of the water closet measured to the centerline of the dispenser.

The outlet of the dispenser shall be 15" minimum and 48" maximum above the floor and shall not be located behind.

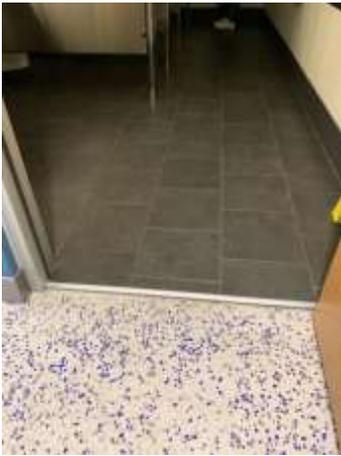
2010 ADA Standards for Accessible Design Codes §303.2
There is a 0.75" change in level.

Resurface the pathway to reduce the change in level to less than 0.25".

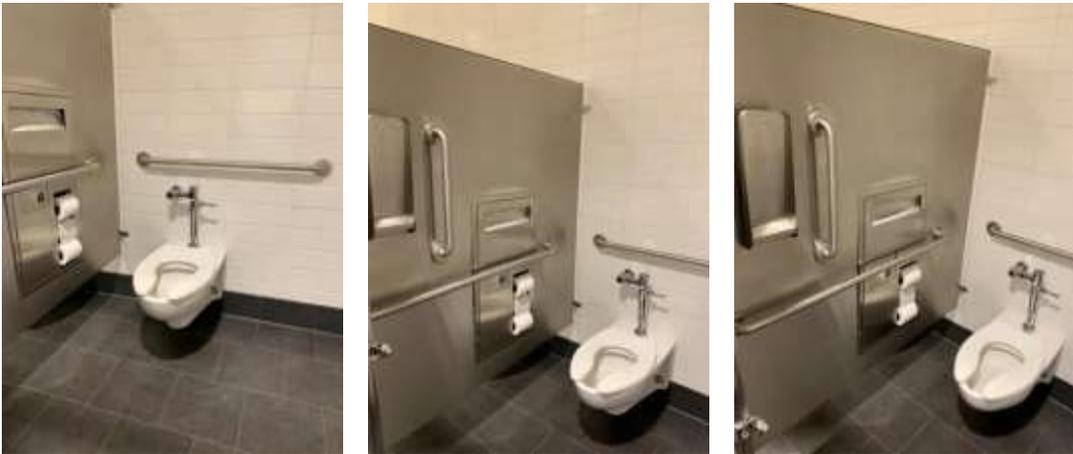
2010 ADA Standards for Accessible Design Codes §604.2
The centerline of the toilet is located 18.5" from the sidewall.

Reposition the centerline of the toilet to be within 16" minimum and 18" maximum from the sidewall.

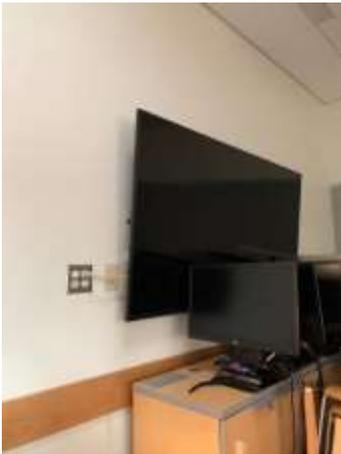
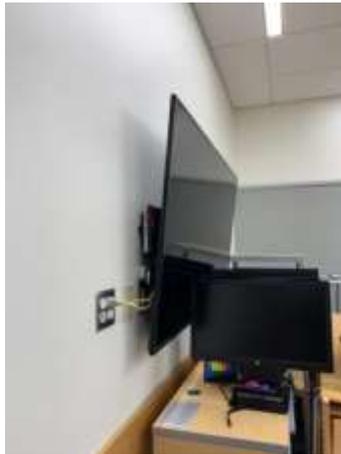
22010 ADA Standards for Accessible Design Codes §307.2

The TV protrudes 5" into the circulation space at 45.5" above the floor.

Ensure that the desk remains underneath the TV to provide cane detectability.

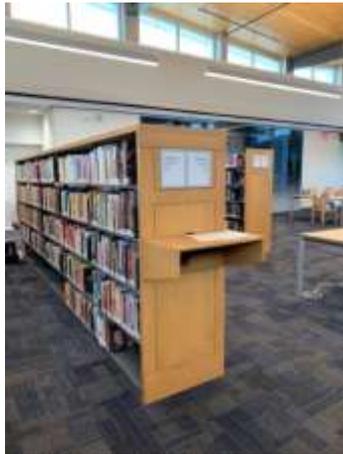
2010 ADA Standards for Accessible Design Codes §307.2

The desks protrude 14.75" into the circulation space at 33" above the floor.

Extend the sides of the desks down so the bottom edge is 27" maximum above the floor.

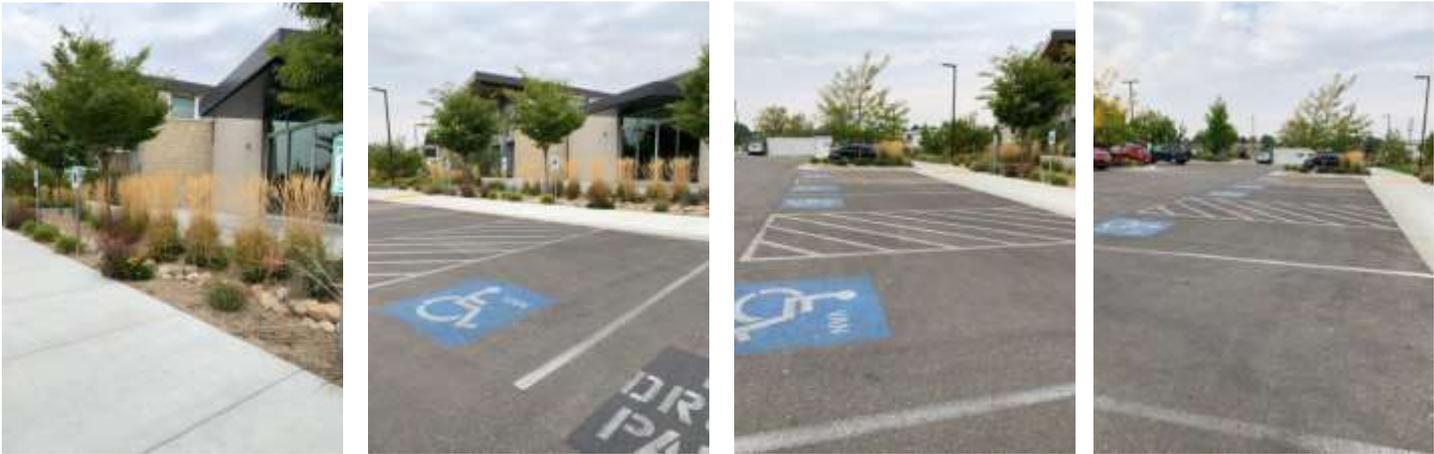
2010 ADA Standards for Accessible Design Codes §502.6
The parking signs identifying the accessible parking space do not meet the minimum height requirement of 60" from the ground.

Install an accessible parking sign at each accessible space at a minimum height of 60" above the ground.

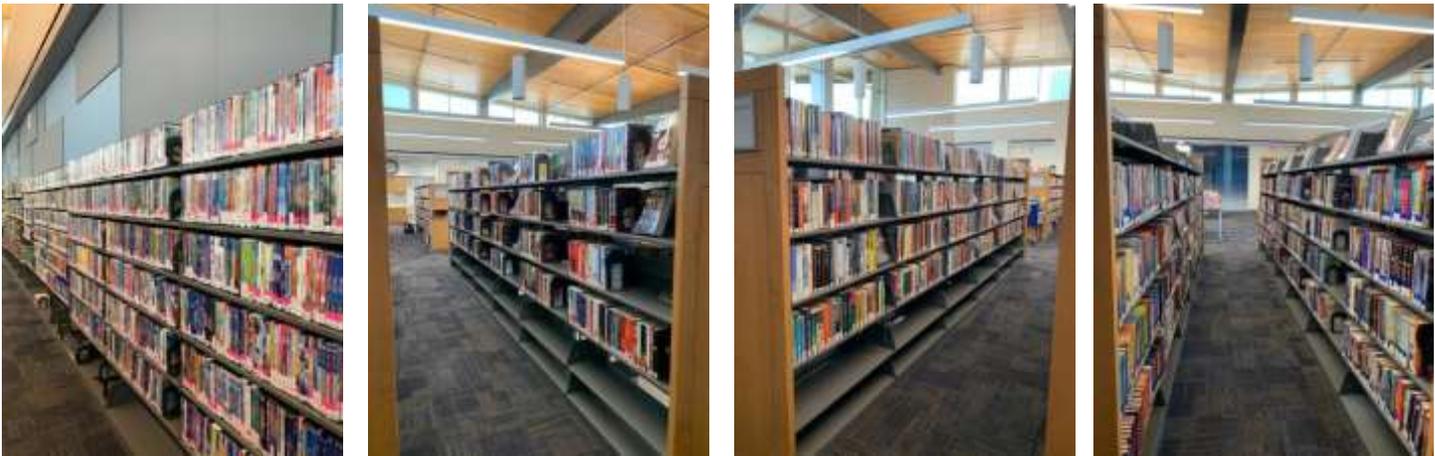
2010 ADA Standards for Accessible Design Codes §308.2.1

The top shelves are outside of the unobstructed forward reach range at 65" above the floor.

Ensure that the library has a policy that provides assistance to employees and volunteers reaching for shelves that are located beyond 48" above the floor.
