City of Boise ADA  
Assessment

# Appendix A - Public Works Farm Office Shop Building

12/30/2020

Report #TO20-B010

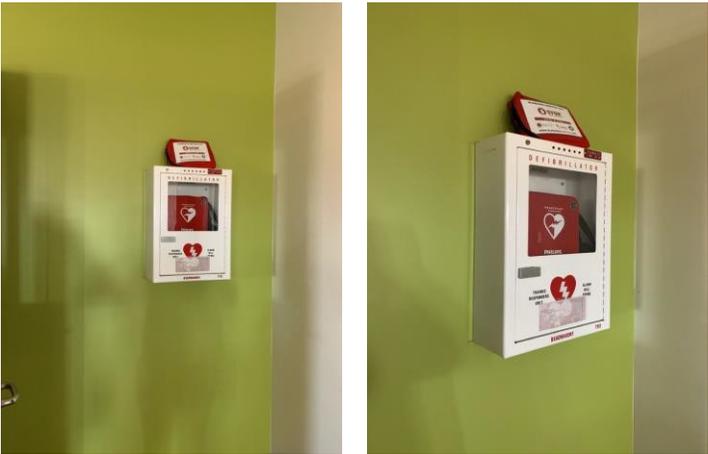
**Location:** AED in Public Area  
**Schedule:** 2021  
**Estimated Cost:** \$100.00

**2010 ADA Standards for Accessible Design Codes: §307.2**  
The AED protrudes 6" into the circulation space at 46" above the floor.

Recess the AED so it protrudes a maximum of 4", lower it so the bottom edge is 27" maximum above the floor, or place a cane detectable object beneath it.

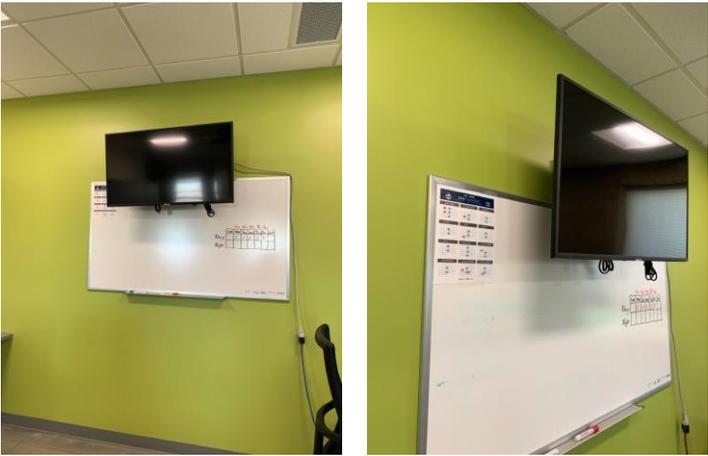
**Location:** Back Office TV  
**Schedule:** 2021  
**Estimated Cost:** \$100.00

**2010 ADA Standards for Accessible Design Codes: §307.2**  
The TV protrudes 9.5" into the circulation space at 71" above the floor.

Recess the TV so it protrudes a maximum of 4", raise it so the bottom edge is 80" maximum above the floor, or place a cane detectable object beneath it.

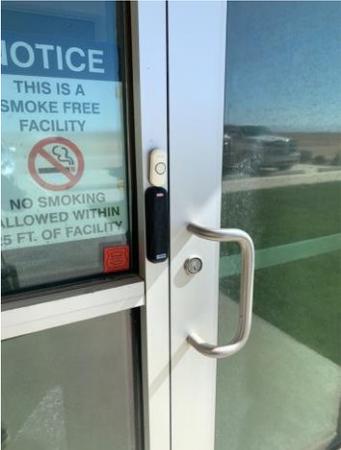
**Location:** Entrance  
**Schedule:** 2021  
**Estimated Cost:** \$100.00

**2010 ADA Standards for Accessible Design Codes: §308.2.1**  
The push button is outside of the unobstructed forward reach range at 50" above the floor.

Lower the push button by at least 2" to meet the accessible reach range of 15" minimum and 48" maximum above the floor.

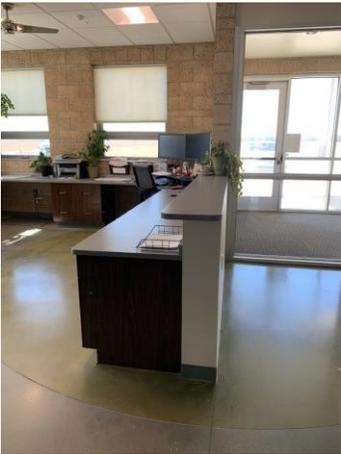
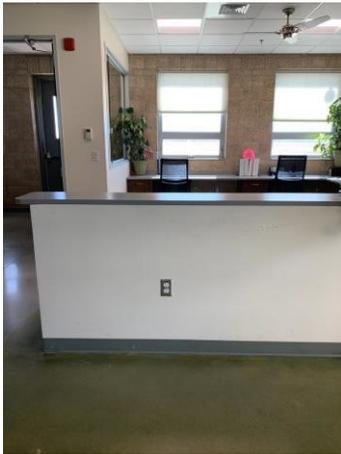
**Location:** Entrance  
**Schedule:** 2021  
**Estimated Cost:** \$1,000.00

**2010 ADA Standards for Accessible Design Codes: §904.4.1**  
The counter is 40" above the floor.

A horizontal distance of 36" of the service counter must be no higher than 36" above the floor.

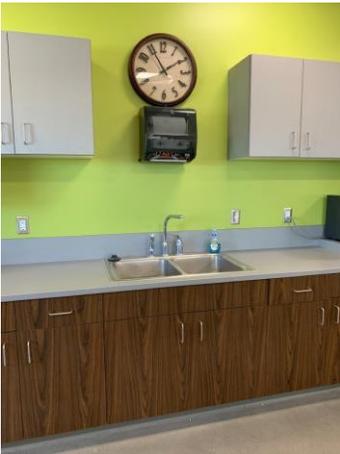
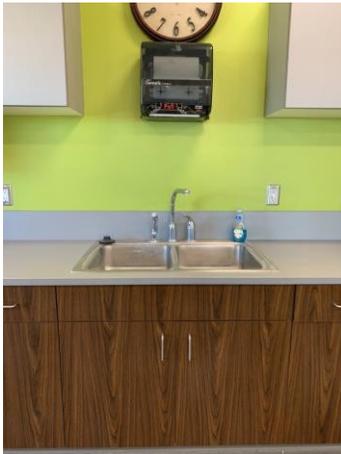
**Location:** Kestrel Conference Room  
**Schedule:** 2021  
**Estimated Cost:** \$100.00

**2010 ADA Standards for Accessible Design Codes: §308.2.2**  
The paper towel dispenser is outside of the obstructed forward reach range at 69" above the floor.

Lower the paper towel dispenser by 21" to meet the accessible reach range of 44" maximum above the floor.

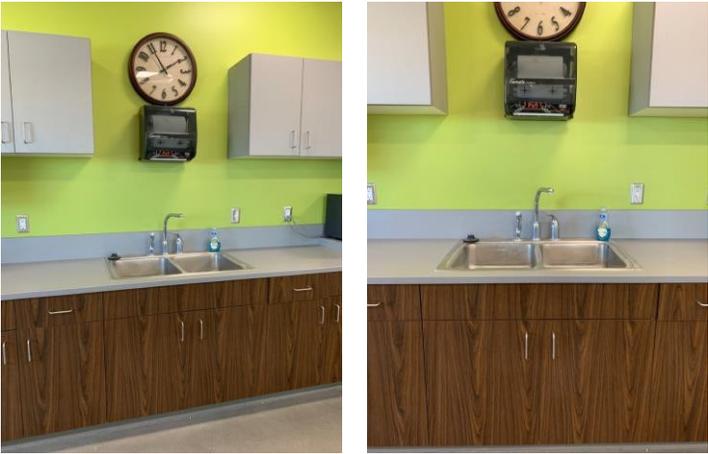
**Location:** Kestrel Conference Room  
**Schedule:** 2022  
**Estimated Cost:** \$1,000.00

**2010 ADA Standards for Accessible Design Codes: §306.3.3**  
There is no knee clearance underneath the counter.

Provide knee clearance underneath the counter at the sink that is a minimum of 11" deep at 9" above the floor and 8" deep at 27" above the floor.

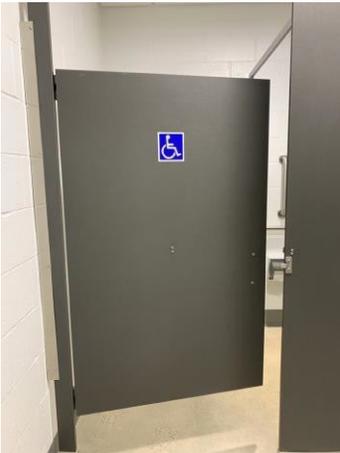
**Location:** Men's Locker Room  
**Schedule:** 2021  
**Estimated Cost:** \$100.00

**2010 ADA Standards for Accessible Design Codes: §604.8.1.2**  
The door to the accessible water closet is not self closing. Either self-closing hinges are not installed on the door or if installed, they are defective.

Install or reinstall self-closing hinges on the door to ensure that the door is self-closing per the ADA requirements.

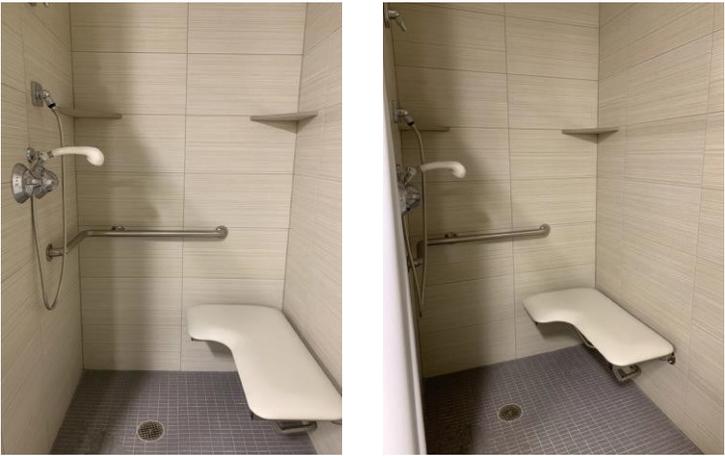
**Location:** Men's Locker Room  
**Schedule:** 2021  
**Estimated Cost:** \$100.00

**2010 ADA Standards for Accessible Design Codes: §307.2**  
The shower curtain rod is 75" above the floor.

Raise the shower curtain rod by 5" so it is 80" above the floor.

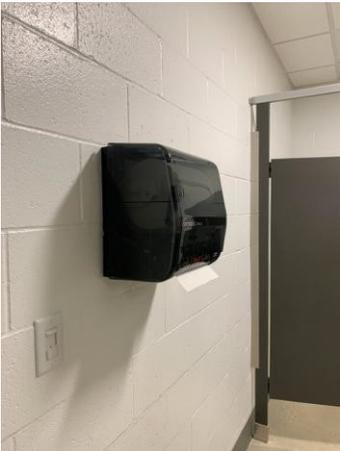
**Location:** Men's Locker Room  
**Schedule:** 2021  
**Estimated Cost:** \$100.00

**2010 ADA Standards for Accessible Design Codes: §307.2, §308.2.1**  
The paper towel dispenser is outside of the unobstructed forward reach range at 52" above the floor. The paper towel dispenser protrudes 8" into the circulation space at 52" above the floor.

Lower the paper towel dispenser by 4" to meet the accessible reach range of 48" maximum above the floor.  
Recess the paper towel dispenser so it protrudes a maximum of 4" or place a cane detectable object beneath it.

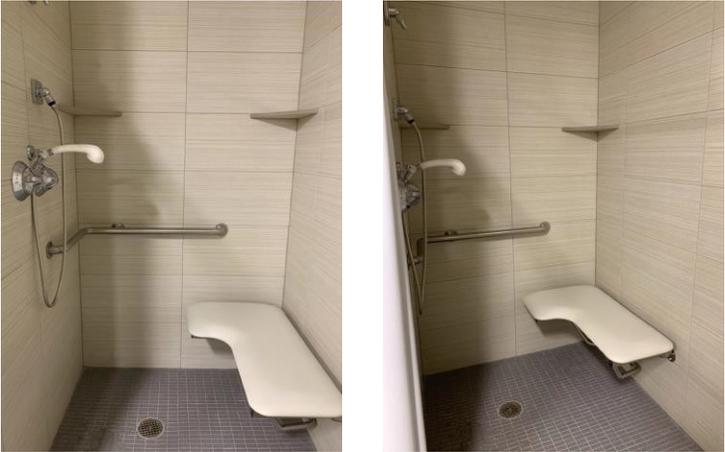
**Location:** Men's Locker Room  
**Schedule:** 2021  
**Estimated Cost:** \$200.00

**2010 ADA Standards for Accessible Design Codes: §308.2.1**  
The shelves are outside of the unobstructed forward reach range at 59.5" above the floor.

Lower the shelves by 11.5" to meet the accessible reach range of 48" maximum above the floor.

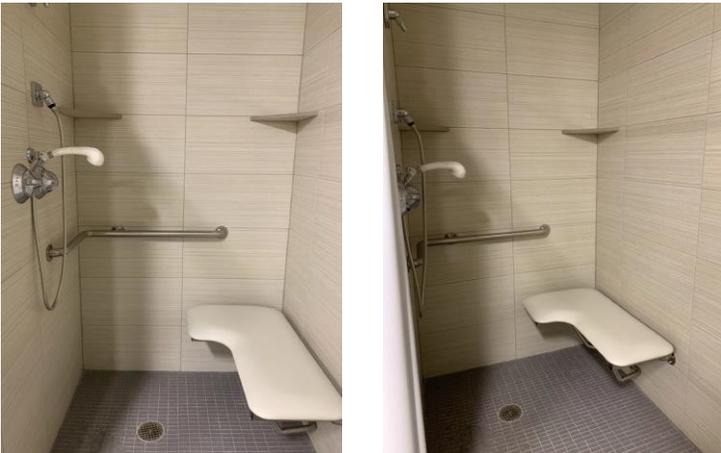
**Location:** Men's Locker Room  
**Schedule:** 2021  
**Estimated Cost:** \$500.00

**2010 ADA Standards for Accessible Design Codes: §610.3.2**  
The L-shaped shower seat does not meet the minimum requirements with a long side depth of 21" and a short side depth of 13.5".

Replace the L-shaped shower seat with one that has a long side depth from the seat wall to the front edge of 22" minimum and 23" maximum and a short side depth from the seat wall to the front edge 15" minimum and 16" maximum.

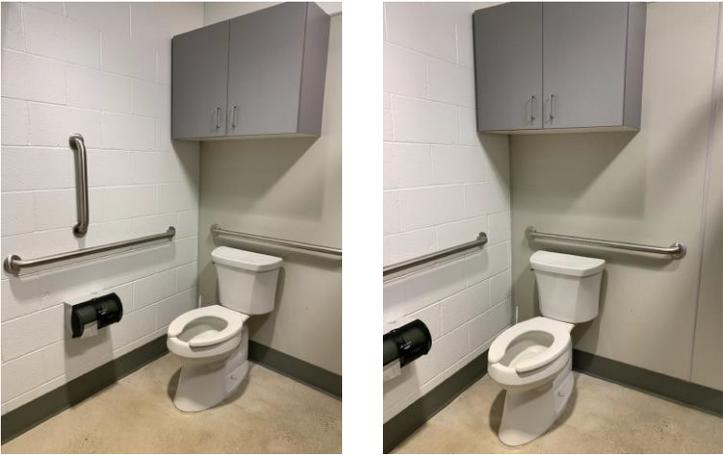
**Location:** Men's Locker Room  
**Schedule:** 2022  
**Estimated Cost:** \$1,000.00

**2010 ADA Standards for Accessible Design Codes: §604.2**  
The toilet is located 18.5" from the sidewall.

Reposition the toilet to be within 16" minimum and 18" maximum from the sidewall.

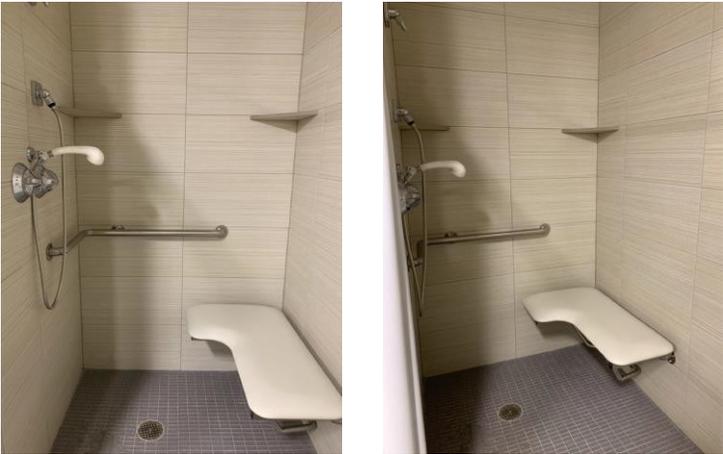
**Location:** Men's Locker Room  
**Schedule:** 2022  
**Estimated Cost:** \$1,000.00

**2010 ADA Standards for Accessible Design Codes:** §607.6, §608.5.1  
The shower controls exceed a height of 48" above ground. The adjustable shower head is 52" above the floor.

Adjust the height of shower controls to a minimum height of 38" and a maximum height of 48" above the floor.  
Install a secondary shower head with a 59" long minimum hose to allow for a user to sit or stand that is a maximum of 48" above the floor.

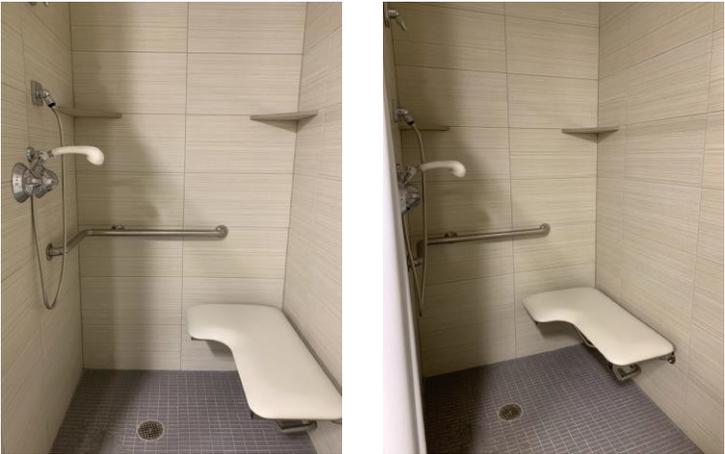
**Location:** Men's Locker Room  
**Schedule:** 2022  
**Estimated Cost:** \$1,000.00

**2010 ADA Standards for Accessible Design Codes: §608.3.1**  
The control wall grab bar is 16" long.

Replace the control wall grab bar with one that is a minimum of 36" long, which is the full length of the control wall for a transfer type shower.

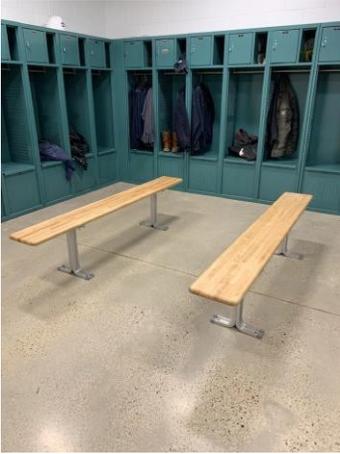
**Location:** Men's Locker Room  
**Schedule:** 2022  
**Estimated Cost:** \$1,000.00

**2010 ADA Standards for Accessible Design Codes: §903.4**  
The benches do not have back support.

Provide back support that is 42" long minimum and extends from a point 2" maximum above the seat surface to a point 18" minimum above the seat surface.  
Back support shall be 2½" maximum from the rear edge of the seat measured horizontally.

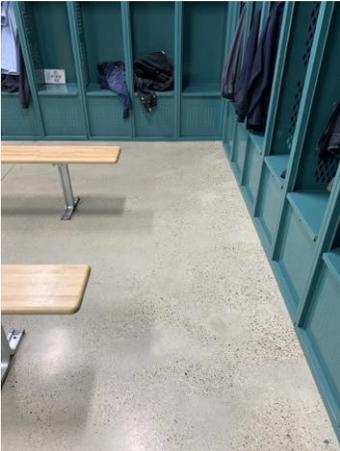
**Location:** Men's Locker Room  
**Schedule:** 2022  
**Estimated Cost:** \$1,000.00

**2010 ADA Standards for Accessible Design Codes:** §403.5.1, §903.4

The bench does not have back support.

There is not a clear 36" width for wheelchairs to pass. The width is 34" between the bench and lockers.

Provide back support that is 42" long minimum and extends from a point 2" maximum above the seat surface to a point 18" minimum above the seat surface.

Back support shall be 2½" maximum from the rear edge of the seat measured horizontally. This can be achieved by relocating one bench to utilize a nearby wall as back support. Shift the bench 2" away from the lockers.

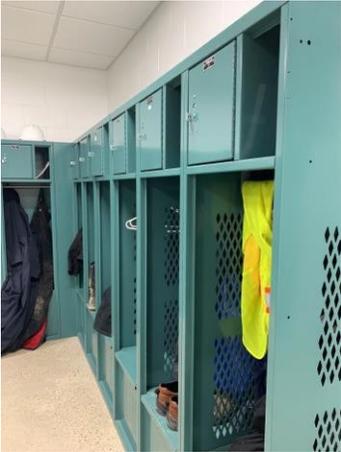
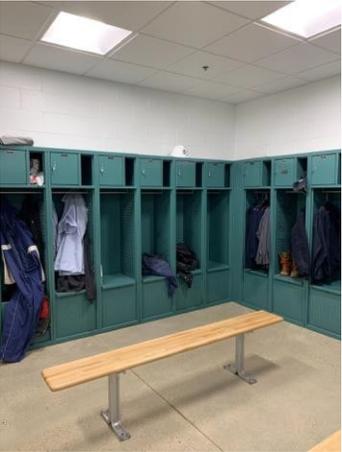
**Location:** Men's Locker Room  
**Schedule:** 2021  
**Estimated Cost:** \$1,500.00

**2010 ADA Standards for Accessible Design Codes: §308.2.1**  
The lockers are outside of the unobstructed forward reach range at 57" above the floor.

Lower 5% of the lockers by 9" to meet the accessible reach range of 15" minimum and 48" maximum above the floor.

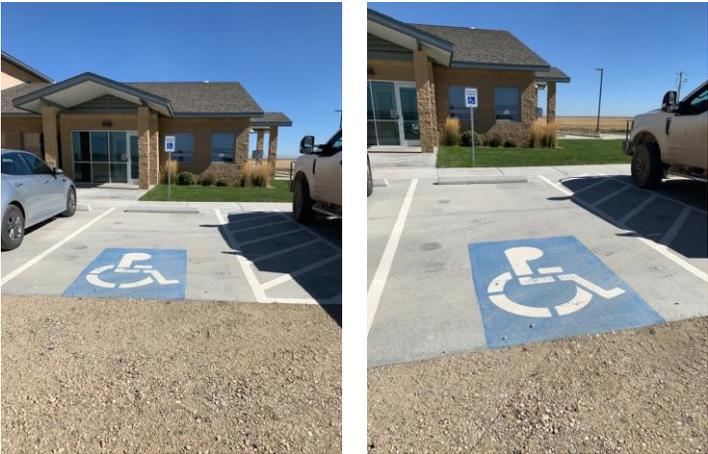
**Location:** Parking  
**Schedule:** 2021  
**Estimated Cost:** \$1,000.00

**2010 ADA Standards for Accessible Design Codes: §502.2, §208.2.4**  
 There is only one space and it is not van accessible. The accessible parking space is not of sufficient width at 108" wide.

Expand the accessible parking space to a minimum of 132" wide. Add a "van accessible" parking sign at a minimum height of 60" above the ground. Ensure the access aisle is a minimum width of 60".

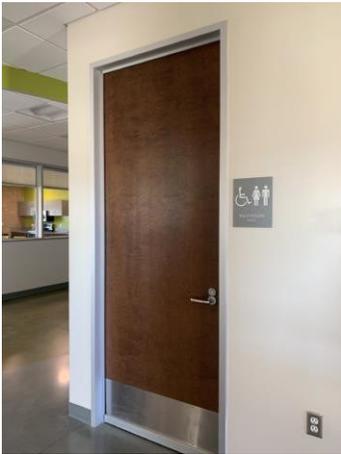
**Location:** Public Restroom  
**Schedule:** 2021  
**Estimated Cost:** \$200.00

**2010 ADA Standards for Accessible Design Codes:** §404.2.8.1, §404.2.9  
 The opening and closing force of the door is 20 pounds. The time required for the door to shut is 2.9 seconds.

Adjust the resistance on the door so that it allows the doors to be continuously opened at a maximum force of 5 pounds.  
 Adjust the closing speed to a minimum of 5 or more seconds.

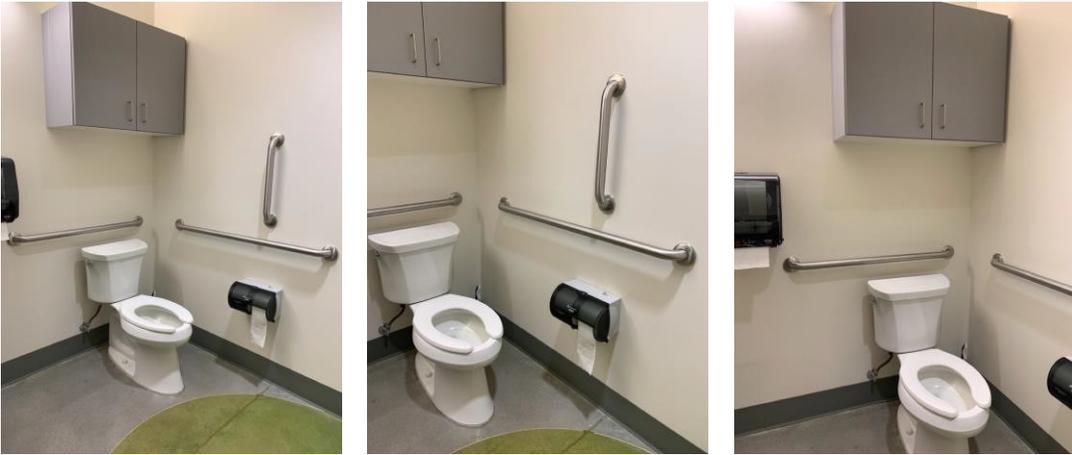
**Location:** Public Restroom  
**Schedule:** 2022  
**Estimated Cost:** \$1,000.00

**2010 ADA Standards for Accessible Design Codes: §604.2**  
The toilet is located 18.5" from the sidewall.

Reposition the toilet to be within 16" minimum and 18" maximum from the sidewall.

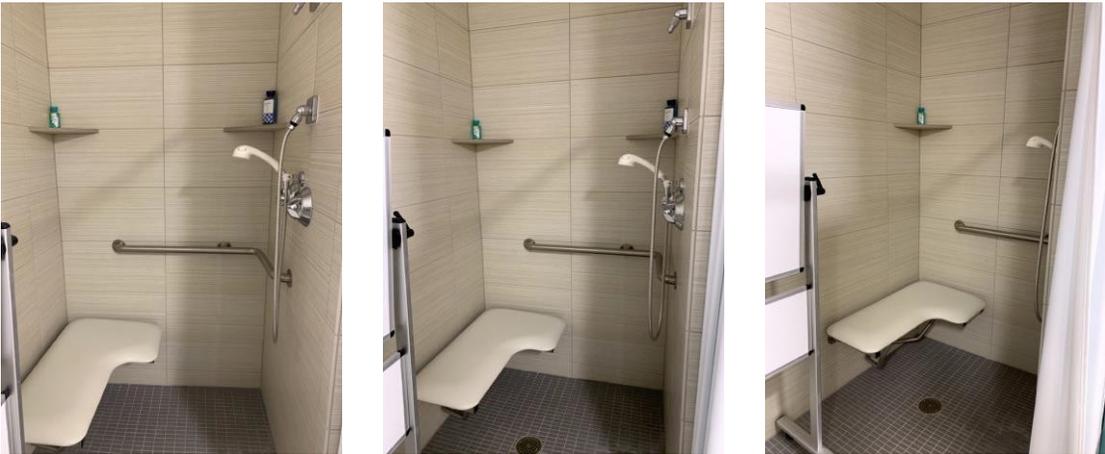
**Location:** Women's Locker Room  
**Schedule:** 2021  
**Estimated Cost:** \$100.00

**2010 ADA Standards for Accessible Design Codes: §307.2**  
The shower curtain rod is 74" above the floor.

Raise the shower curtain rod by 6" so it is 80" above the floor.

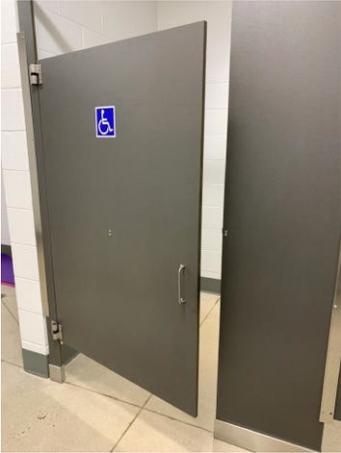
**Location:** Women's Locker Room  
**Schedule:** 2021  
**Estimated Cost:** \$100.00

**2010 ADA Standards for Accessible Design Codes: §604.8.1.2**  
 The door to the accessible water closet is not self closing. Either self-closing hinges are not installed on the door or if installed, they are defective.

Install or reinstall self-closing hinges on the door to ensure that the door is self-closing per the ADA requirements.

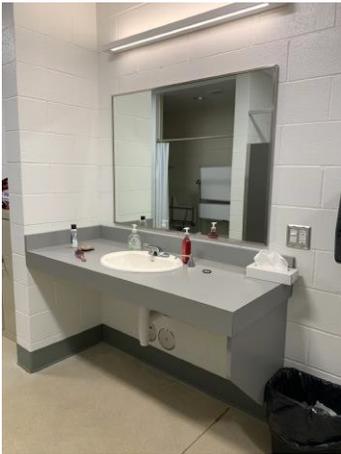
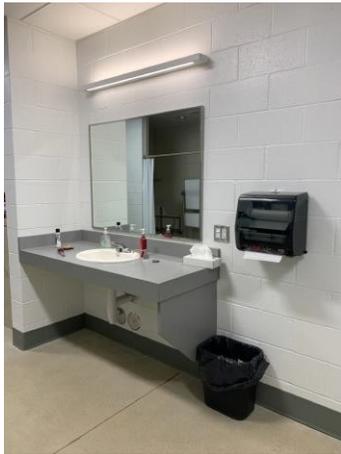
**Location:** Women's Locker Room

**2010 ADA Standards for Accessible Design Codes: §603.3**

The mirror is too high to be accessible at 40.25" above the floor.

Lower the mirror its bottom edge is a maximum height of 40" above the floor.

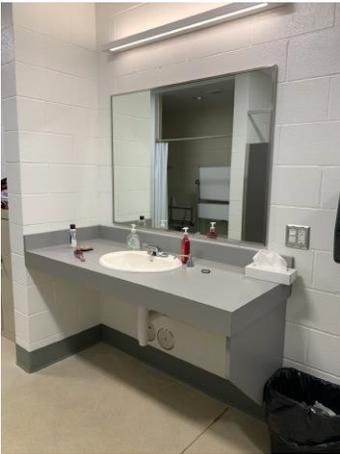
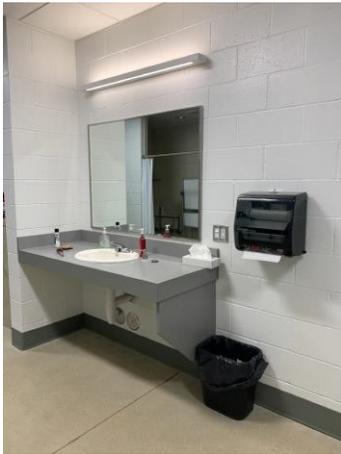
**Location:** Women's Locker Room  
**Schedule:** 2021  
**Estimated Cost:** \$100.00

**2010 ADA Standards for Accessible Design Codes: §307.2**  
The paper towel dispenser protrudes 8" into the circulation space at 41" above the floor.

Recess the paper towel dispenser so it protrudes a maximum of 4" or ensure the detectable object remains beneath it at all times.

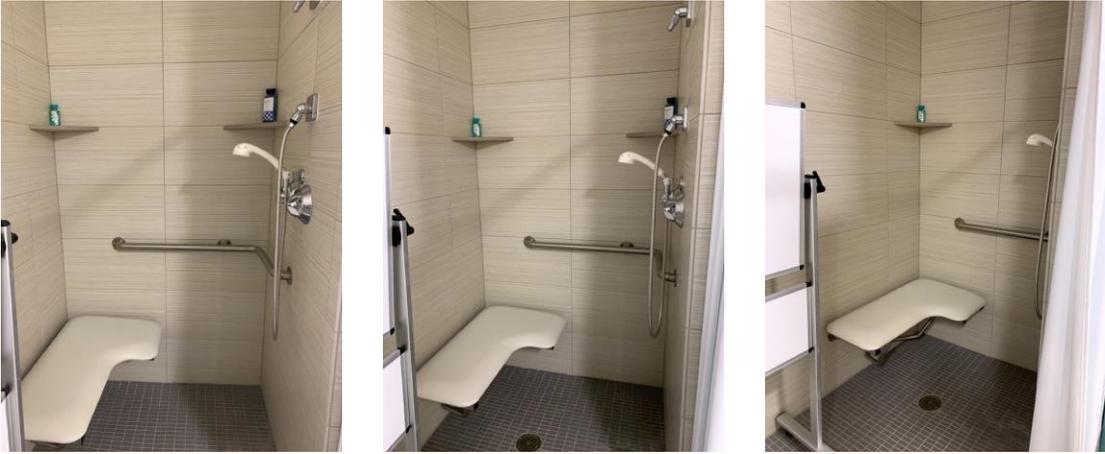
**Location:** Women's Locker Room  
**Schedule:** 2021  
**Estimated Cost:** \$100.00

**2010 ADA Standards for Accessible Design Codes: §308.2.1**  
The corner shelves are outside of the unobstructed forward reach range at 59" above the floor.

Lower the corner shelves by 11" to meet the accessible reach range of 48" maximum above the floor.

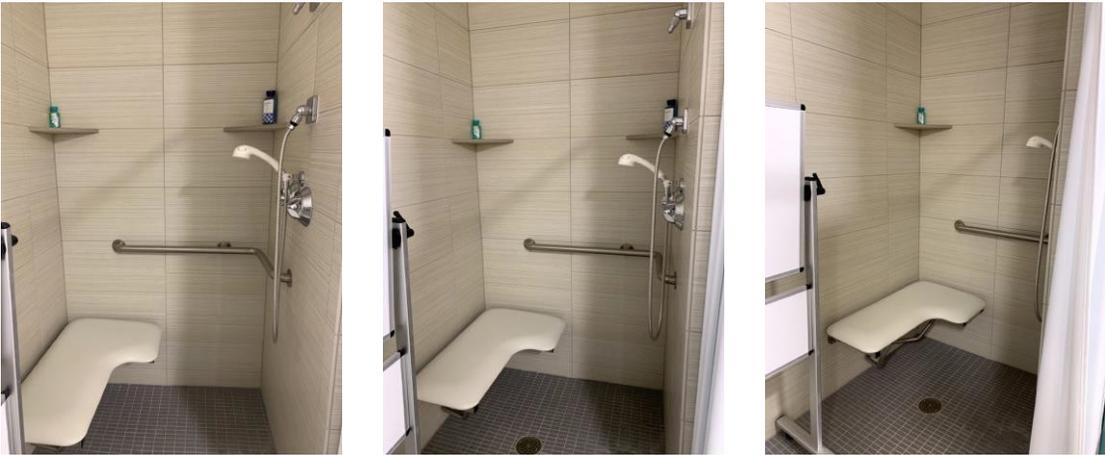
**Location:** Women's Locker Room  
**Schedule:** 2021  
**Estimated Cost:** \$500.00

**2010 ADA Standards for Accessible Design Codes: §607.6**  
 The adjustable shower head is 50" above the floor.

Install a secondary shower head with a 59" long minimum hose to allow for a user to sit or stand that is a maximum of 48" above the floor.

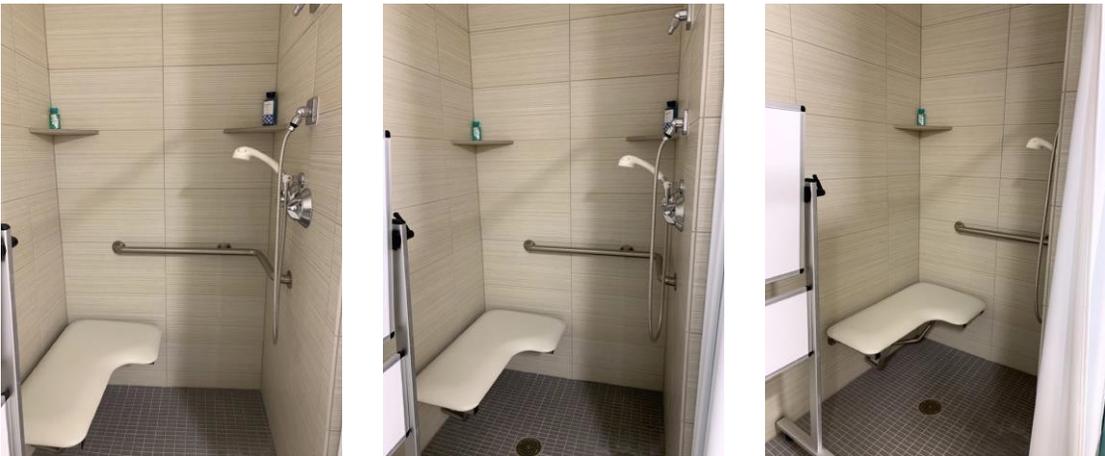
**Location:** Women's Locker Room  
**Schedule:** 2021  
**Estimated Cost:** \$500.00

**2010 ADA Standards for Accessible Design Codes: §610.3.2**  
The L-shaped shower seat does not meet the minimum requirements with a long side depth of 21" and a short side depth of 13".

Replace the L-shaped shower seat with one that has a long side depth from the seat wall to the front edge of 22" minimum and 23" maximum and a short side depth from the seat wall to the front edge 15" minimum and 16" maximum.

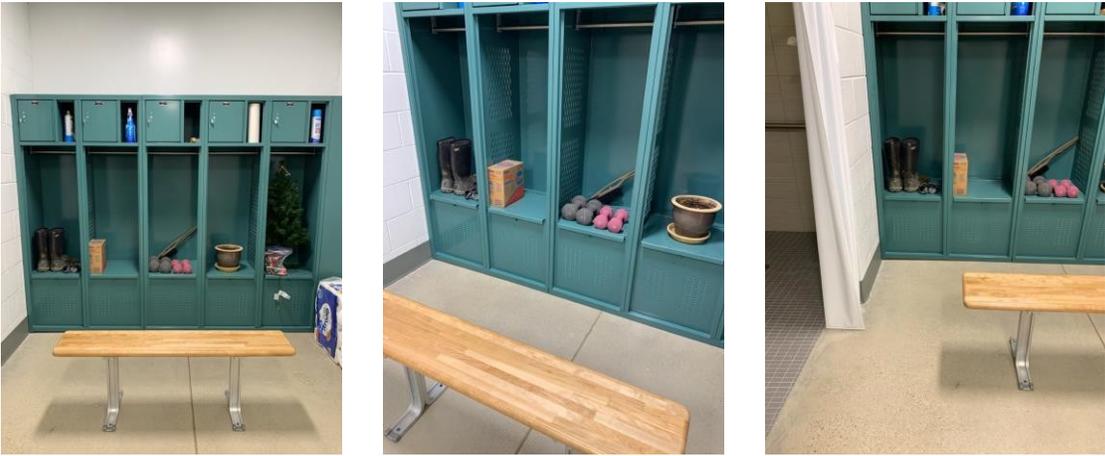
**Location:** Women's Locker Room  
**Schedule:** 2021  
**Estimated Cost:** \$500.00

**2010 ADA Standards for Accessible Design Codes: §903.4**  
The bench does not have back support.

Provide back support that is 42" long minimum and extends from a point 2" maximum above the seat surface to a point 18" minimum above the seat surface.  
Back support shall be 2.5" maximum from the rear edge of the seat measured horizontally.

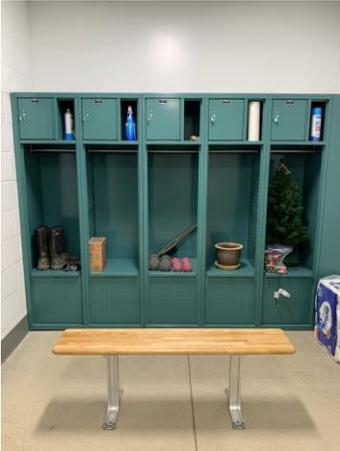
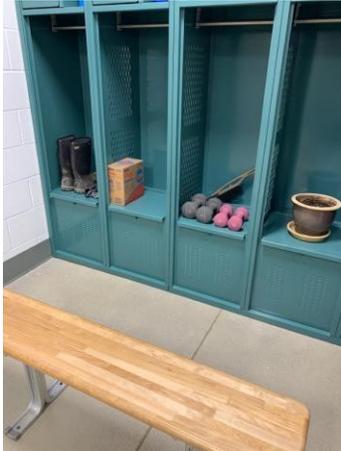
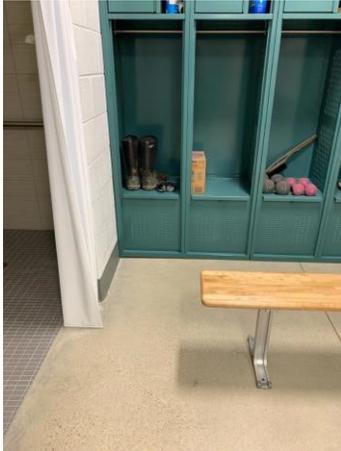
**Location:** Women's Locker Room  
**Schedule:** 2021  
**Estimated Cost:** \$500.00

**2010 ADA Standards for Accessible Design Codes: §308.2.1**  
The lockers and locker curtain rods are outside of the unobstructed forward reach range at 63" and 57" above the floor.

Lower 5% of the lockers and locker curtain rods by 15" and 9" to meet the accessible reach range of 15" minimum and 48" maximum above the floor.

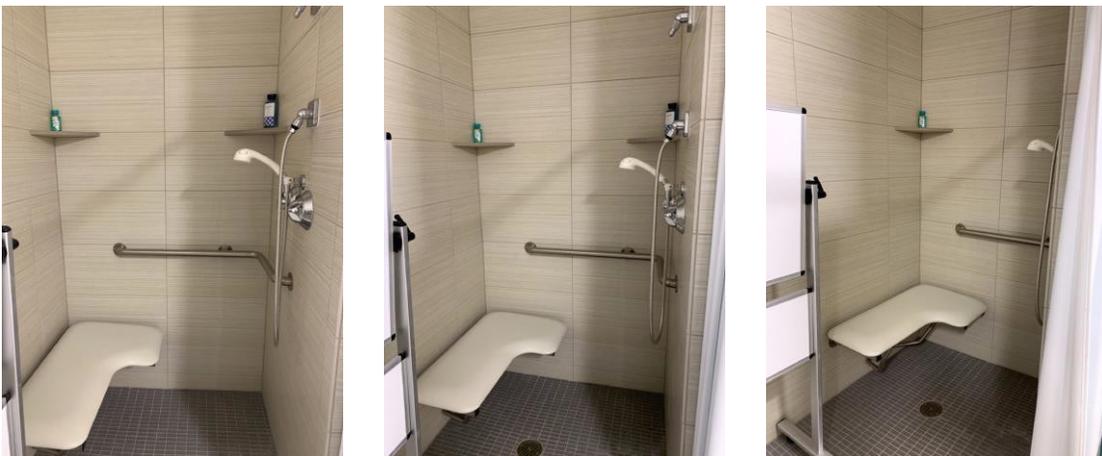
**Location:** Women's Locker Room  
**Schedule:** 2022  
**Estimated Cost:** \$1,000.00

**2010 ADA Standards for Accessible Design Codes: §608.3.1**  
The control wall grab bar is 16" long.

Replace the control wall grab bar with one that is a minimum of 36" long, which is the full length of the control wall for a transfer type shower.

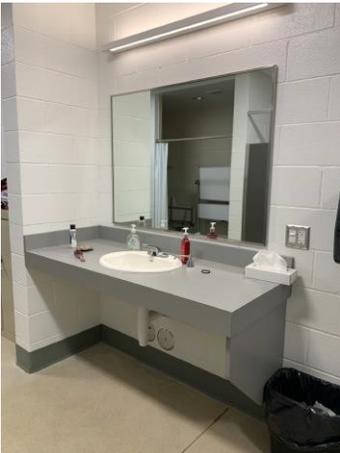
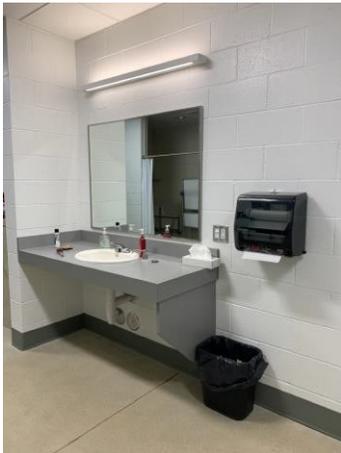
**Location:** Women's Locker Room  
**Schedule:** 2022  
**Estimated Cost:** \$1,000.00

**2010 ADA Standards for Accessible Design Codes: §606.3**  
The sink is 34.5" above the floor.

Lower the sink to a maximum height of 34" above the floor.

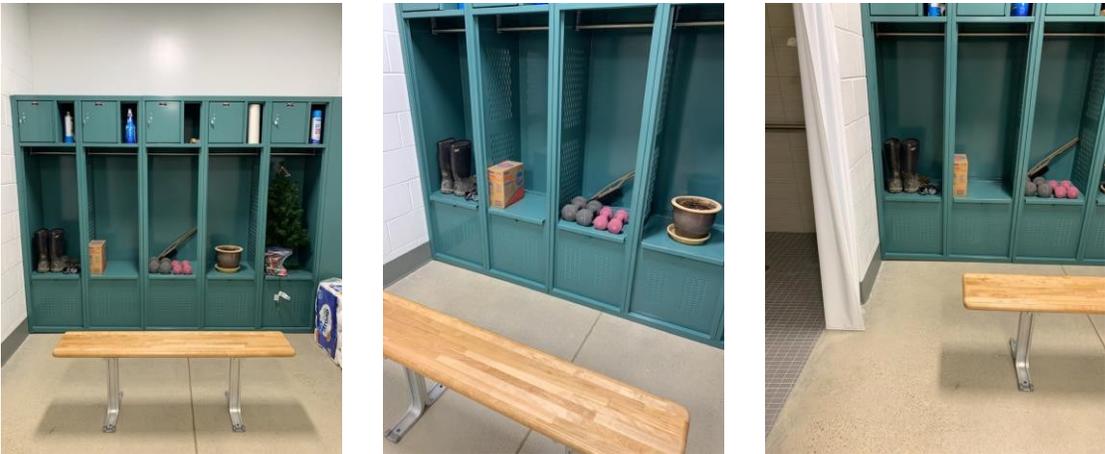
**Location:** Women's Locker Room  
**Schedule:** 2021  
**Estimated Cost:** \$1,500.00

**2010 ADA Standards for Accessible Design Codes: §403.5.1, §903.4**

The bench does not have back support. There is not a clear 36" width for wheelchairs to pass between the bench and lockers and the shower.

The width is 31" between the bench and lockers and 25" between the bench and shower.

Provide back support that is 42" long minimum and extends from a point 2" maximum above the seat surface to a point 18" minimum above the seat surface. Shift the bench 11" away from the shower and 5" away from the lockers.

Back support shall be 2½" maximum from the rear edge of the seat measured horizontally. This can be achieved by relocating one bench to utilize a nearby wall as back support.
