City of Boise ADA
Assessment

Appendix A - Warm Springs Golf Course

2/19/2021

Report #TO21-B019

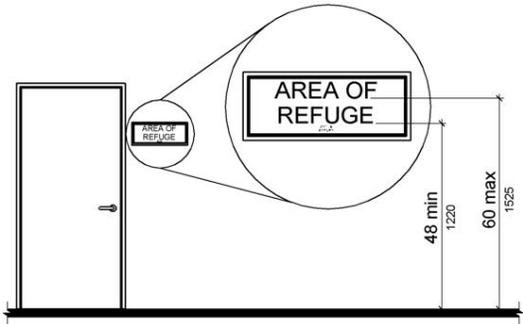
ID: 1492 **Facility:** Warm Springs Golf Course

2010 ADA Standards for Accessible Design Codes §216.2, §703
There is no tactile sign identifying the permanent room.

Install tactile signage on the latch side of the doorway at a height of 48” minimum to 60” maximum above the floor, identifying room by name or room number.

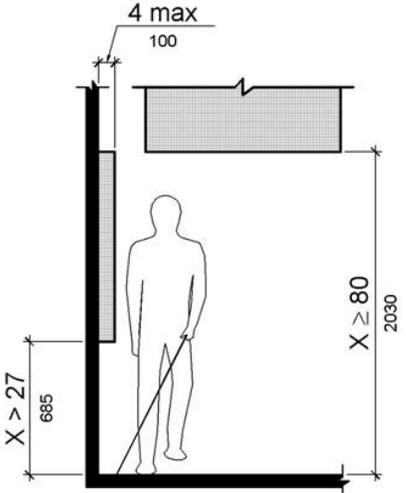
ID: 1493 **Facility:** Warm Springs Golf Course

2010 ADA Standards for Accessible Design Codes §307.2
The TV protrudes 6.75" into the circulation space at 55" above the floor.

Recess the TV so it protrudes a maximum of 4", raise it so the bottom edge is 80" maximum above the floor, or place a cane detectable object beneath it.

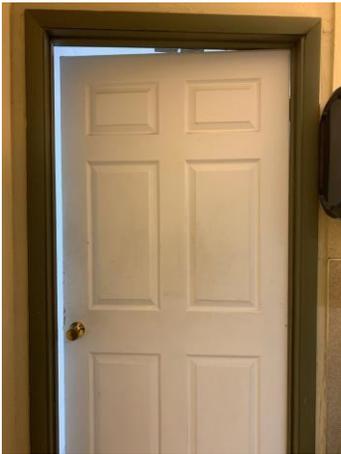
ID: 1500 **Facility:** Warm Springs Golf Course

2010 ADA Standards for Accessible Design Codes §309.4
 The door knob requires twisting of the wrist.

Replace the door knob with a lever handle that can be operated with a closed fist and without twisting the wrist.

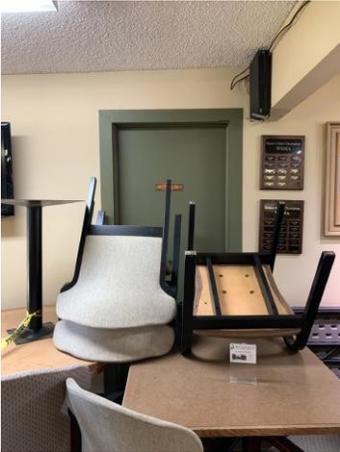
ID: 4483 **Facility:** Warm Springs Golf Course

2010 ADA Standards for Accessible Design Codes §309.4
The door knob requires twisting of the wrist.

Replace the door knob with a lever handle that can be operated with a closed fist and without twisting the wrist.

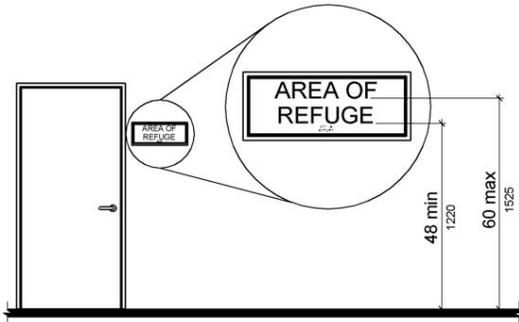
ID: 5
Facility: Warm Springs Golf Course

2010 ADA Standards for Accessible Design Codes §216.2, §703
 There is no tactile sign identifying the permanent room.

Install tactile signage on the latch side of the doorway at a height of 48” minimum to 60” maximum above the floor, identifying room by name or room number.
 Signs shall be Braille with raised lettering and should be placed on the wall in the center of an 18"x18" clear floor space.

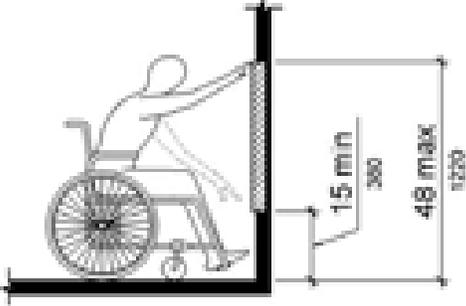
ID: 1471 **Facility:** Warm Springs Golf Course

2010 ADA Standards for Accessible Design Codes §308.2.1
The hand sanitizer is outside of the unobstructed forward reach range at 55" above the floor.

Lower the hand sanitizer by 7" to meet the accessible reach range of 48" maximum above the floor.

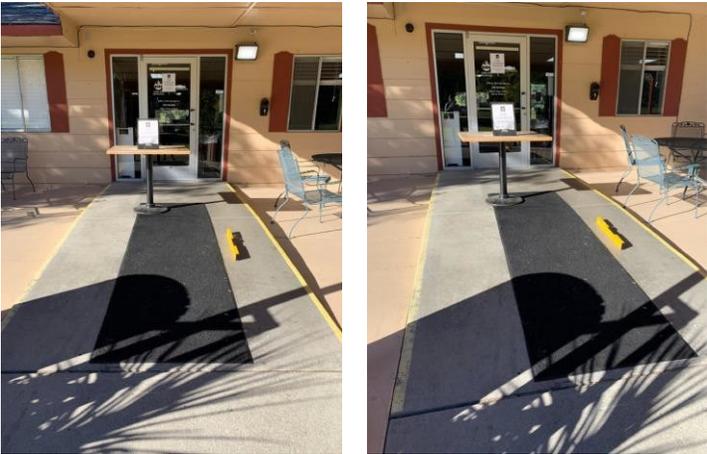
ID: 1485 **Facility:** Warm Springs Golf Course

2010 ADA Standards for Accessible Design Codes §403.3
The running slope to the entrance is 6.5%.

Resurface the route to reduce the running slope to a maximum of 5%. Or install handrails at a minimum height of 34" and maximum of 38" above the ground. Make sure there are adequate handrail extensions both at the top and bottom of the handrail.

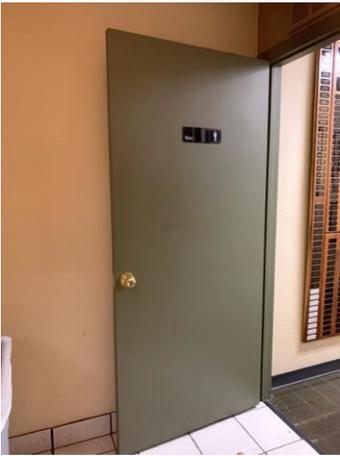
ID: 1499 **Facility:** Warm Springs Golf Course

2010 ADA Standards for Accessible Design Codes §309.4
The door knob requires twisting of the wrist.

Replace the door knob with a lever handle that can be operated with a closed fist and without twisting the wrist.

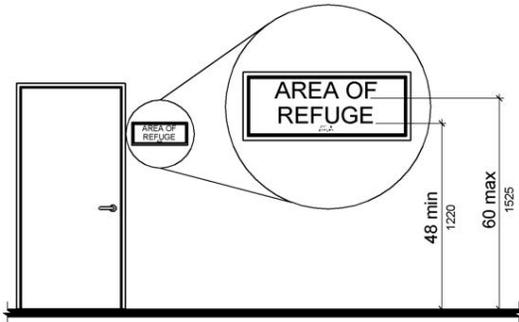
ID: 4485 **Facility:** Warm Springs Golf Course

2010 ADA Standards for Accessible Design Codes §216.2, §703
There is no tactile sign identifying the permanent room.

Install tactile signage on the latch side of the doorway at a height of 48" minimum to 60" maximum above the floor, identifying room by name or room number.
Signs shall be Braille with raised lettering and should be placed on the wall in the center of an 18"x18" clear floor space

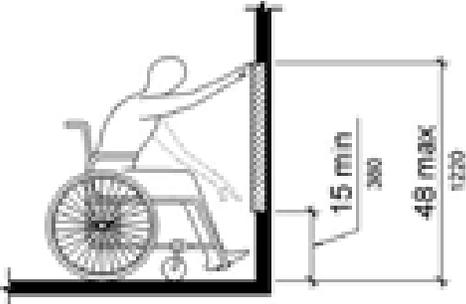
ID: 1509 **Facility:** Warm Springs Golf Course

2010 ADA Standards for Accessible Design Codes §308.2.1
The paper towel dispensers are outside of the unobstructed forward reach range at 55" above the floor.

Lower the paper towel dispensers by 7" to meet the accessible reach range of 48" maximum above the floor.

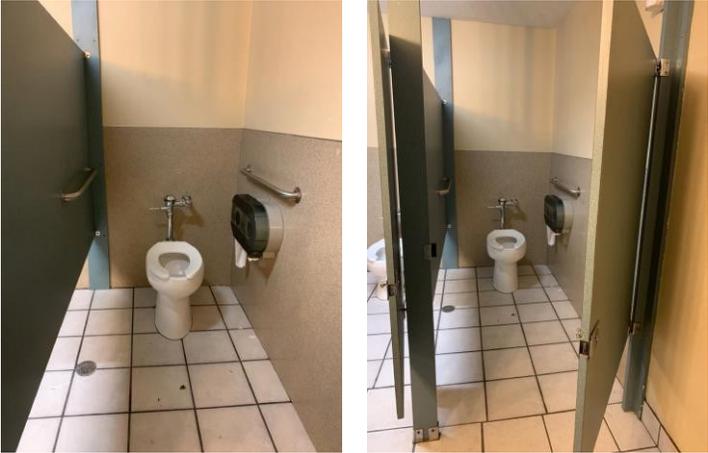
ID: 1505 **Facility:** Warm Springs Golf Course

2010 ADA Standards for Accessible Design Codes §604.8.2.2
The door to the ambulatory water closet is not self closing. Either self-closing hinges are not installed on the door or if installed, they are defective.

Install or reinstall self-closing hinges on the door to ensure that the door is self-closing per the ADA requirements.

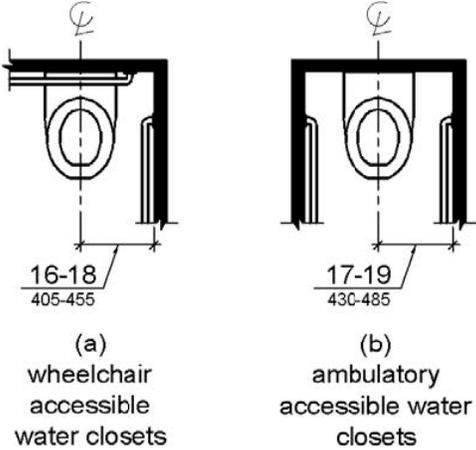
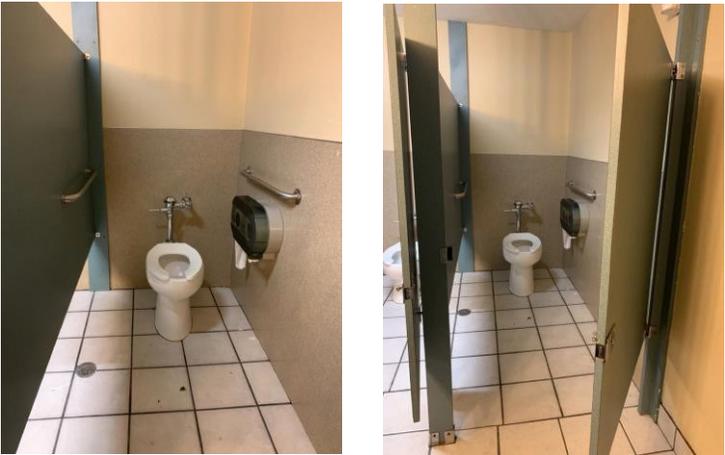
ID: 1503 **Facility:** Warm Springs Golf Course

2010 ADA Standards for Accessible Design Codes §604.2
The centerline of the toilet is located 20.5" from the sidewall.

Reposition the centerline of the toilet to be within 16" minimum and 18" maximum from the sidewall.

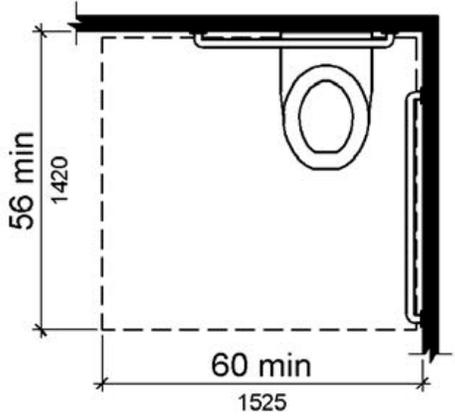
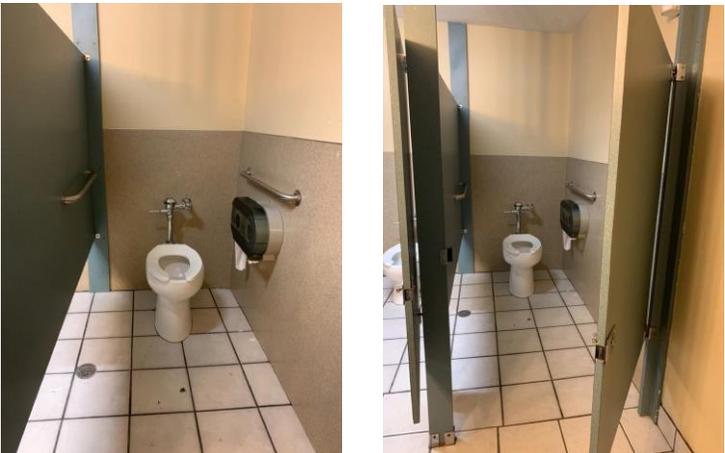
ID: 1506 **Facility:** Warm Springs Golf Course

2010 ADA Standards for Accessible Design Codes §604.3.1, §213.3.1, §604.8.1.1, §604.5.1
The sided grab bars are located 8.5" and 7" from the rear wall and are 31" long.
There is not a wheelchair accessible stall in this restroom. The stall is too narrow at 42.5" wide.

Replace the side grab bar with one that is a minimum of 42" long minimum, located 12" maximum from the rear wall, and extending 54" from the rear wall.
Expand the restroom to ensure 60" minimum measured perpendicular from the side wall and 56" minimum measured perpendicular from the rear wall.

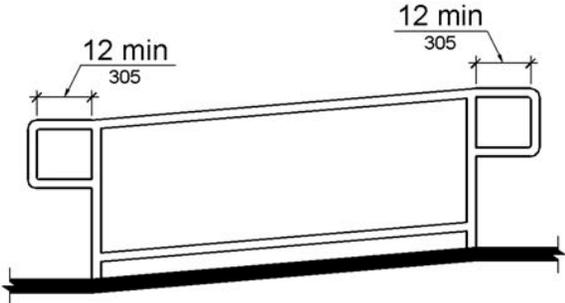
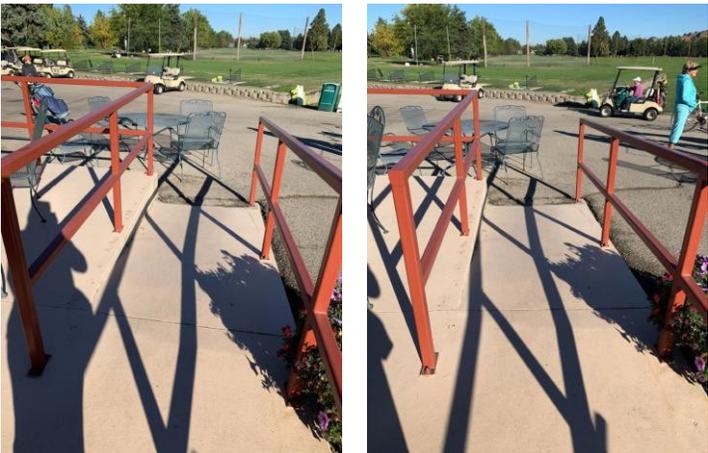
ID: 1483 **Facility:** Warm Springs Golf Course

2010 ADA Standards for Accessible Design Codes §505.10
There are no handrail extensions for the ramp.

Extend the ramp handrails 12" horizontally beyond the top and bottom of ramp runs.

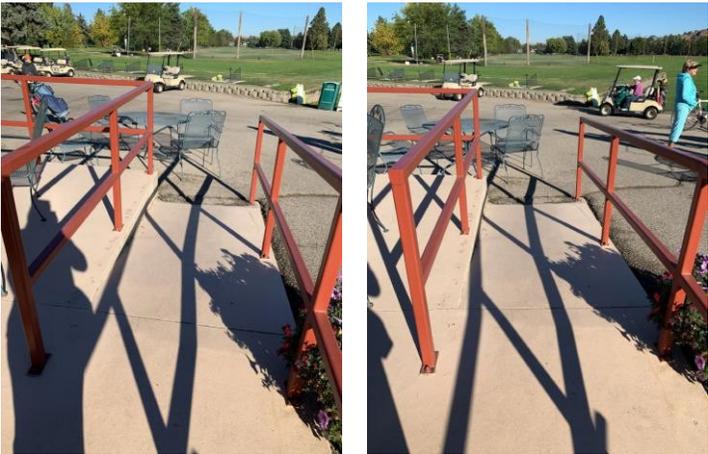
ID: 1482 **Facility:** Warm Springs Golf Course

2010 ADA Standards for Accessible Design Codes §405.2
The running slope of the ramp ranges from 9.7% to 11.3%.

Reconstruct the ramp to reduce the running slope to a maximum of 8.3%.

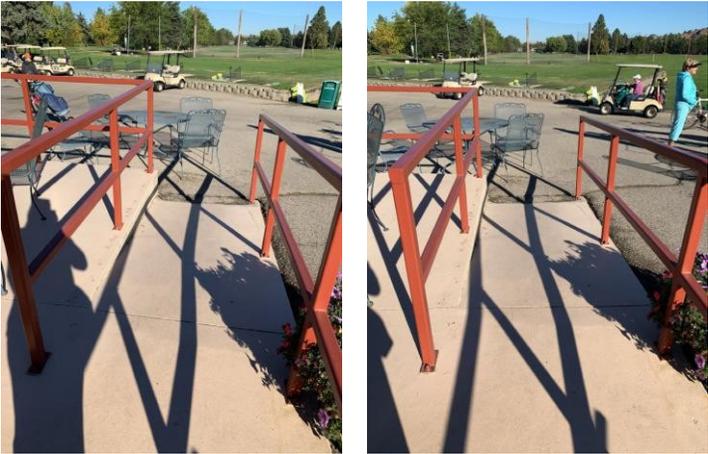
ID: 1484 **Facility:** Warm Springs Golf Course

2010 ADA Standards for Accessible Design Codes §405.9, §505.2
There is no handrail on the left side of the ramp. There is no edge protection on either side of the ramp.

Install a handrail at a minimum height of 34" and maximum of 38" above the ground. Make sure there are adequate handrail extensions both at the top and bottom of the handrail.

Install edge protection on either side of the ramp by extending the floor surface an additional 12" beyond the inside face of the handrails or by installing new handrails that have a lower barrier to prevent the passage of a 4" diameter sphere.

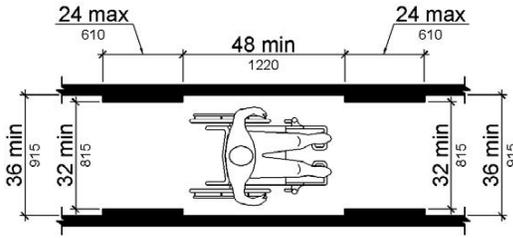
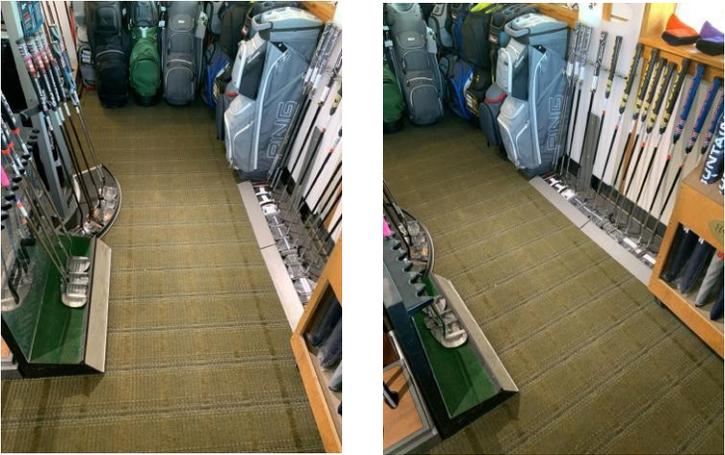
ID: 1487 **Facility:** Warm Springs Golf Course

2010 ADA Standards for Accessible Design Codes §403.5.1
The path in the back of the pro shop is 28.5" wide.

Widen the path to allow for a minimum clear width of 36". This can be achieved by reorganizing the displays and relocating one of the golf club displays.

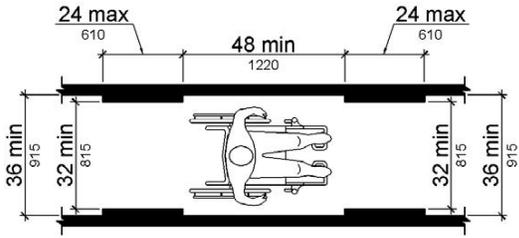
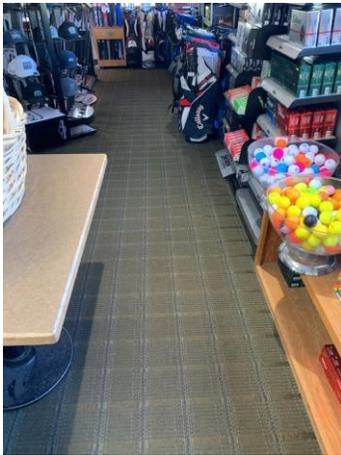
ID: 1488 **Facility:** Warm Springs Golf Course

2010 ADA Standards for Accessible Design Codes §403.5.1
Due to the table, the circulation path is reduced to 22.5" wide.

Remove the table to widen the route to 36".

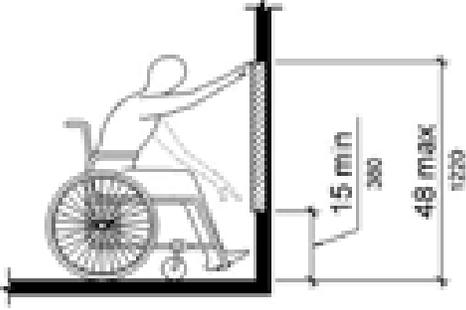
ID: 1490 **Facility:** Warm Springs Golf Course

2010 ADA Standards for Accessible Design Codes §308.2.1
The hook is outside of the unobstructed forward reach range at 63" above the floor.

Lower the hook by 15" to meet the accessible reach range of 48" maximum above the floor.

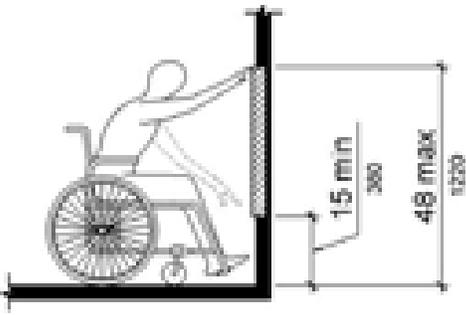
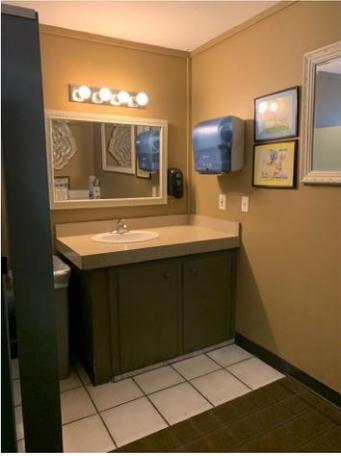
ID: 1497 **Facility:** Warm Springs Golf Course

2010 ADA Standards for Accessible Design Codes §308.2.1
The paper towel dispenser is outside of the unobstructed forward reach range at 55" above the floor.

Lower the paper towel dispenser by 7" to meet the accessible reach range of 48" maximum above the floor.

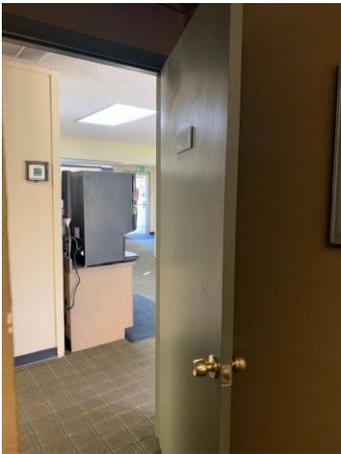
ID: 1498 **Facility:** Warm Springs Golf Course

2010 ADA Standards for Accessible Design Codes §309.4

Replace the door knob with a lever handle that can be operated with a closed fist and without twisting the wrist.

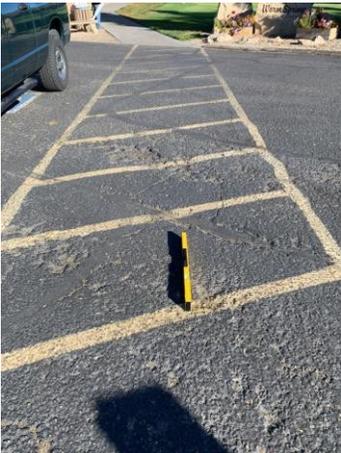
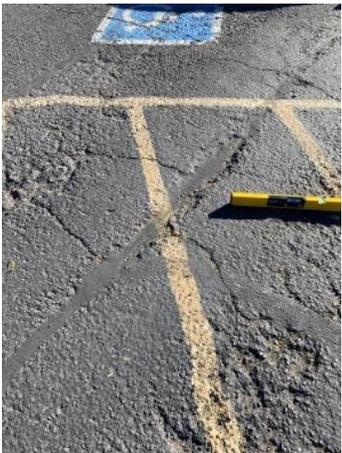
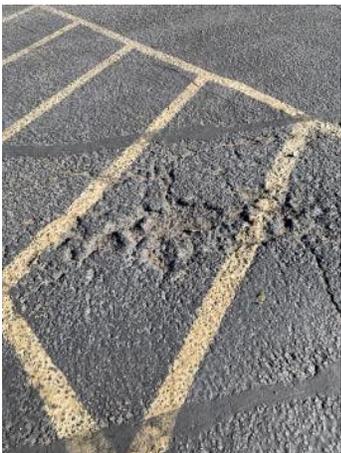
ID: 1473 **Facility:** Warm Springs Golf Course

2010 ADA Standards for Accessible Design Codes §302.1
There are tripping hazards in the accessible route.

Repave the area of the sidewalk to remove the hazard.

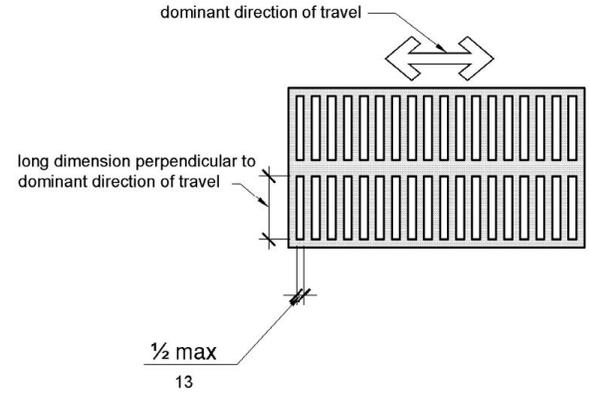
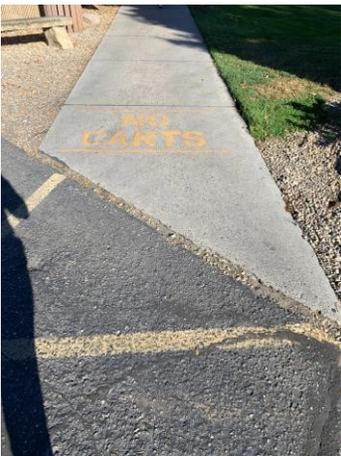
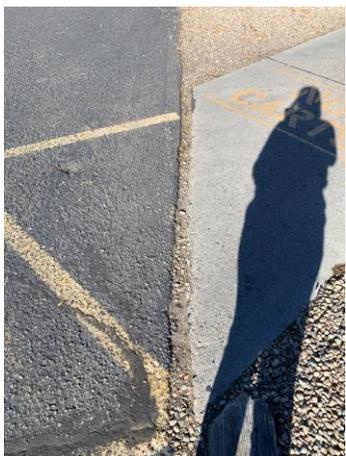
2010 ADA Standards for Accessible Design Codes §302.3
There is a 2.5" gap in the accessible route posing a tripping hazard.

Fill in the gap to ensure that it is a maximum of 0.5" wide.
