City of Boise ADA  
Assessment

# Appendix A-City of Boise Zoo

03/12/2021

Report #TO21-B023

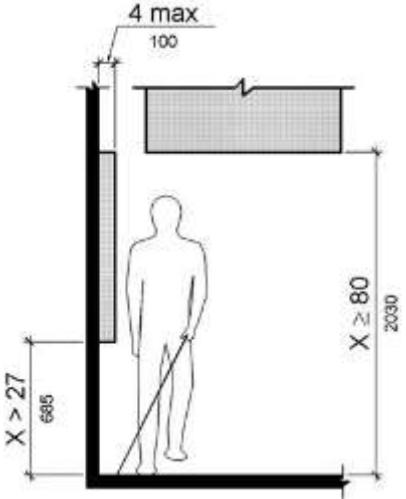
**Location** AED near Gift Shop Restroom  
**Schedule** 2021  
**Estimated Cost:** \$100.00

**2010 ADA Standards for Accessible Design Codes §307.2**  
The AED protrudes 6.5" into the circulation space at 38" above the floor.

Recess the AED so it protrudes a maximum of 4" or place a cane detectable object beneath it.

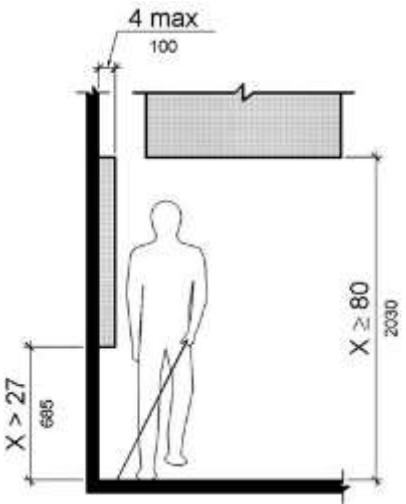
**Location** African Plains Exhibit Animal Presentation Area  
**Schedule** 2021  
**Estimated Cost:** \$100.00

**2010 ADA Standards for Accessible Design Codes §307.2**  
The box protrudes 9" into the circulation space at 36" above the floor.

Recess the box so it protrudes a maximum of 4" or place a cane detectable object beneath it.

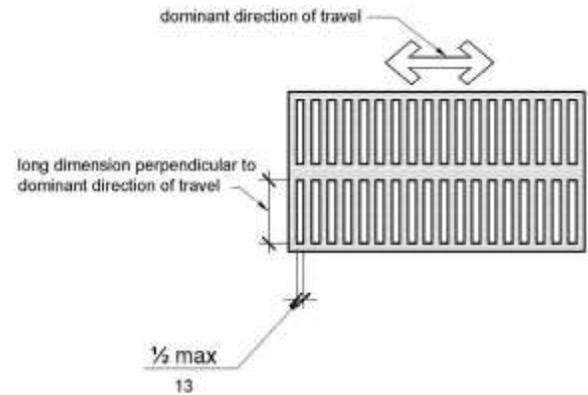
**2010 ADA Standards for Accessible Design Codes** §302.3  
There is a 1" in the pathway posing a tripping hazard.

Fill in the gap to reduce the gap to a maximum of 0.5".

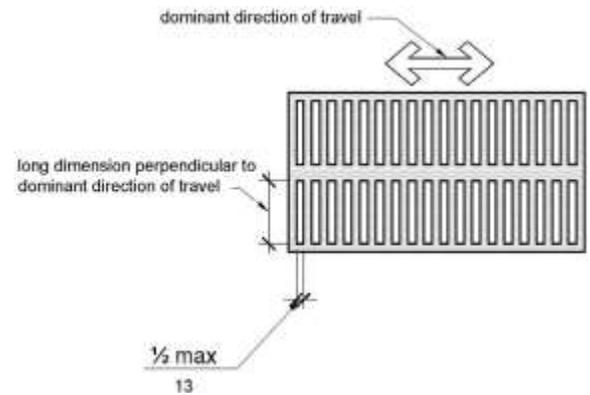
**2010 ADA Standards for Accessible Design Codes §302.3**  
There are open grates in the pathway posing a tripping hazard.

Replace the grate with one that has gaps that are a maximum of 0.5".

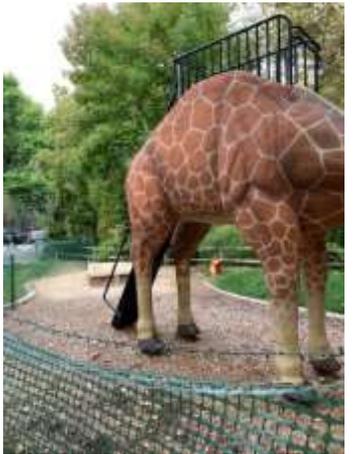
**2010 ADA Standards for Accessible Design Codes** §302.1, ASTM F1951-99  
The giraffe slide is not accessible. There are changes in level that pose tripping hazards on the route to the giraffe slide.  
The playground surface is not stable, firm, and slip resistant.

Install an accessible play element in addition to the giraffe slide.  
Repave the area of the sidewalk to remove the change in level.  
Replace the mulch with an accessible playground surface material such as pour-in-place rubber, rubber tiles, artificial grass, and engineered wood fiber.
