City of Boise
ADA Assessment

Appendix A-Borah Pool House

12/4/2020

Report #TO21-B0XX

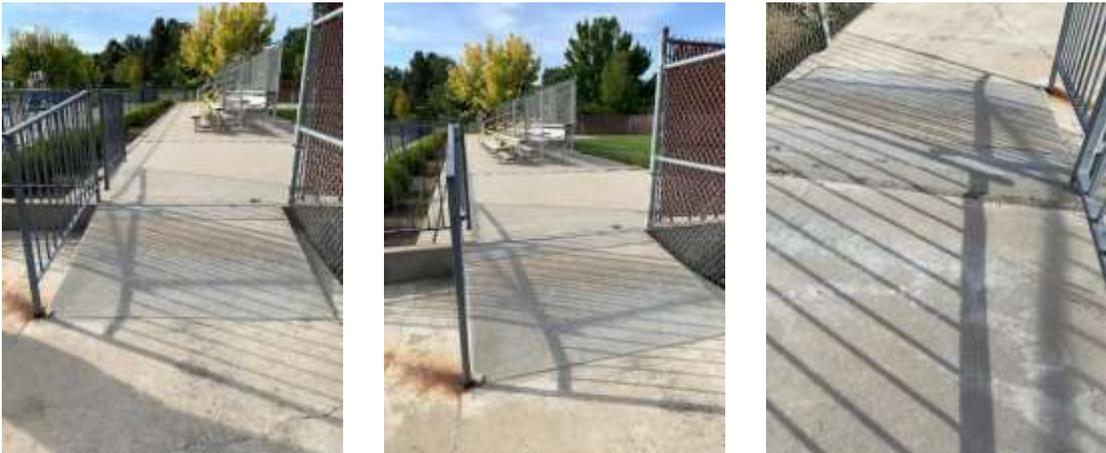
2010 ADA Standards for Accessible Design Codes: §303.3
There is a 0.5" change in level at the top of the ramp.

Bevel the change in level with a slope not steeper than 1:2.

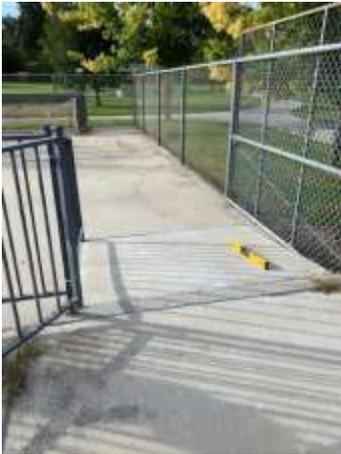
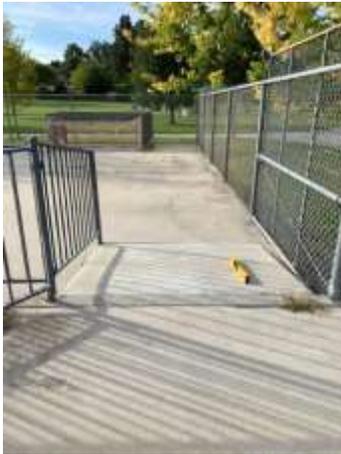
2010 ADA Standards for Accessible Design Codes: §405.2
The ramp leading to the bleachers has a running slope of 14.9%, and there are no handrails.

Reconstruct the ramp to reduce the running slope to a maximum 8.3%. Install handrails at a minimum height of 34" and maximum of 38" above the ground.
Make sure there are adequate handrail extensions both at the top and bottom of the handrail and edge protection on each side of ramp runs.

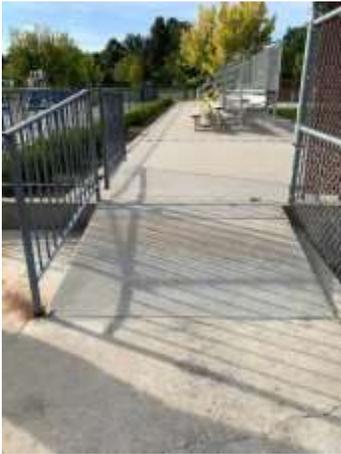
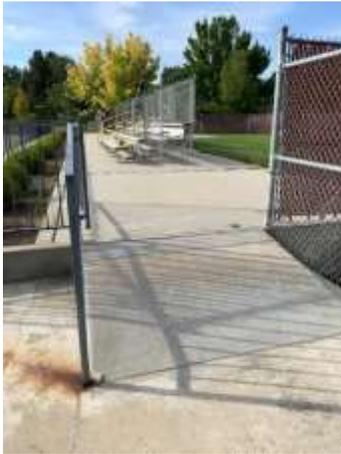
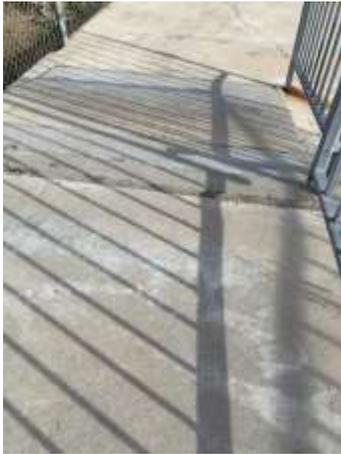
2010 ADA Standards for Accessible Design Codes: §405.2, §505.2
The ramp leading to the bleachers has a running slope reaching 16.5%, and there are no handrails. The bleachers are located south of the swimming pool.

Reconstruct the ramp to reduce the running slope to a maximum of 8.3%. Install handrails at a minimum height of 34" and maximum of 38" above the ground.
Make sure there are adequate handrail extensions both at the top and bottom of the handrail and edge protection on each side of ramp runs.

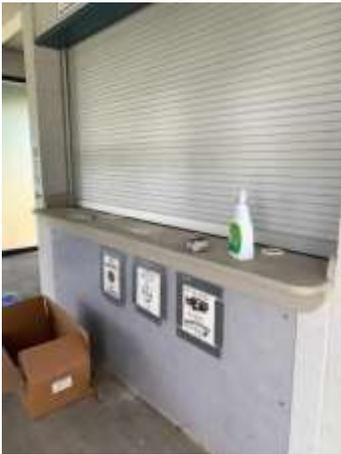
2010 ADA Standards for Accessible Design Codes: §904.4.1
The check in counter is 37.25" above the floor.

A portion of the service counter must be no higher than 36" above the floor for a horizontal distance of 36".

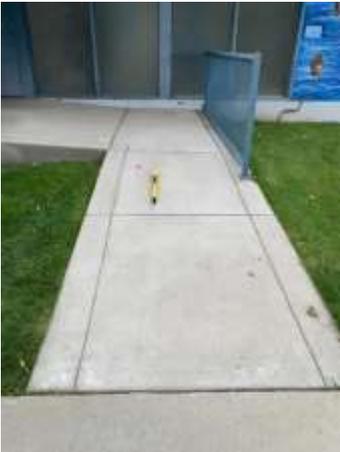
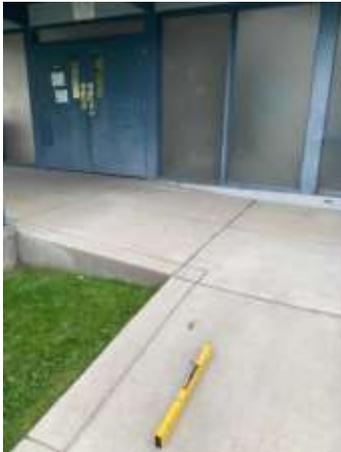
2010 ADA Standards for Accessible Design Codes: §505.2
The ramp at the main entrance has no handrails.

Install handrails at a minimum height of 34” and maximum of 38” above the ground.
Make sure there are adequate handrail extensions both at the top and bottom of the handrail and edge protection on each side of ramp runs.

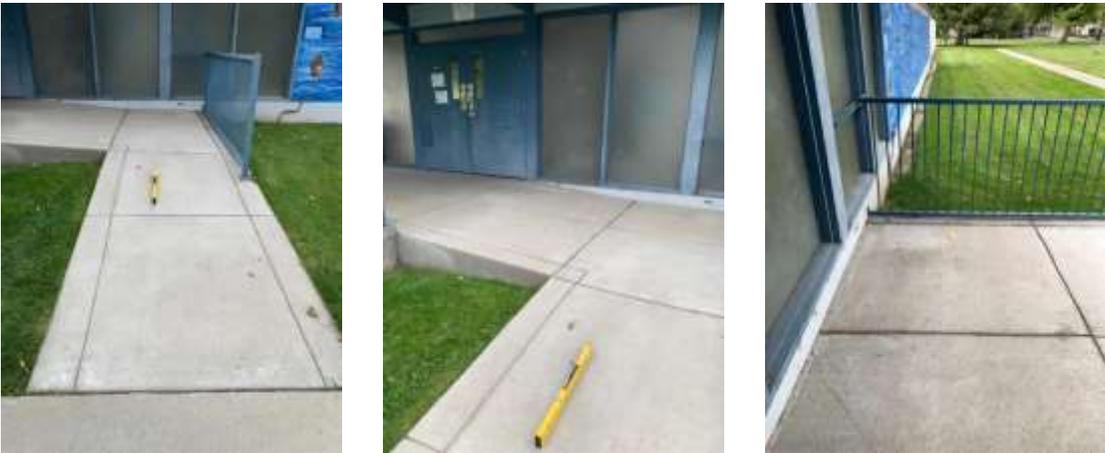
2010 ADA Standards for Accessible Design Codes: §405.2
The ramp leading to the main entrance has a running slope of 11.4%.

Resurface the ramp to reduce the running slope to a maximum of 8.3%. Install handrails at a minimum height of 34" and maximum of 38" above the ground. Make sure there are adequate handrail extensions both at the top and bottom of the handrail and edge protection on each side of ramp runs.

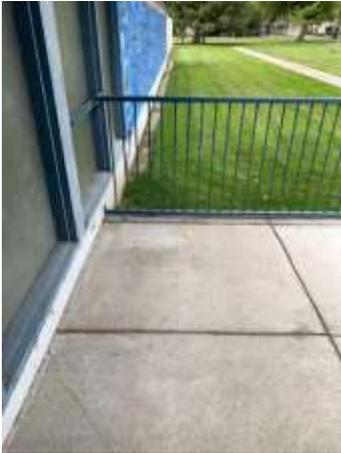
2010 ADA Standards for Accessible Design Codes: §405.7.2, §405.7.3
The landing at the top of the entry ramp is not 60"x60".

Expand the provided landing to ensure that the clear length is 60" long minimum to allow adequate turning space.

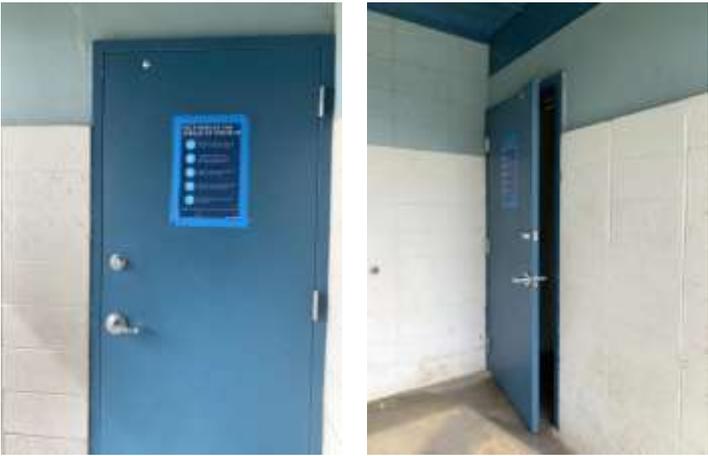
2010 ADA Standards for Accessible Design Codes: §216.2, §703
There is no tactile sign identifying the restroom.

Install tactile signage on the latch side of the doorway at a height of 48” minimum to 60” maximum above the floor, identifying room by name or room number.
Signs shall be Braille with raised lettering and should be placed on the wall in the center of an 18"x18" clear floor space.

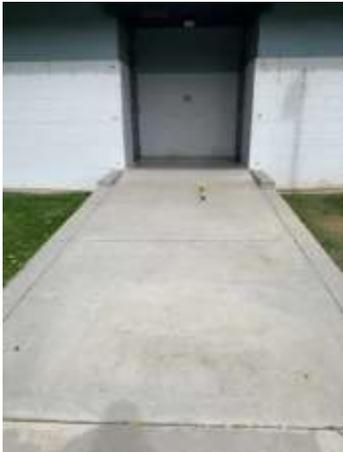
2010 ADA Standards for Accessible Design Codes: §505.2
There are no handrails provided on either side of the ramp.

Install handrails at a minimum height of 34” and maximum of 38” above the ground.
Make sure there are adequate handrail extensions both at the top and bottom of the handrail and edge protection on each side of ramp runs.

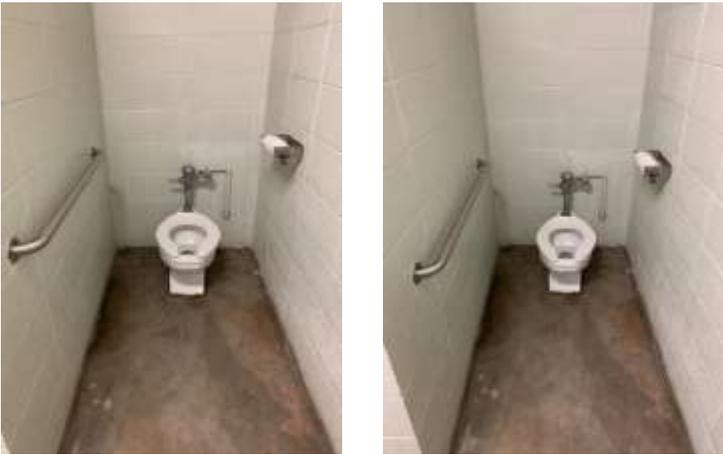
2010 ADA Standards for Accessible Design Codes: §604.7
The toilet paper dispenser is located behind the rim of the toilet.

Remount the toilet paper dispenser so that the centerline is located 7" minimum to 9" maximum in front of the toilet.
Ensure that the height is within the accessible reach range of 15" minimum to 48" maximum above the floor.

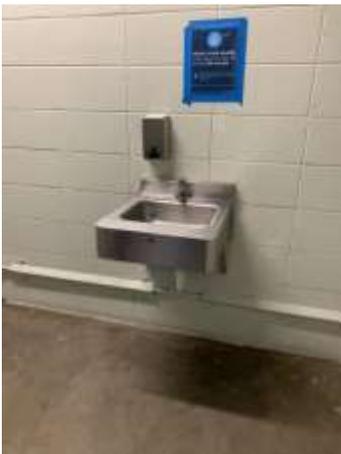
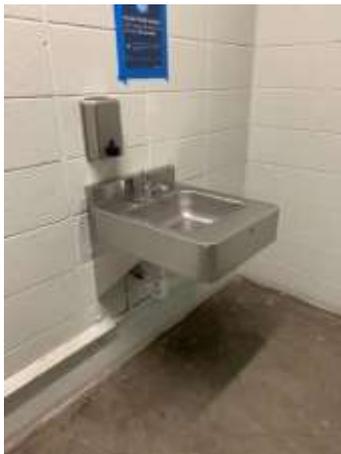
The sink protrudes 10.5" into the circulation space at 33.5" above the floor.

Recess the sink so it protrudes a maximum of 4", lower it so the bottom edge is 27" maximum above the floor, or extend the skirt underneath the sink to provide additional detectability.

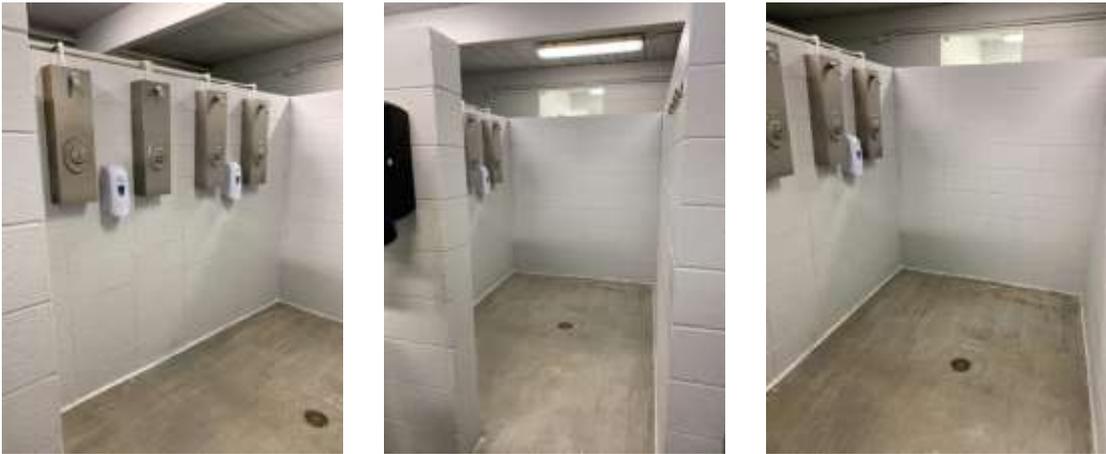
2010 ADA Standards for Accessible Design Codes: §308.2.1
The hooks are outside of the unobstructed forward reach range at 63" above the floor.

Lower the hooks by 15" to meet the accessible reach range of 15" minimum and 48" maximum above the floor.

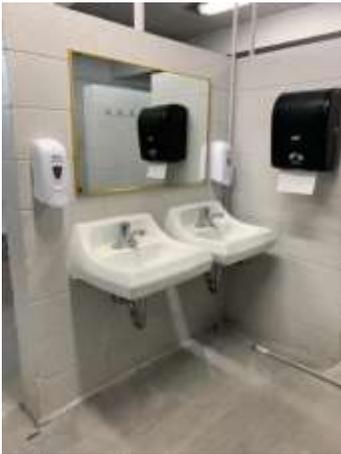
2010 ADA Standards for Accessible Design Codes: §603.3
The mirror is too high to be accessible at 42" above the floor.

Lower the mirror its bottom edge is a maximum height of 40" above the floor.

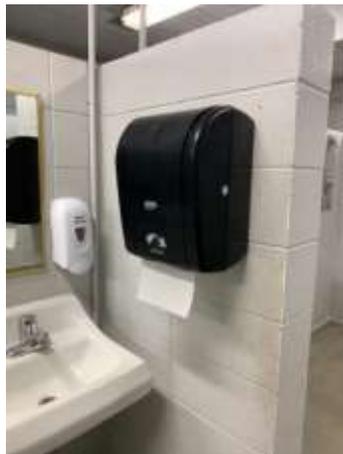
The paper towel dispenser protrudes 8" into the circulation space at 46" above the floor.

Recess the paper towel dispenser so it protrudes a maximum of 4", lower it so the bottom edge is 27" maximum above the floor, or place a cane detectable object beneath it.

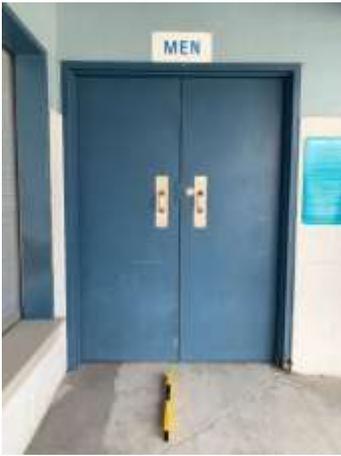
2010 ADA Standards for Accessible Design Codes: §216.2, §703
There is no tactile sign identifying the men's locker room.

Install tactile signage on the latch side of the doorway at a height of 48" minimum to 60" maximum above the floor, identifying the locker room by name or room number.
Signs shall be Braille with raised lettering and should be placed on the wall in the center of an 18"x18" clear floor space.

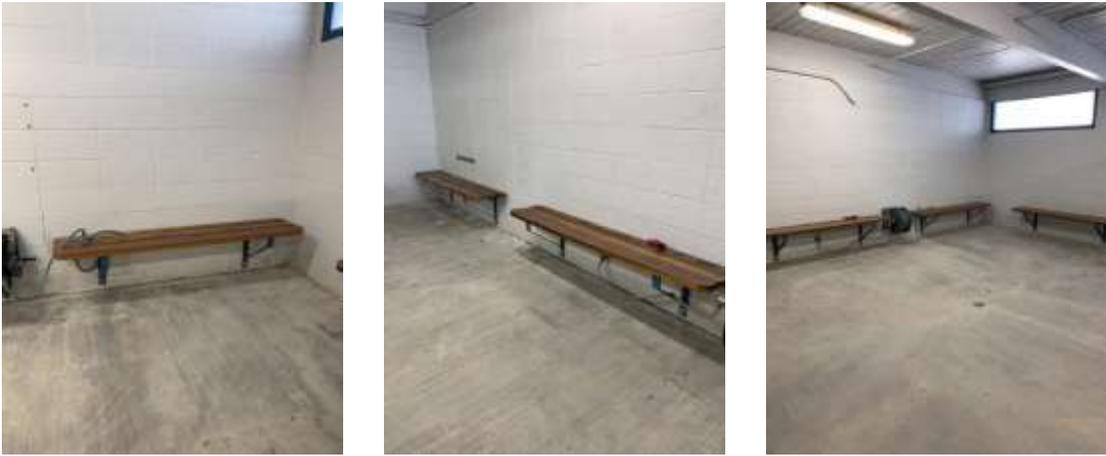
2010 ADA Standards for Accessible Design Codes: §903.3
 The benches in the men's locker room are 15" deep.

Install one new bench that is at least 42" long and 20" to 24" inches deep. The accessible bench shall have a back support or be affixed to a wall.

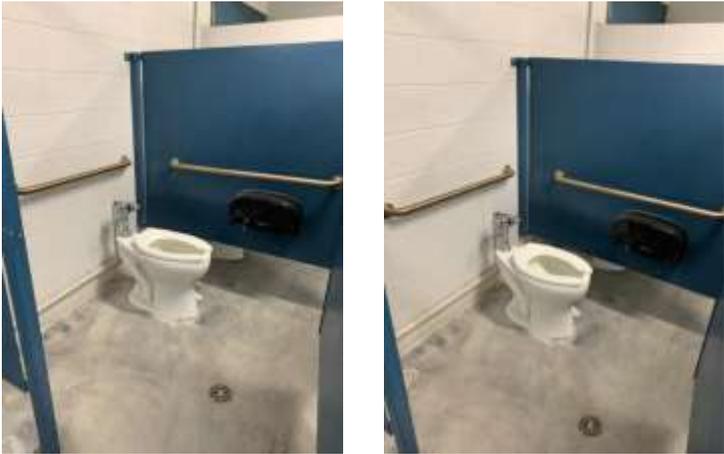
2010 ADA Standards for Accessible Design Codes: §604.5.2
The rear grab bar is located 4.5" from the side wall.

Replace the rear grab bar with one that is a minimum of 36" long minimum and extends from the centerline of the water closet 12" minimum on one side and 24" minimum on the other.

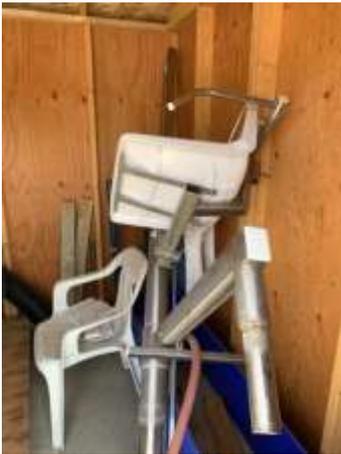
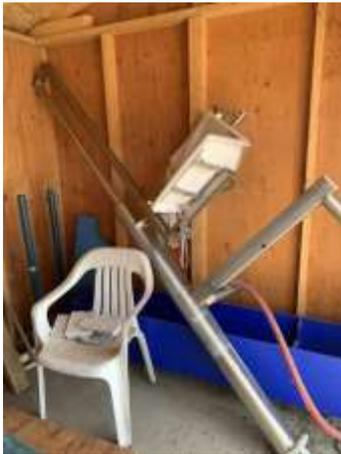
Location: Pool Lift
Schedule: 2021
Estimated Cost: \$500.00

2010 ADA Standards for Accessible Design Codes: §1009.2.4
When installed, the pool lift seat is 14" above the pool deck.

Raise the height of the pool lift to be a minimum of 16" to a maximum of 19" above the pool deck.

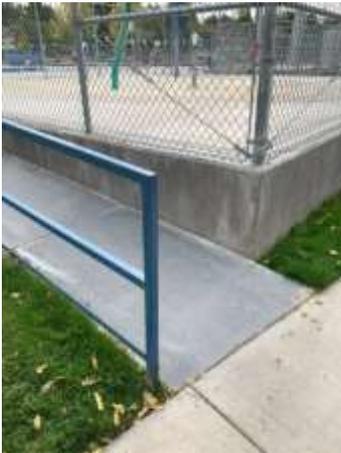
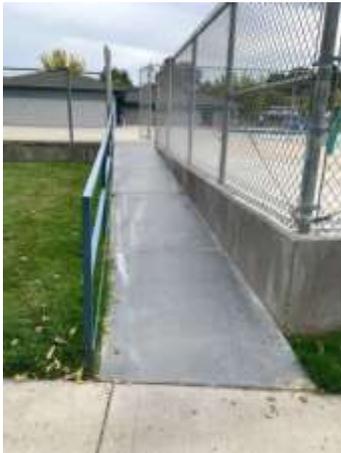
Location: Splash Pad Ramp
Schedule: 2022
Estimated Cost: \$1,000.00

2010 ADA Standards for Accessible Design Codes: §505.2
Handrails are only on one side of the ramp.

Install handrails at a minimum height of 34” and maximum of 38” above the ground. Make sure there are adequate handrail extensions both at the top and bottom of the handrail.

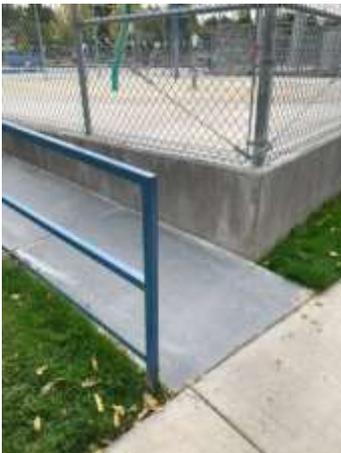
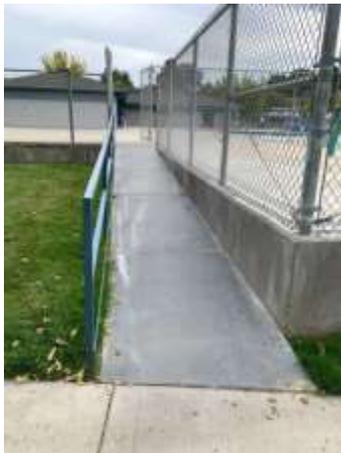
Location: Splash Pad Ramp

2010 ADA Standards for Accessible Design Codes: §505.10

There are no handrail extensions for the ramp.

Extend the ramp handrails 12" horizontally beyond the top and bottom of ramp runs.

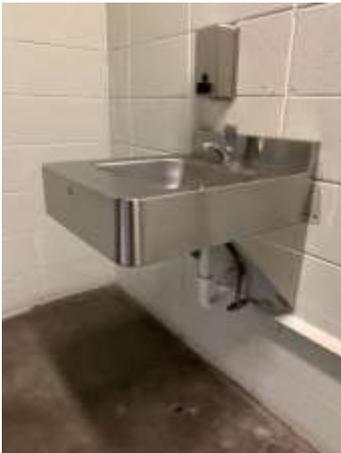
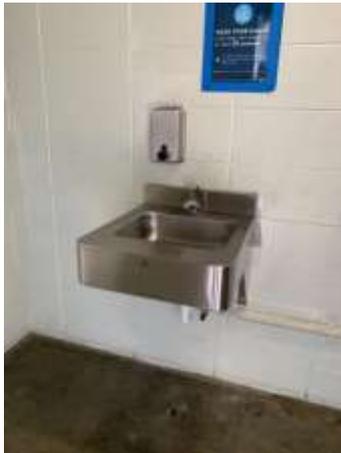
Location: Women's Exterior Restrooms

2010 ADA Standards for Accessible Design Codes: §606.5

The pipes under the sink are not covered.

Wrap the pipes beneath the sink with soft protective wrap or plastic.

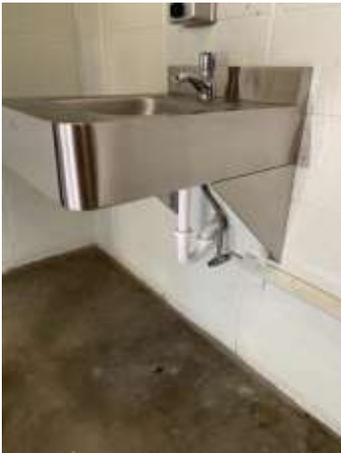
Location: Women’s Exterior Restrooms

2010 ADA Standards for Accessible Design Codes: §606.5

The pipes under the sink are not covered.

Wrap the pipes beneath the sink with soft protective wrap or plastic.
