City of Boise ADA
Assessment

Appendix A-City Hall

11/11/2021

Report #TO21-B002

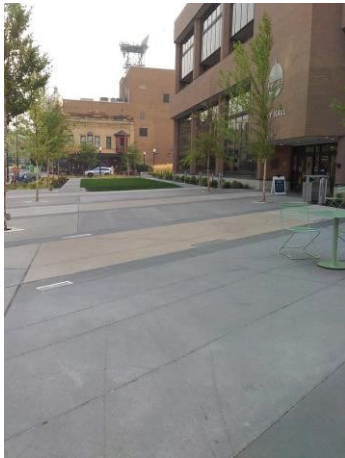
ID:
4053

Boise staff notified us that previously a guide dog was circling around the plaza and could not find its way back to the street.

For the purpose of achieving greater accessibility and Human Centric Design, consider adding handrails to the ramp or painting the sloped walkway to distinguish it from the rest of the plaza.

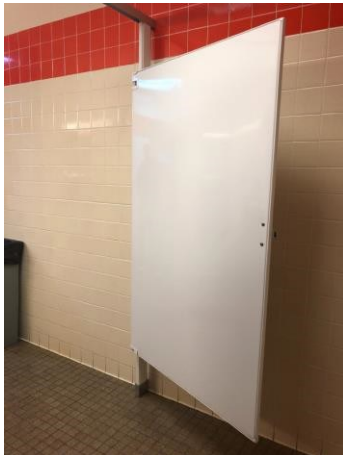
ID: 3846
Facility: City Hall

The door to the accessible water closet is not self closing. Either self-closing hinges are not installed on the door or if installed, they are defective.

Install or reinstall self-closing hinges on the door to ensure that the door is self-closing per the ADA requirements.

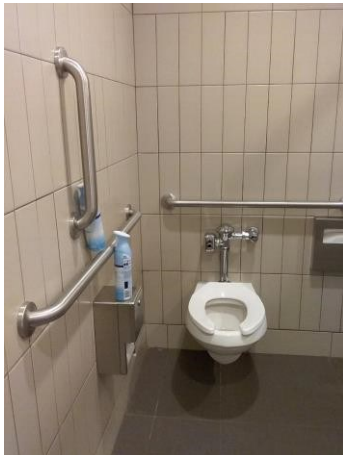
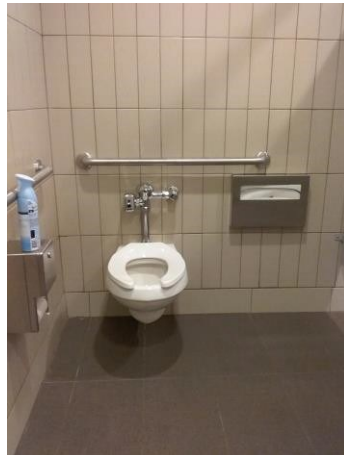
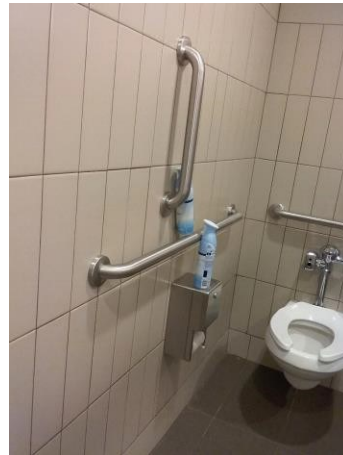
ID: 3781
Facility: City Hall

The door to the accessible water closet is not self closing. Either self-closing hinges are not installed on the door or if installed, they are defective.

Install or reinstall self-closing hinges on the door to ensure that the door is self-closing per the ADA requirements.

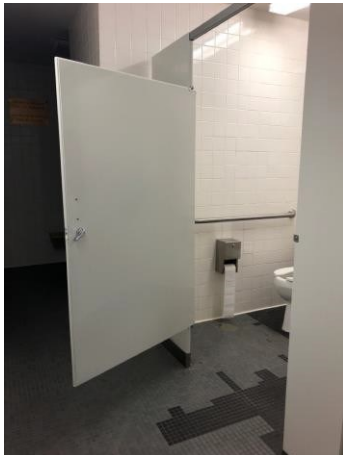
ID: 3913
Facility: City Hall

The door to the accessible water closet is not self closing. Either self-closing hinges are not installed on the door or if installed, they are defective.

Install or reinstall self-closing hinges on the door to ensure that the door is self-closing per the ADA requirements.

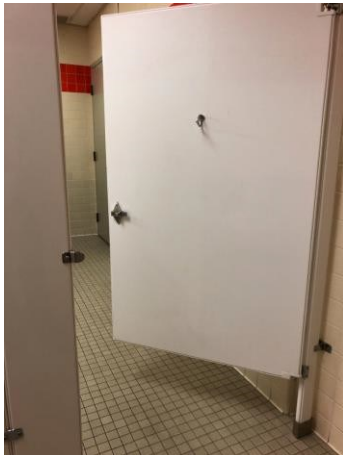
ID: 3916
Facility: City Hall

The door to the accessible water closet is not self closing. Either self-closing hinges are not installed on the door or if installed, they are defective.

Install or reinstall self-closing hinges on the door to ensure that the door is self-closing per the ADA requirements.

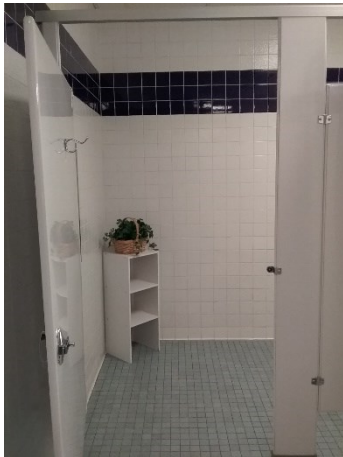
ID: 3966
Facility: City Hall

The door to the accessible water closet is not self closing. Either self-closing hinges are not installed on the door or if installed, they are defective.

Install or reinstall self-closing hinges on the door to ensure that the door is self-closing per the ADA requirements.

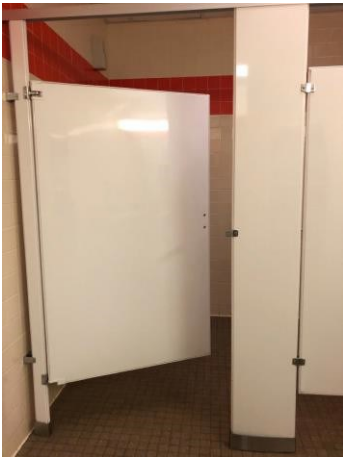
ID: 3979
Facility: City Hall

The door to the accessible water closet is not self closing. Either self-closing hinges are not installed on the door or if installed, they are defective.

Install or reinstall self-closing hinges on the door to ensure that the door is self-closing per the ADA requirements.

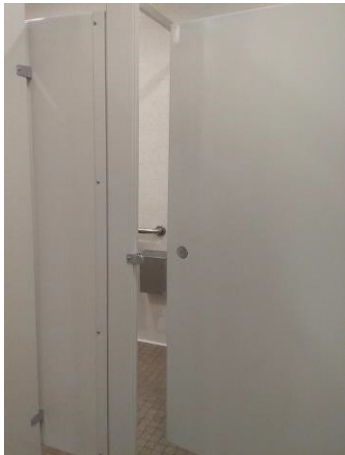
The door to the accessible water closet is not self closing. Either self-closing hinges are not installed on the door or if installed, they are defective.

Install or reinstall self-closing hinges on the door to ensure that the door is self-closing per the ADA requirements.

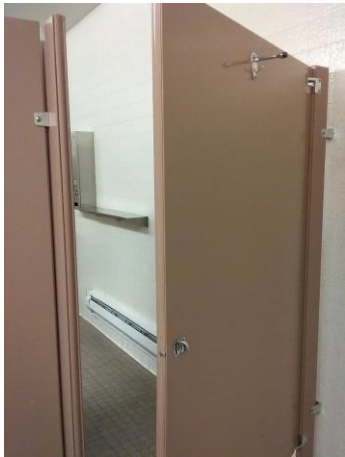
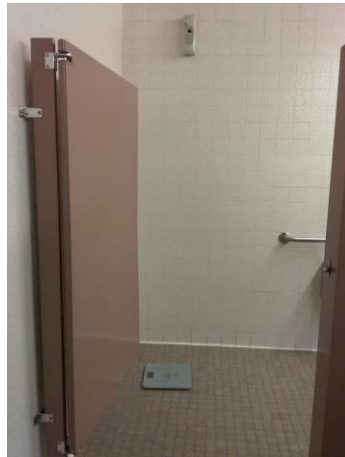
The door to the accessible water closet is not self closing. Either self-closing hinges are not installed on the door or if installed, they are defective.

Install or reinstall self-closing hinges on the door to ensure that the door is self-closing per the ADA requirements.

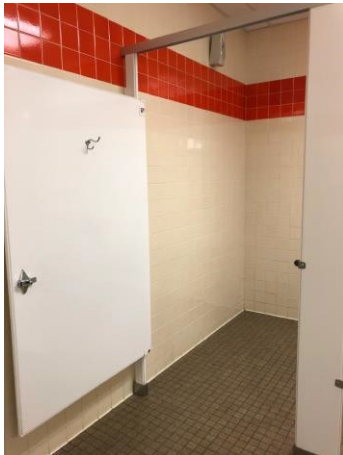
The door to the accessible water closet is not self closing. Either self-closing hinges are not installed on the door or if installed, they are defective.

Install or reinstall self-closing hinges on the door to ensure that the door is self-closing per the ADA requirements.

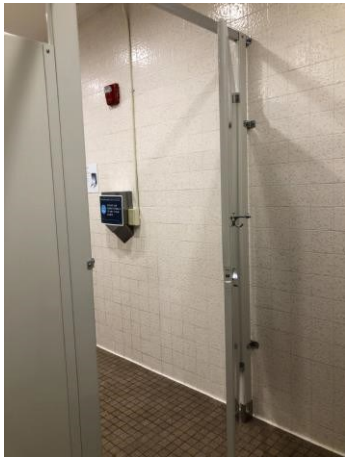
The door to the accessible water closet is not self closing. Either self-closing hinges are not installed on the door or if installed, they are defective.

Install or reinstall self-closing hinges on the door to ensure that the door is self-closing per the ADA requirements.

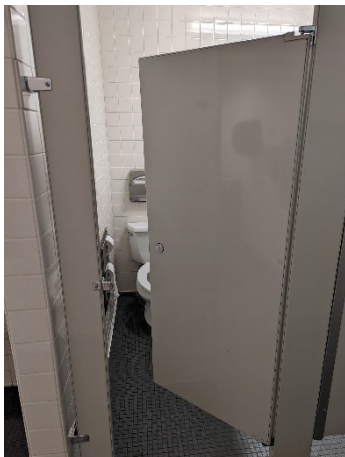
The door to the accessible water closet is not self closing. Either self-closing hinges are not installed on the door or if installed, they are defective.

Install or reinstall self-closing hinges on the door to ensure that the door is self-closing per the ADA requirements.

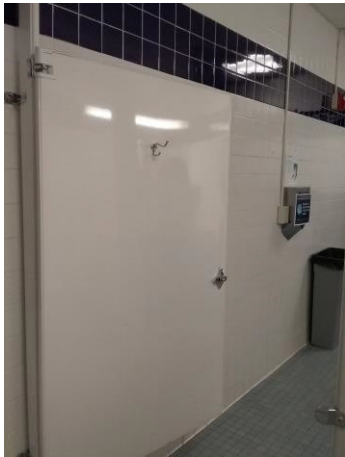
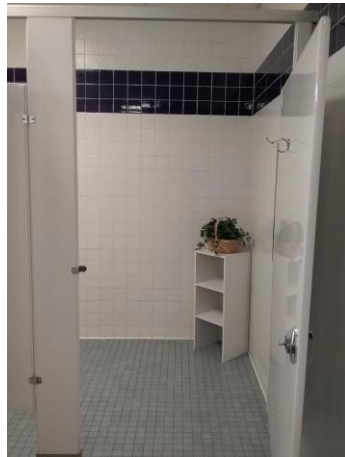
The door to the accessible water closet is not self closing. Either self-closing hinges are not installed on the door or if installed, they are defective.

Install or reinstall self-closing hinges on the door to ensure that the door is self-closing per the ADA requirements.

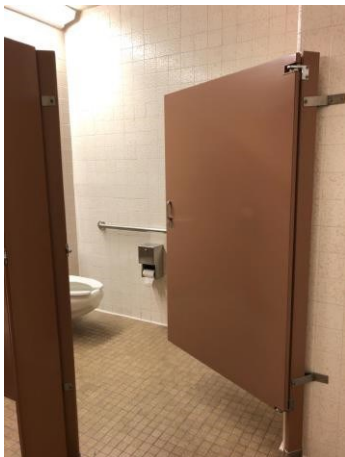
The door to the accessible water closet is not self closing. Either self-closing hinges are not installed on the door or if installed, they are defective.

Install or reinstall self-closing hinges on the door to ensure that the door is self-closing per the ADA requirements.

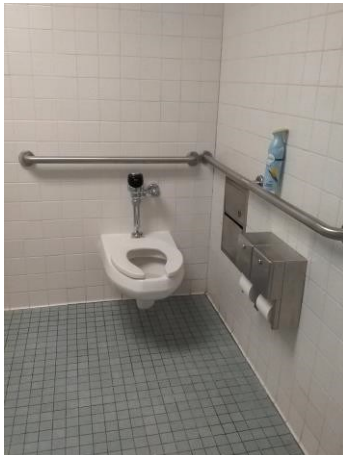
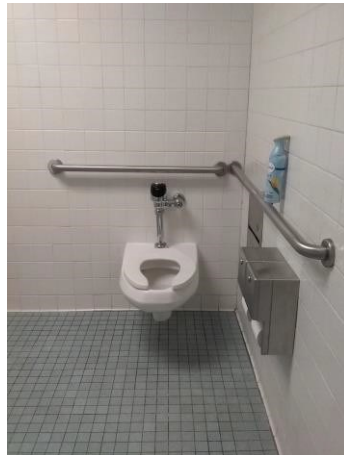
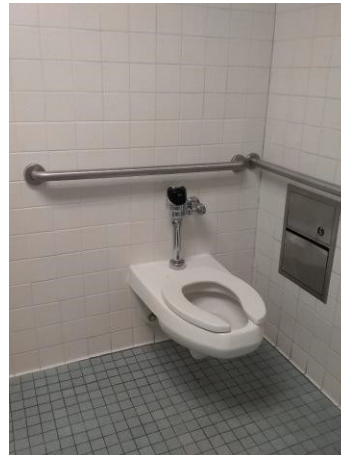
The door to the accessible water closet is not self closing. Either self-closing hinges are not installed on the door or if installed, they are defective.

Install or reinstall self-closing hinges on the door to ensure that the door is self-closing per the ADA requirements.

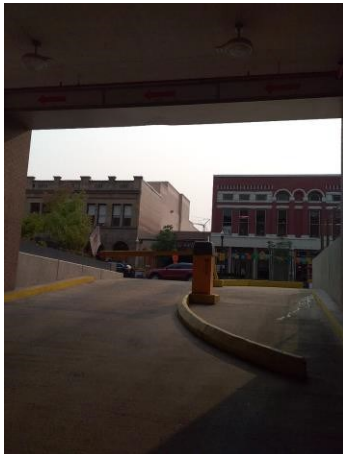
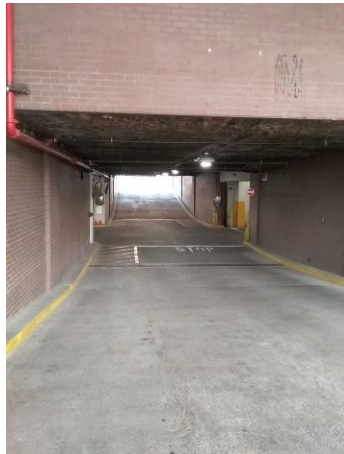
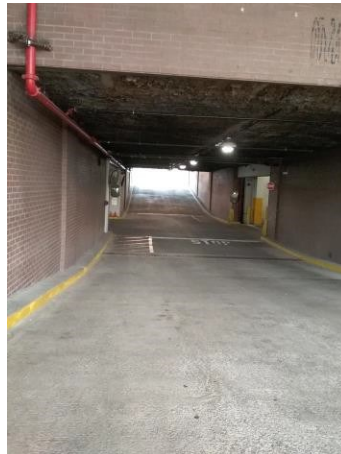
Although it is not in violation of the 2010 ADA Standards for Accessible Design, it must be noted that the maximum height of the garage is not posted for users.

If the internal clearance within the garage is less than 98", van accessible parking will need to be provided at another location.

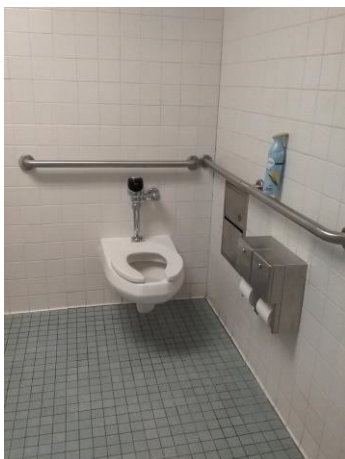
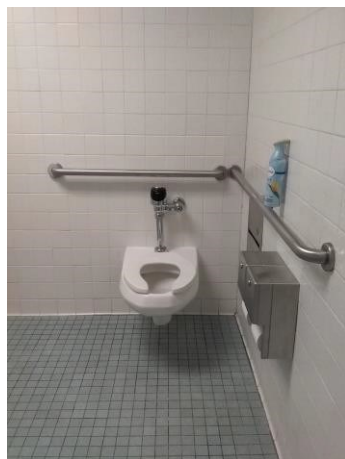
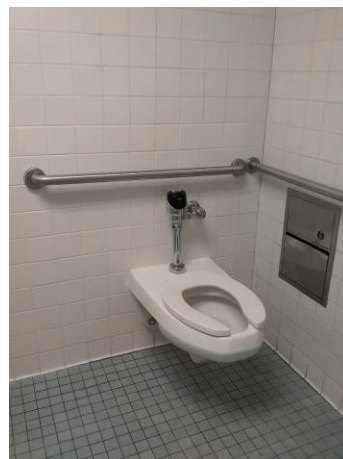
(b)
ambulatory
accessible water
closets
