City of Boise ADA
Assessment

Appendix A - City Hall West

02/19/2021

Report #TO21-B021

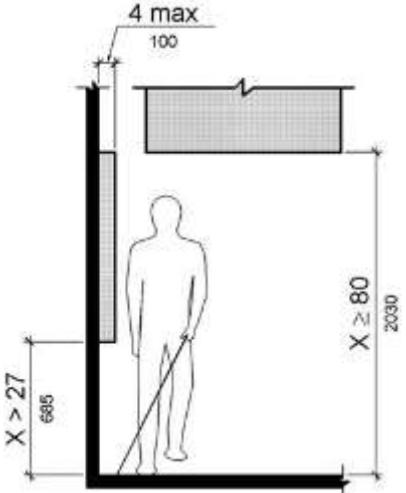
2010 ADA Standards for Accessible Design Codes §307.2
The AED protrudes 8.5" into the circulation space at 31" above the floor.

Recess the AED so it protrudes a maximum of 4", lower it so the bottom edge is 27" maximum above the floor, or place a cane detectable object beneath it.

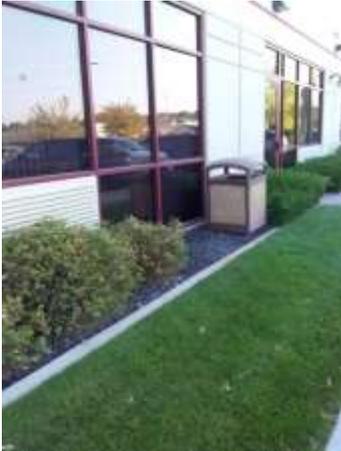
ID: 3569 **Facility:** City Hall West

2010 ADA Standards for Accessible Design Codes §302.1, §305
 There is not a firm, stable, and slip resistant route to the garbage can.

Relocate the garbage can adjacent to the accessible route.

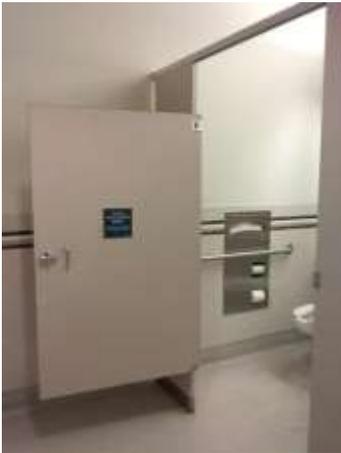
ID: 3443 **Facility:** City Hall West

2010 ADA Standards for Accessible Design Codes §604.8.1.2
The door to the accessible water closet is not self closing. Either self-closing hinges are not installed on the door or if installed, they are defective.

Install or reinstall self-closing hinges on the door to ensure that the door is self-closing per the ADA requirements.

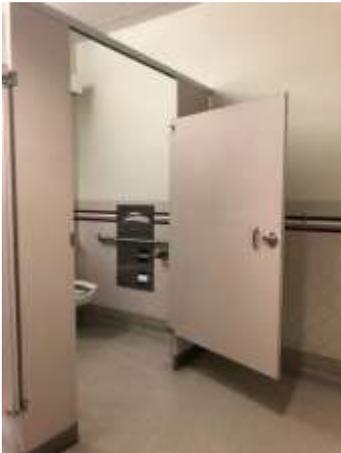
ID: 3618 **Facility:** City Hall West

2010 ADA Standards for Accessible Design Codes §604.8.1.2
 The door to the accessible water closet is not self closing. Either self-closing hinges are not installed on the door or if installed, they are defective.

Install or reinstall self-closing hinges on the door to ensure that the door is self-closing per the ADA requirements.

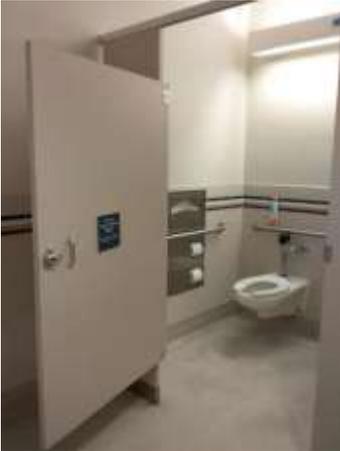
2010 ADA Standards for Accessible Design Codes §604.8.1.2
The door to the accessible water closet is not self closing. Either self-closing hinges are not installed on the door or if installed, they are defective.

Install or reinstall self-closing hinges on the door to ensure that the door is self-closing per the ADA requirements.

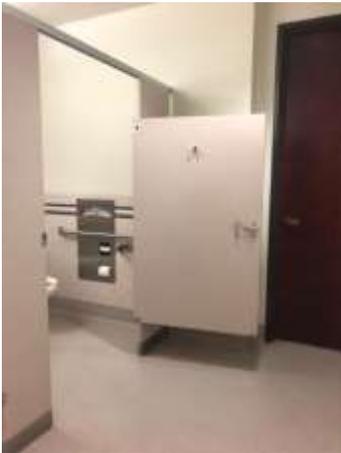
ID: 3681 **Facility:** City Hall West

2010 ADA Standards for Accessible Design Codes §604.8.1.2
 The door to the accessible water closet is not self closing. Either self-closing hinges are not installed on the door or if installed, they are defective.

Install or reinstall self-closing hinges on the door to ensure that the door is self-closing per the ADA requirements.

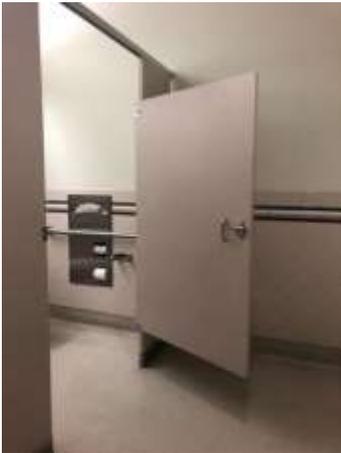
ID: 3356 **Facility:** City Hall West

2010 ADA Standards for Accessible Design Codes §604.8.1.2
The door to the accessible water closet is not self closing. Either self-closing hinges are not installed on the door or if installed, they are defective.

Install or reinstall self-closing hinges on the door to ensure that the door is self-closing per the ADA requirements.

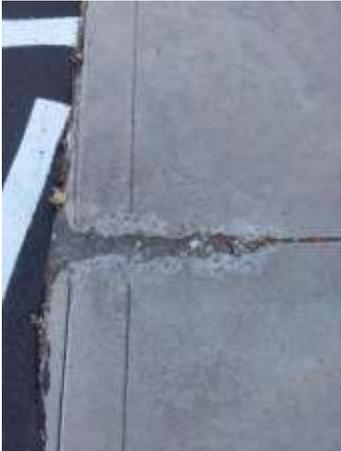
2010 ADA Standards for Accessible Design Codes §302.1
There are tripping hazards in the accessible route.

Repave the area of the sidewalk to remove the crack.

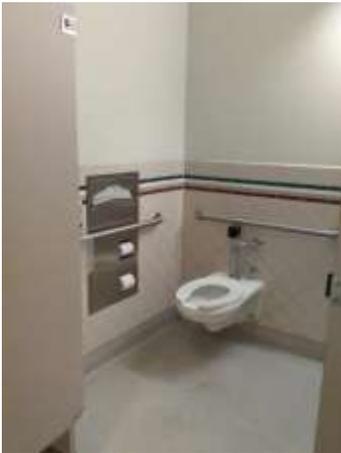
PHOTOGRAPH(S) OF THIS LOCATION

The door to the accessible water closet is not self closing. Either self-closing hinges are not installed on the door or if installed, they are defective.

Install or reinstall self-closing hinges on the door to ensure that the door is self-closing per the ADA requirements.

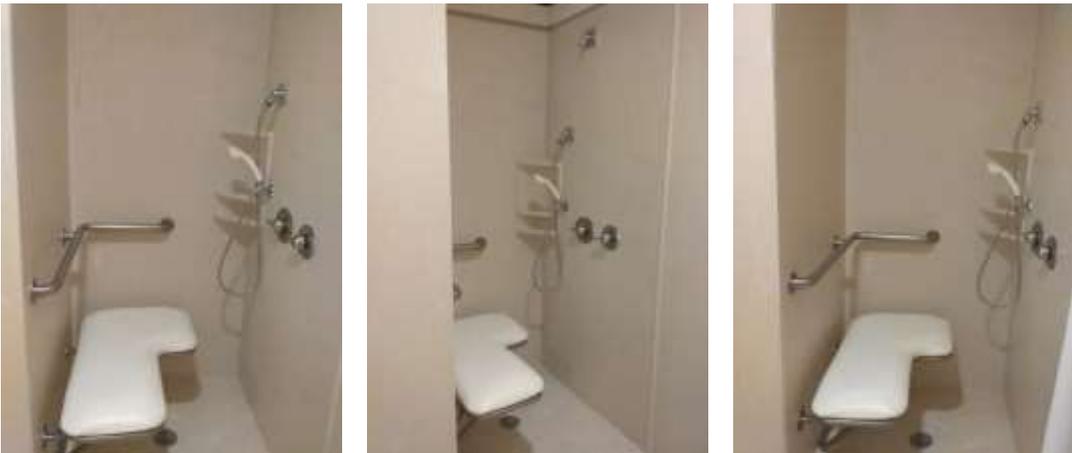
PHOTOGRAPH(S) OF THIS LOCATION

Note: inside finished dimensions measured at the center points of opposing sides
