City of Boise ADA  
Assessment

# Appendix A-Foothills Learning Center

12/30/2020

Report #TO20-B009

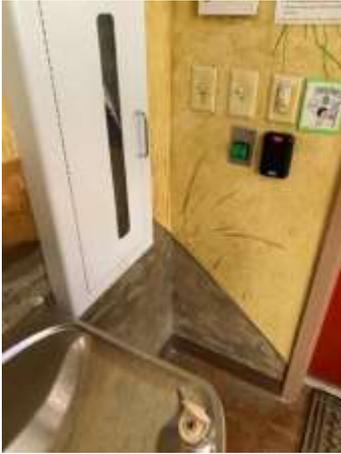
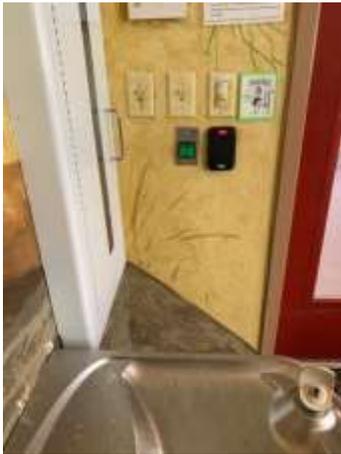
**ID:** 2      **Facility:** Foothills Learning Center

**2010 ADA Standards for Accessible Design Codes** §305.2  
The clear floor space in front of the exit button is 24" deep.

For the purposes of achieving greater accessibility and Human Centric Design, relocate the exit button closer to the door.

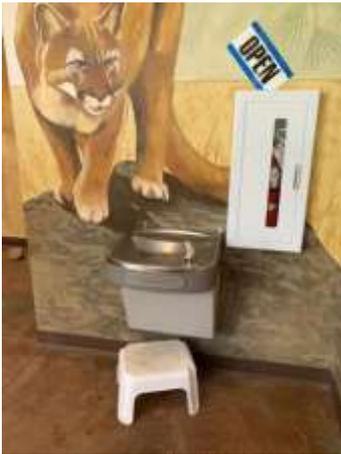
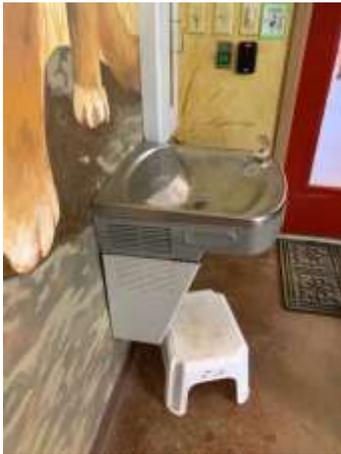
**ID:** 1700      **Facility:** Foothills Learning Center

**2010 ADA Standards for Accessible Design Codes** §211.2, §602.7  
There is only one drinking fountain provided at 32" above the floor.

Install an additional drinking fountain at a minimum spout height of 38" and maximum of 43" above the floor.

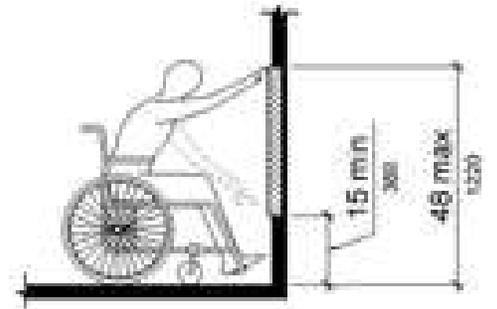
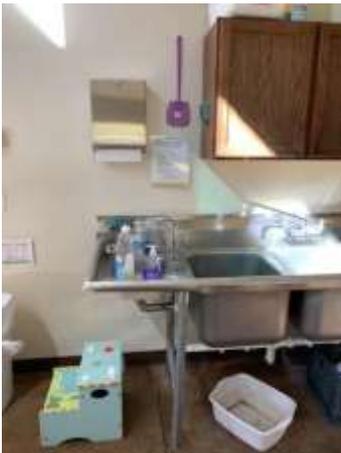
**ID:** 1685      **Facility:** Foothills Learning Center

**2010 ADA Standards for Accessible Design Codes §308.2.1**  
 The paper towel dispenser is outside of the unobstructed forward reach range at 52" above the floor.

Lower the paper towel dispenser by 4" to meet the accessible reach range of 15" minimum and 48" maximum above the floor.

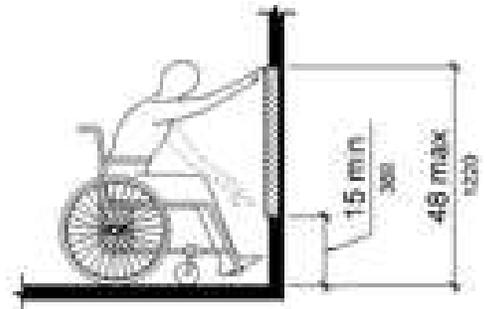
**ID:** 1691      **Facility:** Foothills Learning Center

**2010 ADA Standards for Accessible Design Codes §308.2.1**  
The hook is outside of the unobstructed forward reach range at 49" above the floor.

Lower the hook by 1" to meet the accessible reach range of 48" maximum above the floor.

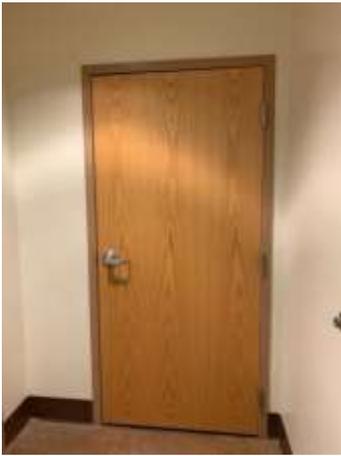
**ID:** 1692      **Facility:** Foothills Learning Center

**2010 ADA Standards for Accessible Design Codes** §216.2, §703  
There is no tactile sign identifying the permanent room.

Install tactile signage on the latch side of the doorway at a height of 48" minimum to 60" maximum above the floor, identifying room by name or room number.  
Signs shall be Braille with raised lettering and should be placed on the wall in the center of an 18"x18" clear floor space.

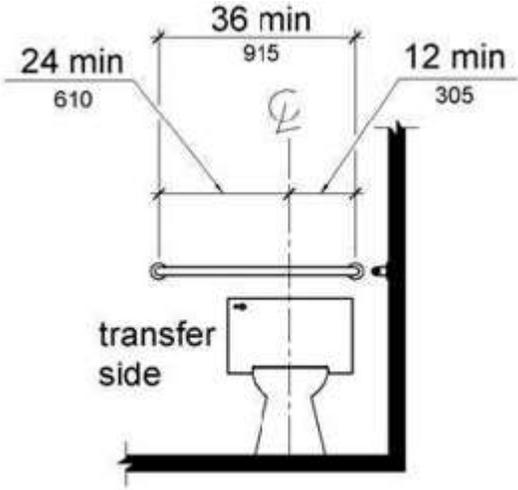
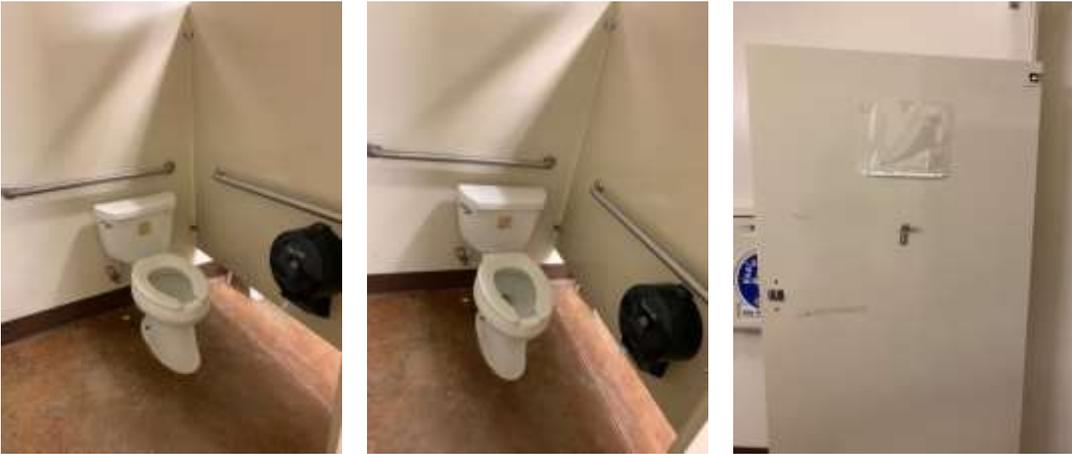
**ID:** 1688      **Facility:** Foothills Learning Center

**2010 ADA Standards for Accessible Design Codes §604.5.2**  
The rear grab bar is 37" long and located 11" to the center of the toilet.

Relocate the rear grab bar so it extends from the centerline of the water closet 12" minimum on one side and 24" minimum on the other.

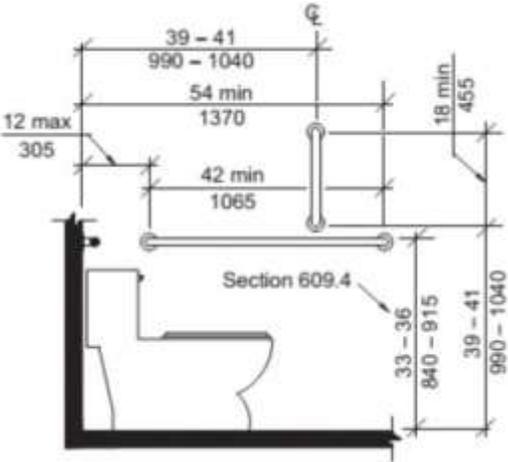
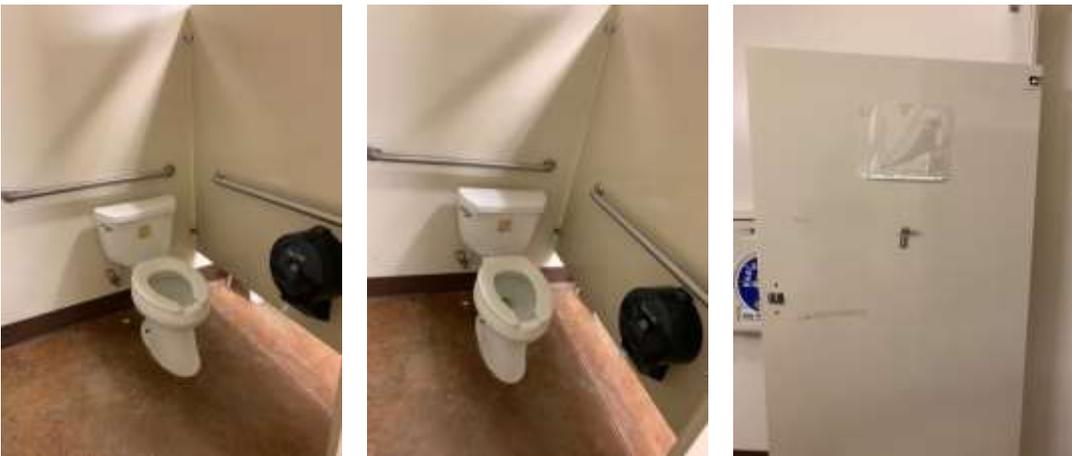
**ID:** 1689      **Facility:** Foothills Learning Center

**2010 ADA Standards for Accessible Design Codes** ICC A117.1 §604.5.1  
The accessible water closet does not have a vertical grab bar.

Install an 18" long (minimum) vertical grab bar on the side wall. The grab bar shall be mounted with the bottom located at 39" minimum and 41" maximum above the floor. The centerline of the vertical grab bar shall be located 39" minimum and 41" maximum from the real wall.

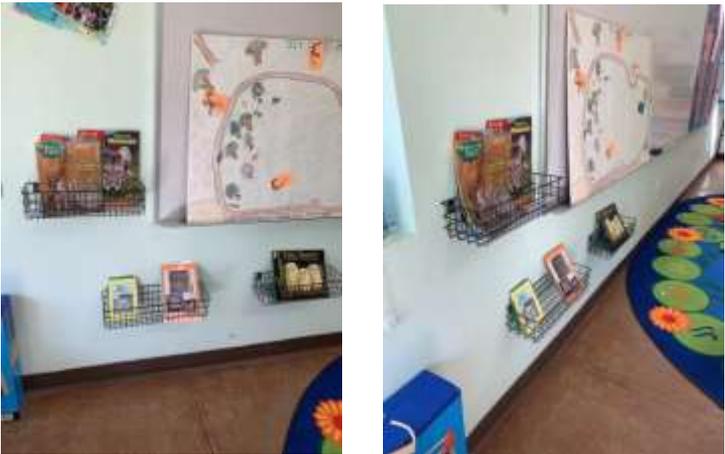
**ID:** 1683      **Facility:** Foothills Learning Center

**2010 ADA Standards for Accessible Design Codes §307.2**  
The higher basket protrudes 4.75" into the circulation space.

Remount the lower basket directly underneath the higher basket to provide cane detectability.

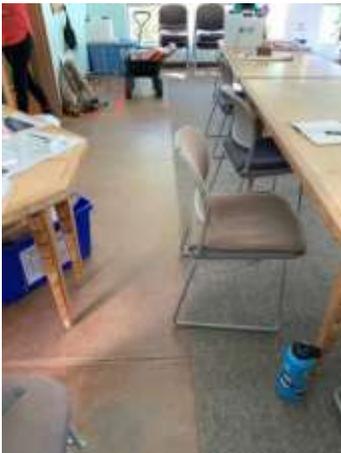
**ID:** 1682      **Facility:** Foothills Learning Center

**2010 ADA Standards for Accessible Design Codes §403.5.1**  
 The space between the two tables is 30" wide, making the route inaccessible.

Move the tables to widen the route to 36" wide minimum.

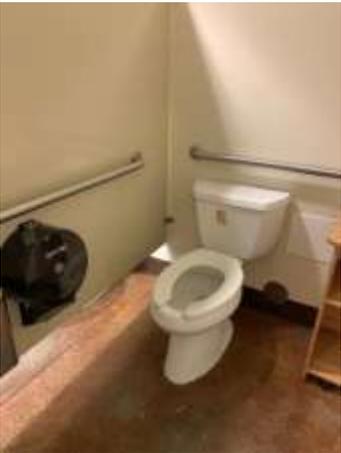
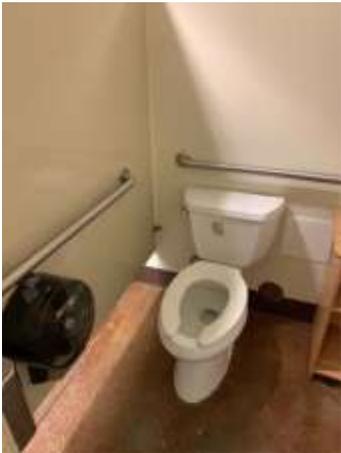
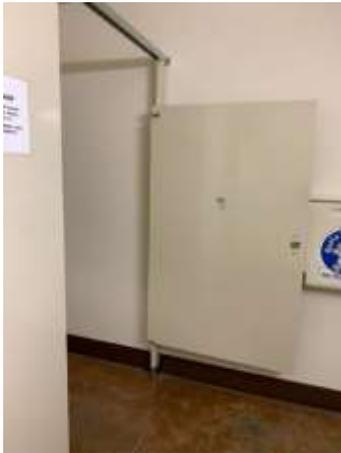
**ID:** 1693      **Facility:** Foothills Learning Center

**2010 ADA Standards for Accessible Design Codes** §604.8.1.2  
The door to the accessible water closet is not self closing. Either self-closing hinges are not installed on the door or if installed, they are defective.

Install or reinstall self-closing hinges on the door to ensure that the door is self-closing per the ADA requirements.

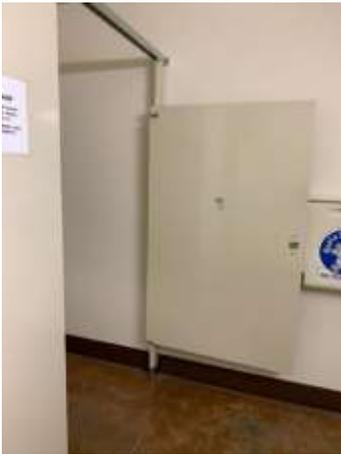
**ID:** 1697      **Facility:** Foothills Learning Center

**2010 ADA Standards for Accessible Design Codes §308.2.1**

The hook is outside of the unobstructed forward reach range at 49" above the floor.

Lower the hook by 1" to meet the accessible reach range of 48" maximum above the floor.

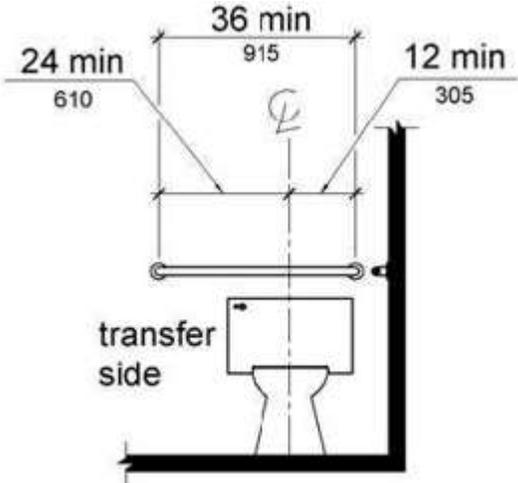
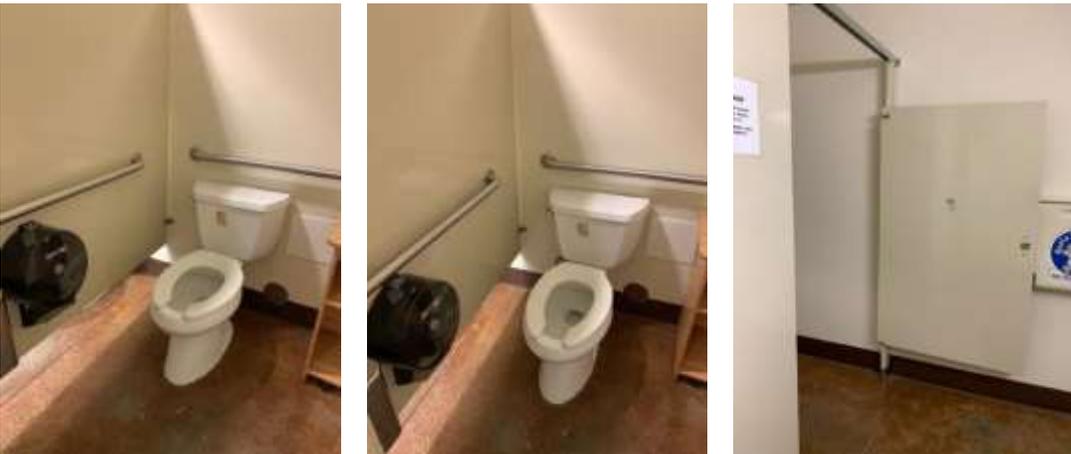
**2010 ADA Standards for Accessible Design Codes §604.5.2**  
The rear grab bar is 38" long and located 11" to the center of the toilet.

Relocate the rear grab bar so it extends from the centerline of the water closet 12" minimum on one side and 24" minimum on the other.

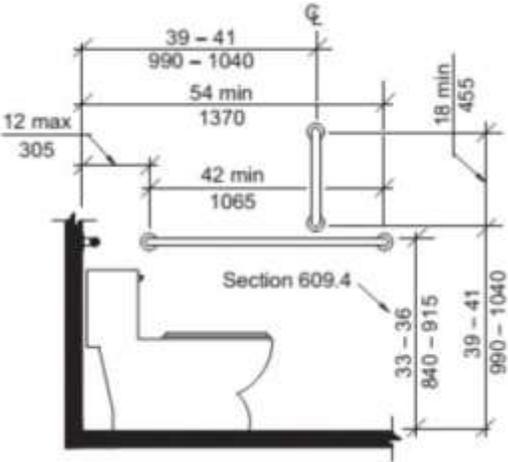
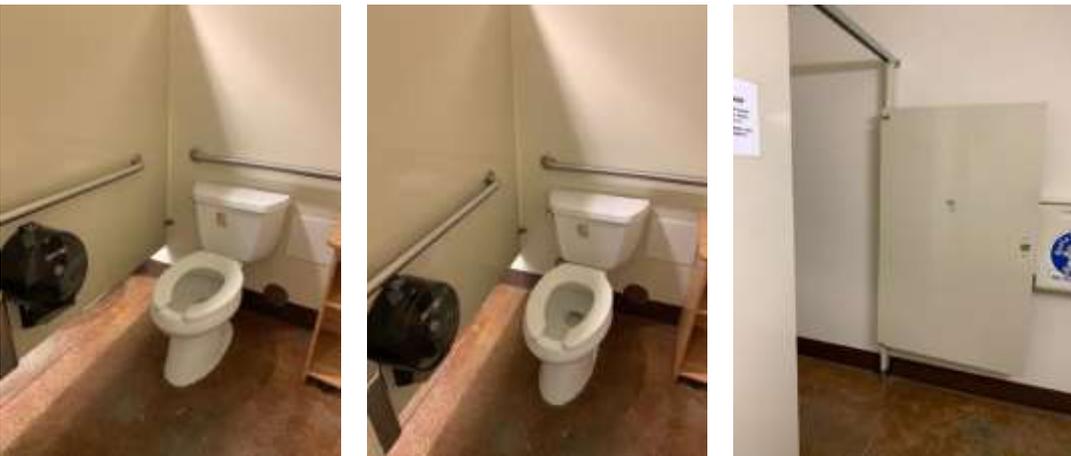
**ID:** 1695      **Facility:** Foothills Learning Center

**2010 ADA Standards for Accessible Design Codes** ICC A117.1 §604.5.1  
The accessible water closet does not have a vertical grab bar.

Install an 18" long (minimum) vertical grab bar on the side wall. The grab bar shall be mounted with the bottom located at 39" minimum and 41" maximum above the floor. The centerline of the vertical grab bar shall be located 39" minimum and 41" maximum from the rear wall.

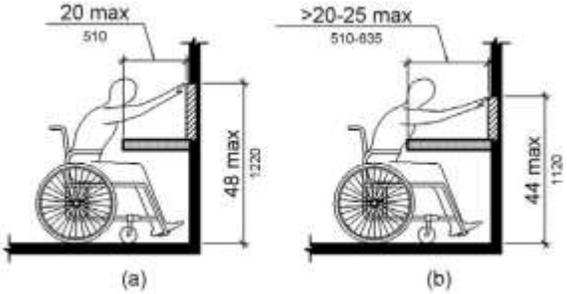
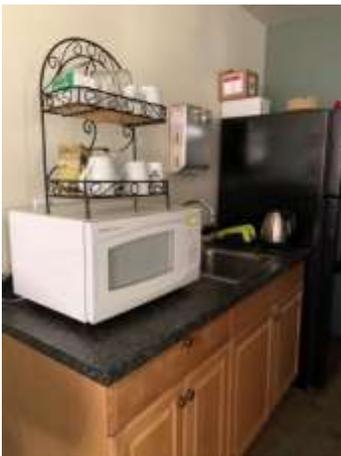
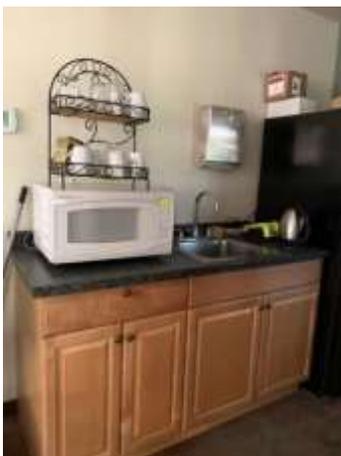
**2010 ADA Standards for Accessible Design Codes §308.2.2**  
The paper towel dispenser is outside of the obstructed forward reach range at 54.25" above the floor.

Lower the paper towel dispenser by 10.25" to meet the accessible reach range of 44" maximum above the floor.

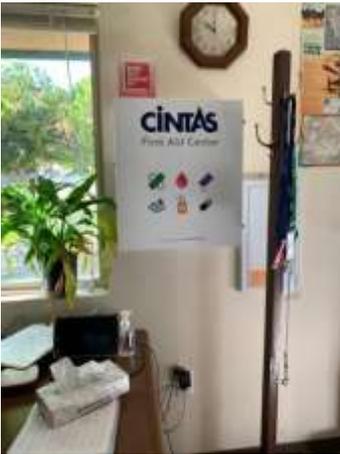
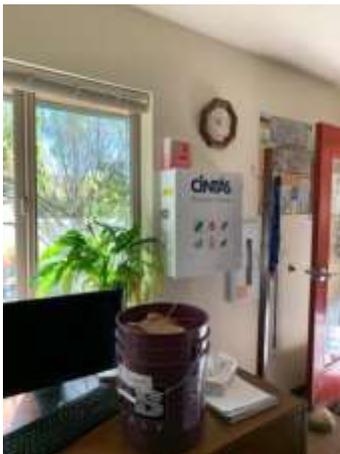
**ID:** 1701      **Facility:** Foothills Learning Center

**2010 ADA Standards for Accessible Design Codes §307.2**  
The first aid box protrudes 5.75" into the circulation space at 44" above the floor.

Recess the first aid box so it protrudes a maximum of 4", lower it so the bottom edge is 27" maximum above the floor, or place a cane detectable object beneath it.

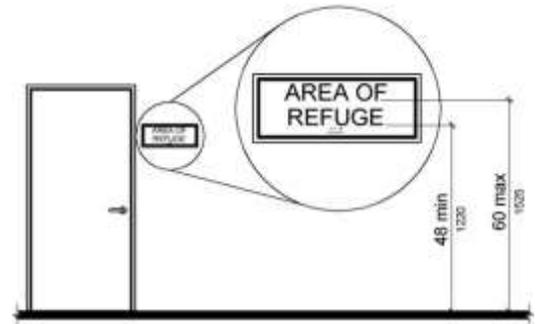
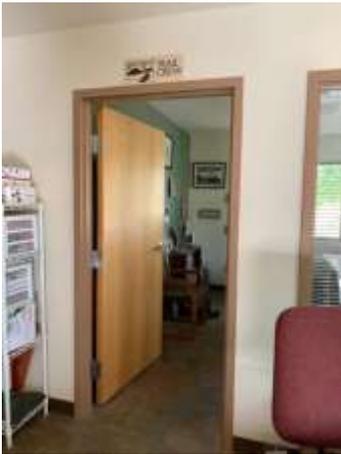
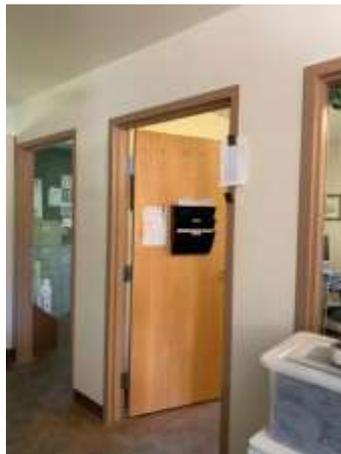
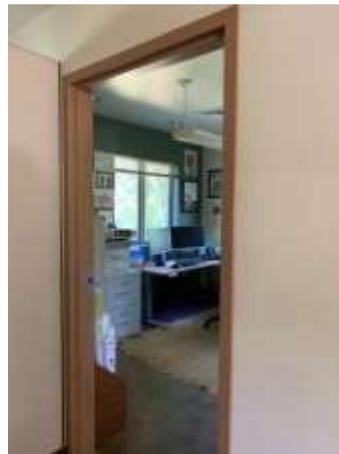
**ID:** 1702      **Facility:** Foothills Learning Center

**2010 ADA Standards for Accessible Design Codes** §216.2, §703

There are no tactile signs identifying the permanent rooms.

Install tactile signage on the latch side of the doorway at a height of 48" minimum to 60" maximum above the floor, identifying room by name or room number.

Signs shall be Braille with raised lettering and should be placed on the wall in the center of an 18"x18" clear floor space.

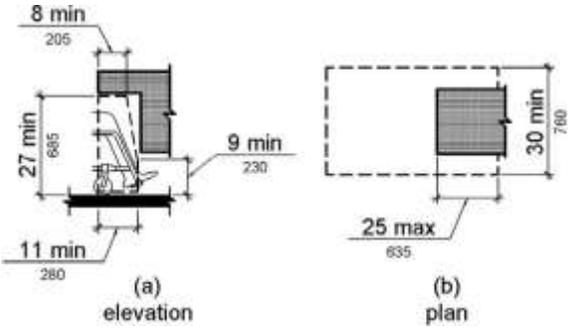
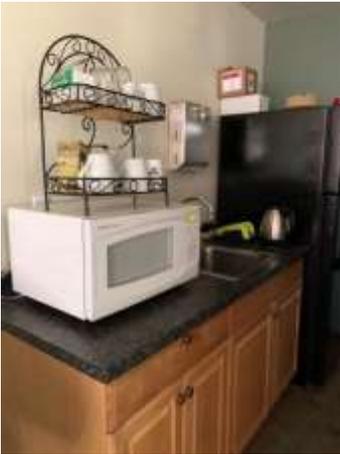
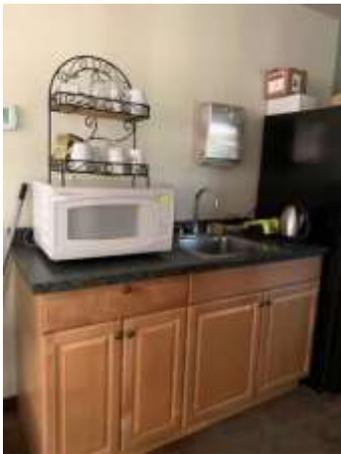
**ID:** 1686      **Facility:** Foothills Learning Center

**2010 ADA Standards for Accessible Design Codes** §306.3, §902.3  
The dining and work surface counter and sink are 36.25" above the floor.

A 30" long portion of the dining and work surface must be no higher than 34" above the floor.  
Provide knee clearance that is a minimum of 11" deep at 9" above the floor and 8" deep.

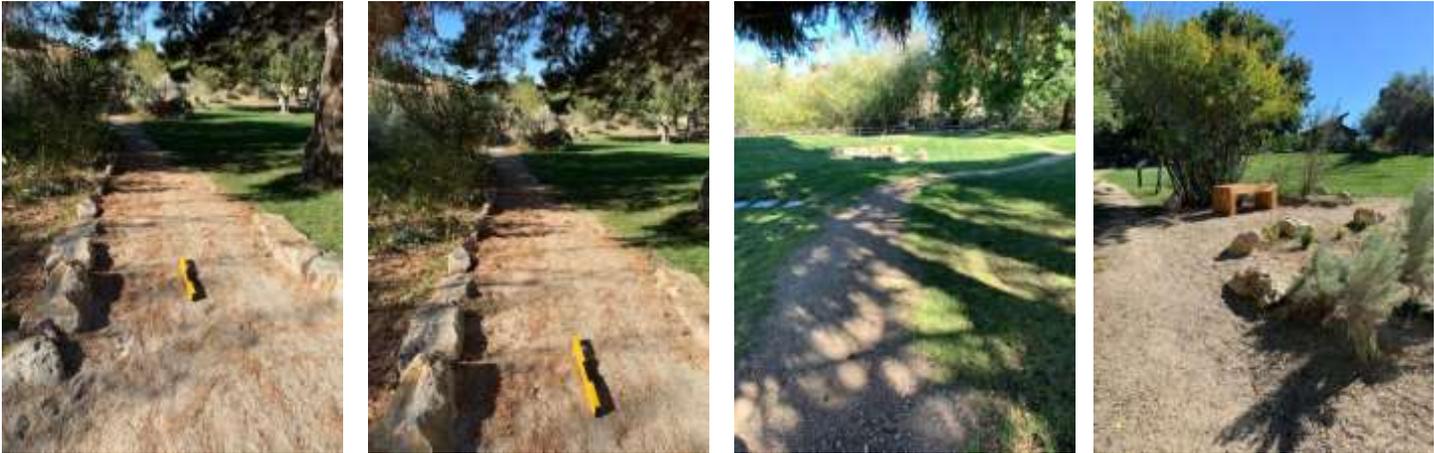
**ID:** 1681      **Facility:** Foothills Learning Center

**2010 ADA Standards for Accessible Design Codes** §403.3, §302.1, §305

There is not a firm, stable, and slip resistant route to three picnic tables, three benches, a garbage can, and the nature play area.

The outdoor program area path near the garden has a 12.6% running slope.

Construct a firm, stable, and slip resistant accessible route with a maximum cross slope of 2% and maximum running slope of 5%. At least one accessible route shall connect the learning center with all accessible spaces and elements.

Reconstruct the route to reduce the running slope to a maximum of 5%. Ensure that the cross slope is a maximum of 2%.

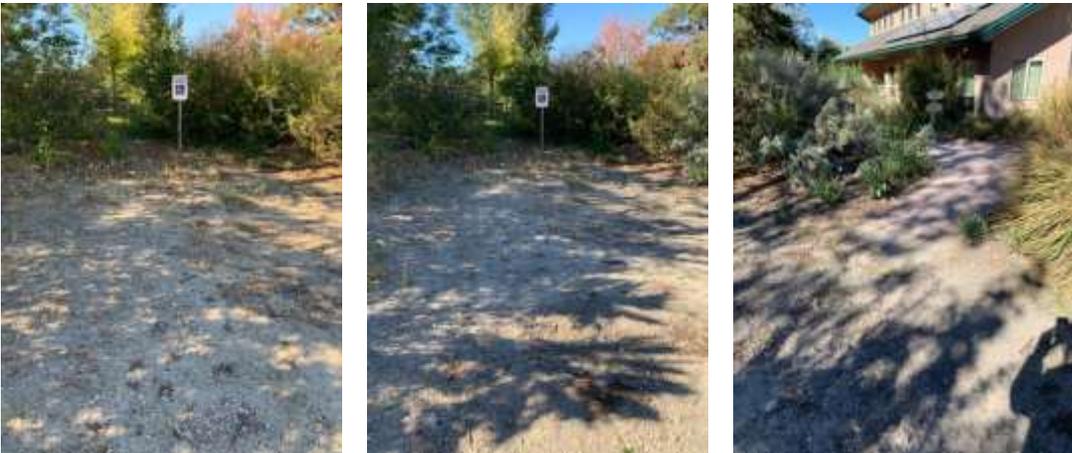
**ID:** 1673      **Facility:** Foothills Learning Center

**2010 ADA Standards for Accessible Design Codes §208.2**  
There are no accessible parking spaces as the current space is made of gravel.

Install an accessible parking space that is a minimum of 132" wide. Ensure the ground surface is stable, firm, and slip resistant.  
Install a 60" wide access aisle connecting to an accessible route.  
Install a sign 60" above the ground.

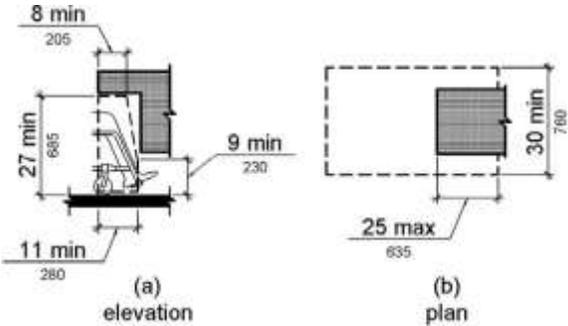
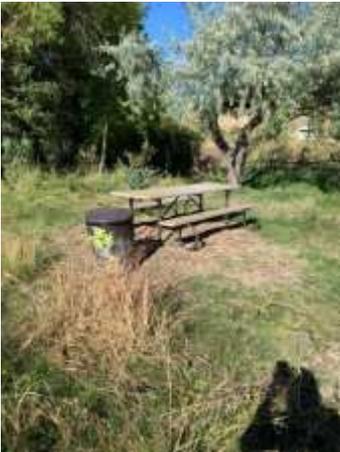
**ID:** 1676      **Facility:** Foothills Learning Center

**2010 ADA Standards for Accessible Design Codes** §302.1, §305  
There is not a firm, stable, and slip resistant route to the picnic tables and garbage can.

Construct a firm, stable, and slip resistant accessible route with maximum cross and running slopes of 2% and 5% respectively.  
Install an accessible picnic table at a minimum height of 28" and maximum of 34". Provide knee clearance that is a minimum of 11" deep at 9" above the floor and 8" deep.

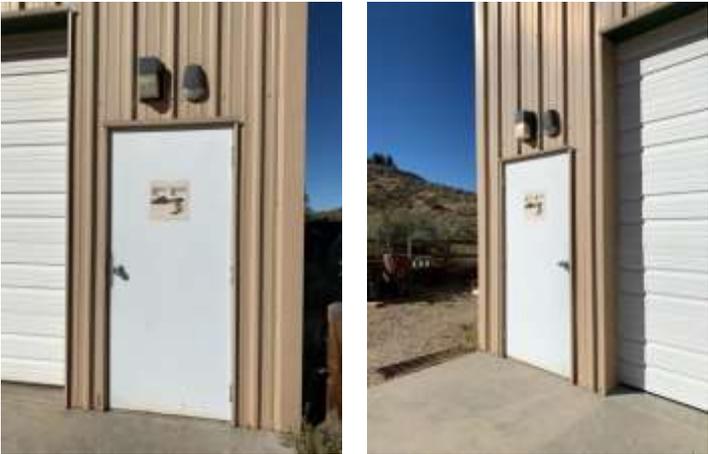
**ID:** 1713      **Facility:** Foothills Learning Center

**2010 ADA Standards for Accessible Design Codes** , §309.4, §216.2, §703  
The door knob requires twisting of the wrist. There is no tactile sign identifying the permanent room.

Replace the door knob with a lever handle that can be operated with a closed fist and without twisting the wrist.  
Install tactile signage on the latch side of the doorway at a height of 48" minimum to 60" maximum above the floor, identifying room by name or room number.

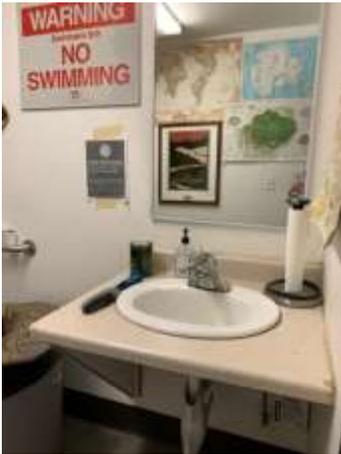
**ID:** 1712      **Facility:** Foothills Learning Center

**2010 ADA Standards for Accessible Design Codes §603.3**  
 The mirror is too high to be accessible at 42" above the floor.

Lower the mirror its bottom edge is a maximum height of 40" above the floor.

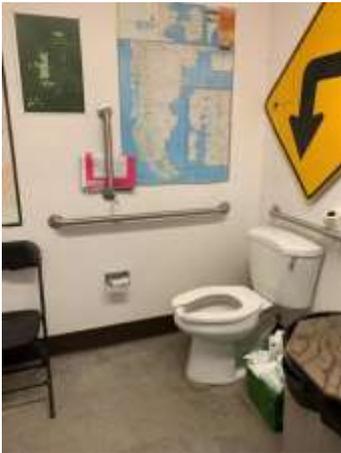
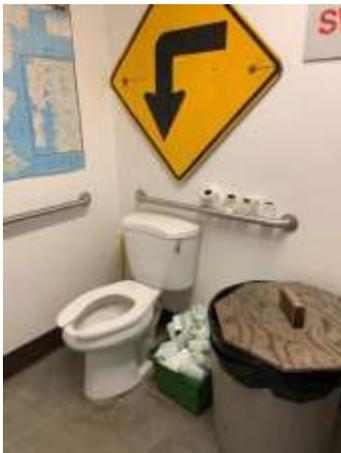
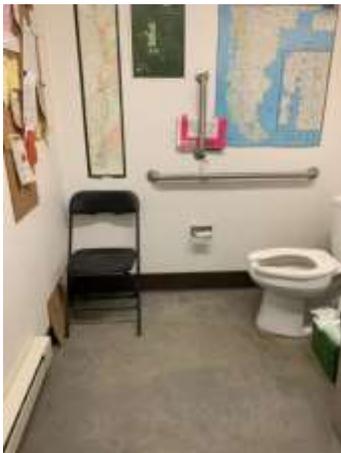
**ID:** 1709      **Facility:** Foothills Learning Center

**2010 ADA Standards for Accessible Design Codes §604.8.1.2**  
The door to the accessible water closet is not self closing. Either self-closing hinges are not installed on the door or if installed, they are defective.

Install or reinstall self-closing hinges on the door to ensure that the door is self-closing per the ADA requirements.

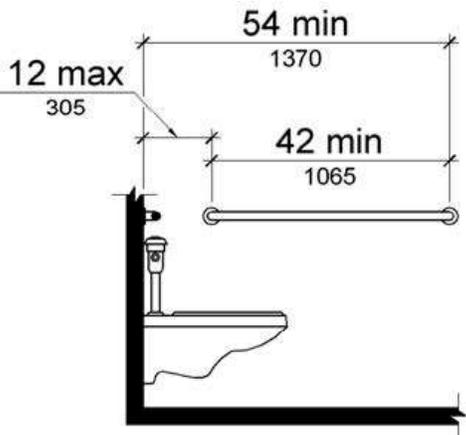
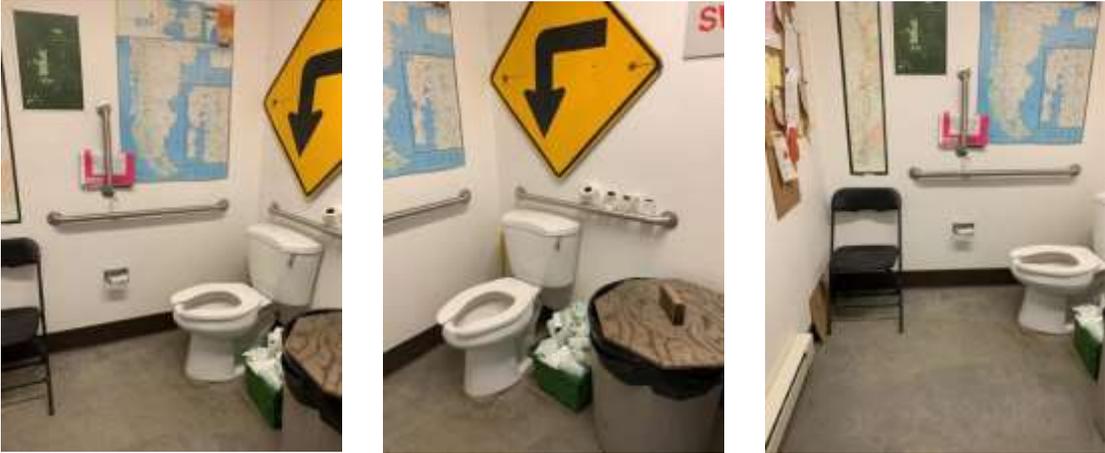
**ID:** 1707      **Facility:** Foothills Learning Center

**2010 ADA Standards for Accessible Design Codes §604.5.1**  
The side grab bar is located 10" from the rear wall.

Remount the side grab bar 12" maximum from the rear wall and extending 54" minimum from the rear wall.
