City of Boise
ADA Assessment

Appendix A - James Castle House

Report #TO20-B003

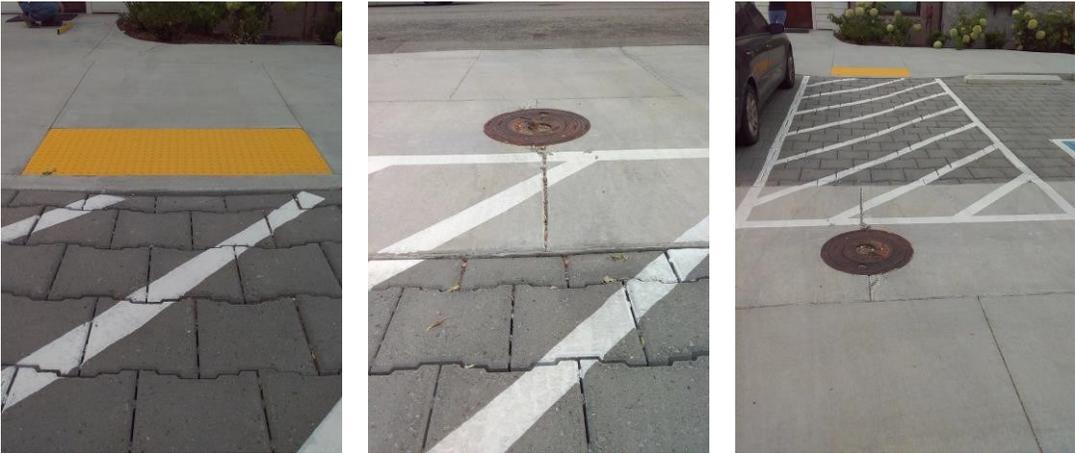
Location: Accessible Parking
Schedule: 2022
Estimated Cost: \$1,000.00

2010 ADA Standards for Accessible Design Codes: §303.2
There is a change in level of 1" from the access aisle to the accessible route.

Repave the pathway to reduce the change in level to less than 0.25".

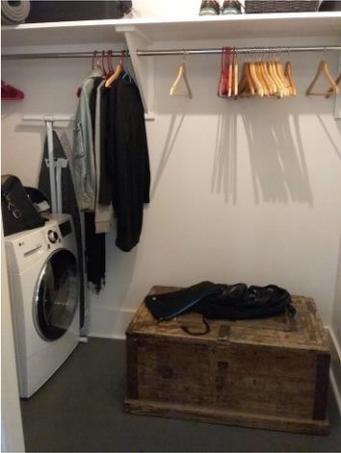
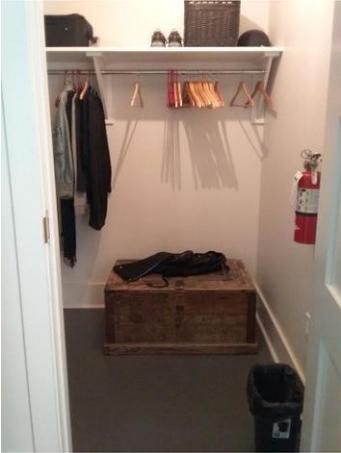
Location: Closet/Laundry Space
Schedule: 2022
Estimated Cost: \$100.00

2010 ADA Standards for Accessible Design Codes: §404.2.4.3
The closet/laundry space is 59" wide and 63" deep therefore, the turning space is not large enough.

Remove the trunk from the closet or push the washing machine and dryer back 1" to allow for a 60" wide turning space.

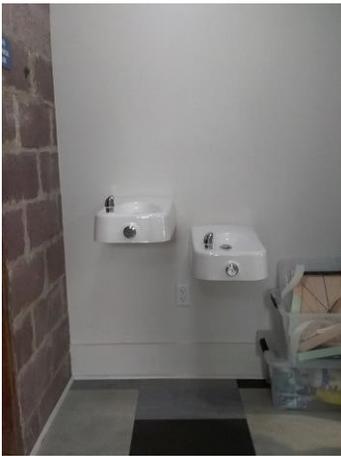
Location: Drinking Fountain
Schedule: 2023
Estimated Cost: \$500.00

2010 ADA Standards for Accessible Design Codes: §602, §307.2
The drinking fountains protrude into the circulation space and do not have cane detectability.

Place a drinking fountain skirt at this location to provide cane detectability or place an object under the fountains.

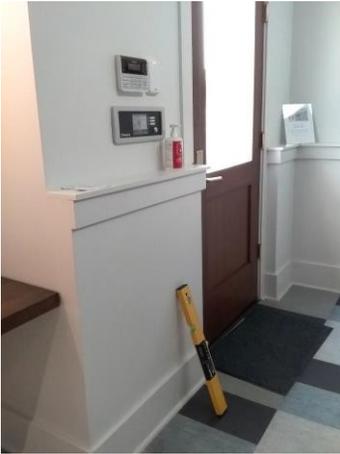
Location: Entrance
Schedule: 2023
Estimated Cost: \$1,000.00

2010 ADA Standards for Accessible Design Codes: §308.2.1
The building safety buttons are outside of the unobstructed forward reach range at 50" above the floor. The alarm controls are outside of the unobstructed forward reach range at 58" above the floor.

Lower the building safety buttons and alarm controls to meet the accessible reach range of 15" minimum and 48" maximum above the floor.

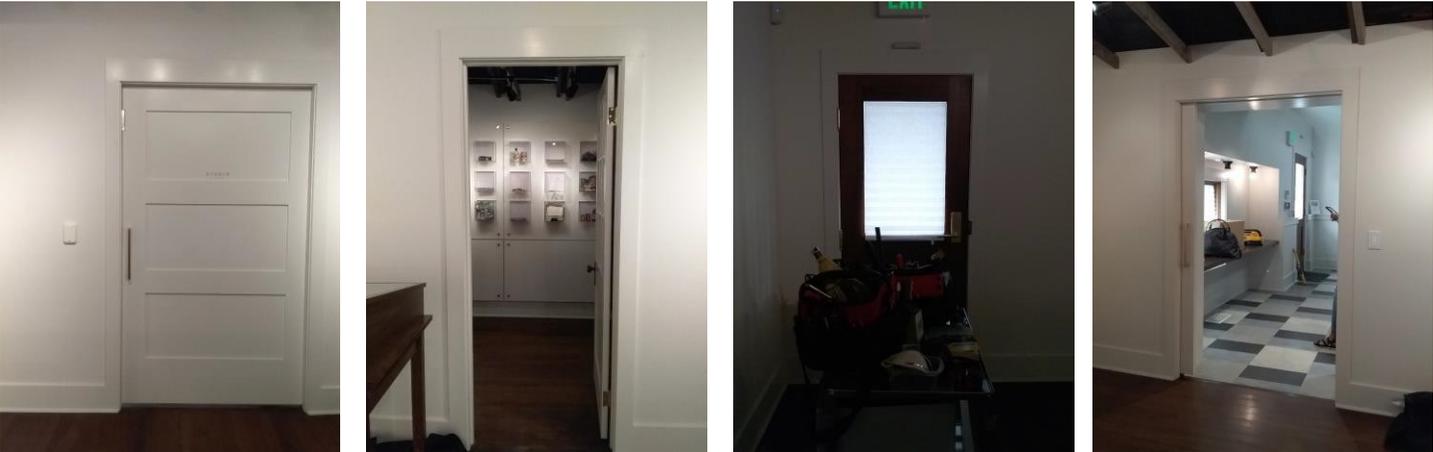
Location: Gallery
Schedule: 2021
Estimated Cost: \$500.00

2010 ADA Standards for Accessible Design Codes: §216.2, §703
There is no tactile sign identifying five permanent rooms in the gallery space.

Install tactile signage on the latch side of the doorway at a height of 48" minimum to 60" maximum above the floor, identifying room by name or room number.
Signs shall be Braille with raised lettering and should be placed on the wall in the center of an 18"x18" clear floor space.

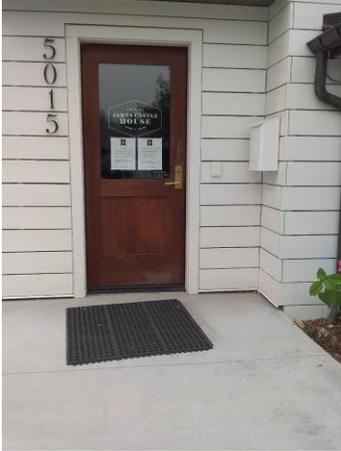
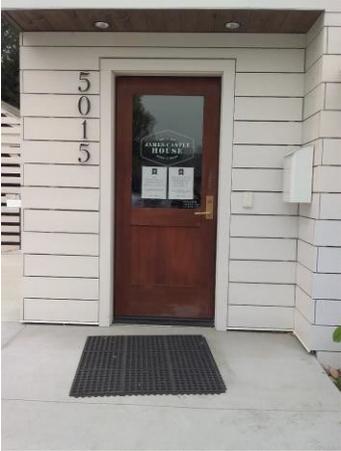
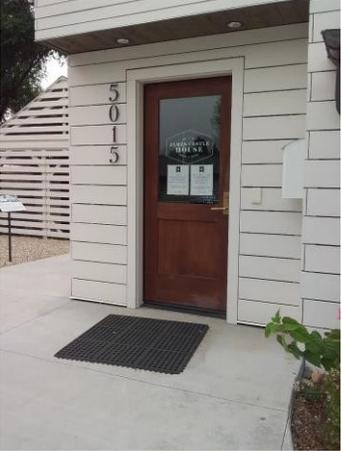
Location: Gift Shop Entrance
Schedule: 2021
Estimated Cost: \$1,000.00

2010 ADA Standards for Accessible Design Codes: §404.2.4.4
The entryway maneuvering clearance has a 7.2% slope.

Reconstruct the cement walkway so that the slope is a maximum of 2% in all directions for 60" perpendicular to the doorway.

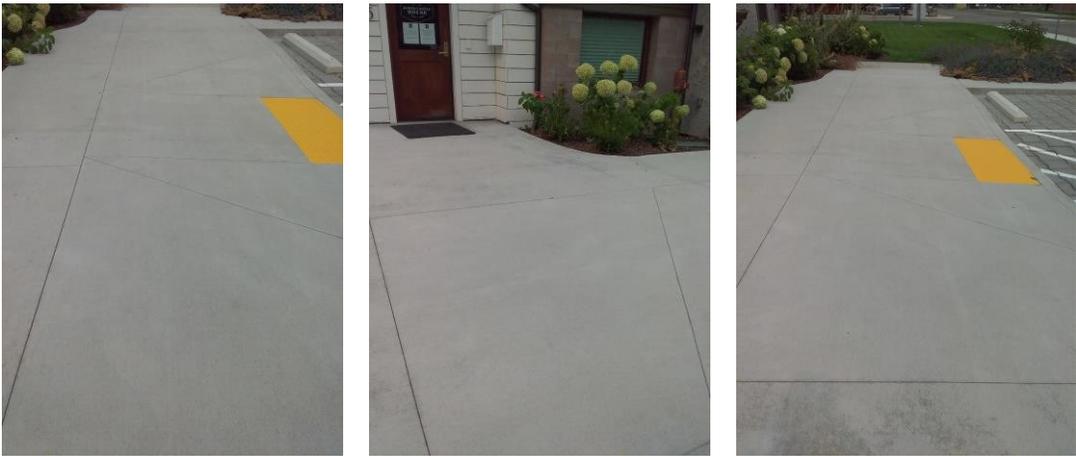
Location: Gift Shop Entrance
Schedule: 2021
Estimated Cost: \$1,000.00

2010 ADA Standards for Accessible Design Codes: §406.4
The ramp's landing area has a slope ranging from 2.5% to 3%.

Repave the landing area to make sure the turning space has a maximum slope of 2% in all directions.

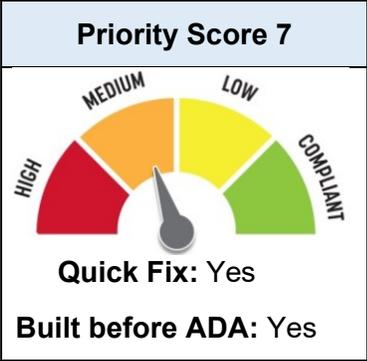
ID: 3576 **Facility:** James Castle House

Location: Historic Artifacts Area
Schedule: 2022
Estimated Cost: \$100.00

2010 ADA Standards for Accessible Design Codes: §309.4
 The door knob requires twisting of the wrist.

Replace the door knob with a lever handle that can be operated with a closed fist and without twisting the wrist.

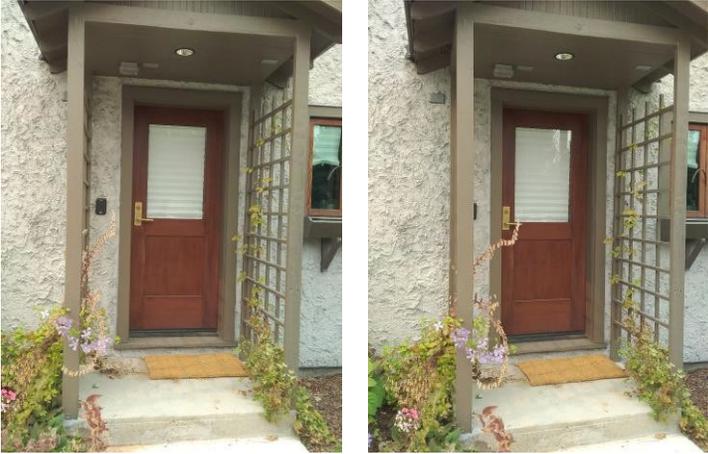
Location: Inaccessible Entrance
Schedule: 2022
Estimated Cost: \$100.00

2010 ADA Standards for Accessible Design Codes: §703.5.5, §703.5.6
There is no signage at the inaccessible entrance directing patrons to the nearby accessible entrance.

Install a visual sign at the front entrance directing patrons to the accessible entrance complying with §703.5.5 and §703.5.6 at a minimum height of 40" above the floor.

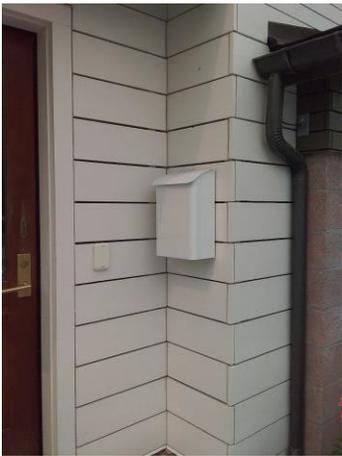
Location: Mailbox
Schedule: 2023
Estimated Cost: \$100.00

2010 ADA Standards for Accessible Design Codes: §308.2.1
The mailbox is outside of the unobstructed forward reach range at 59" above the floor.

Lower the mailbox by 11" to meet the accessible reach range of 15" minimum and 48" maximum above the floor.

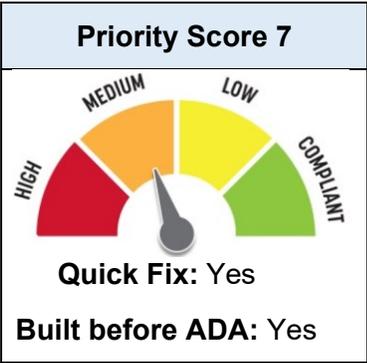
ID: 3046 **Facility:** James Castle House

Location: Office Door
Schedule: 2022
Estimated Cost: \$100.00

2010 ADA Standards for Accessible Design Codes: §309.4
 The door knob requires twisting of the wrist.

Replace the door knob with a lever handle that can be operated with a closed fist and without twisting the wrist.

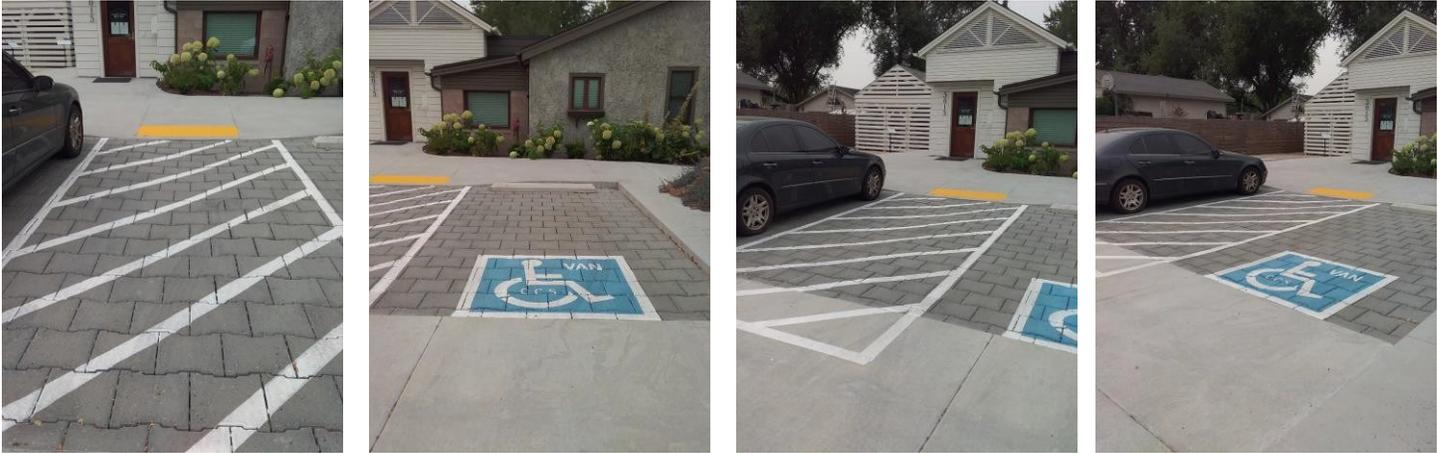
Location: Parking
Schedule: 2023
Estimated Cost: \$100.00

2010 ADA Standards for Accessible Design Codes: §502.6
There is no signage present identifying the accessible parking spaces.

Install an accessible parking sign at each accessible space at a minimum height of 60" above the ground.

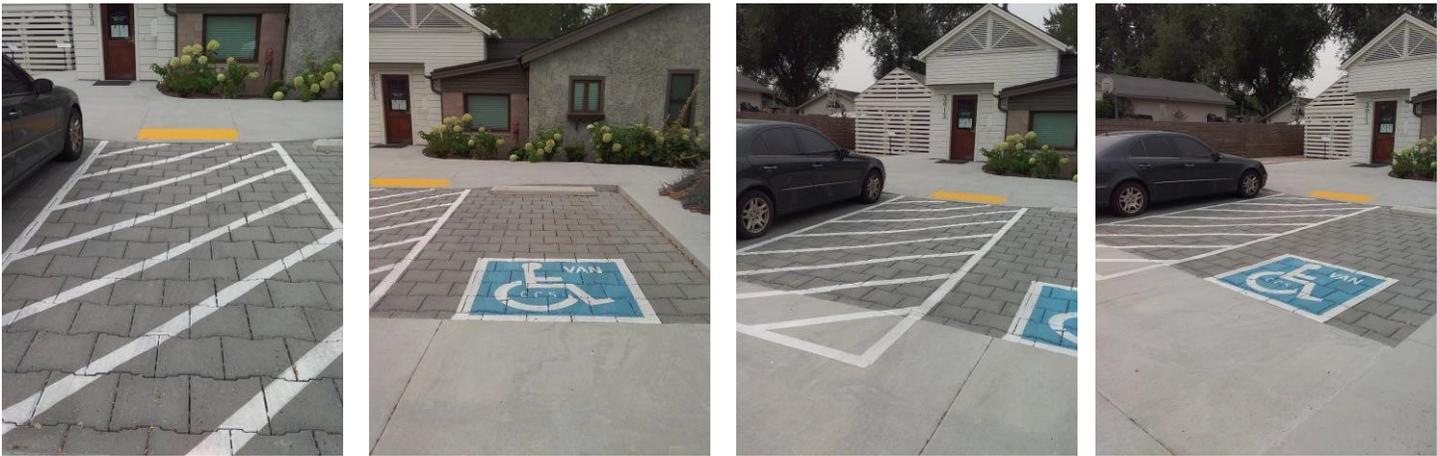
Location: Parking
Schedule: 2021
Estimated Cost: \$2,500.00

2010 ADA Standards for Accessible Design Codes: §502.4
The access aisle has a 5.5% slope.

Reconstruct the access aisle to reduce the slope to a maximum of 2% in all directions.

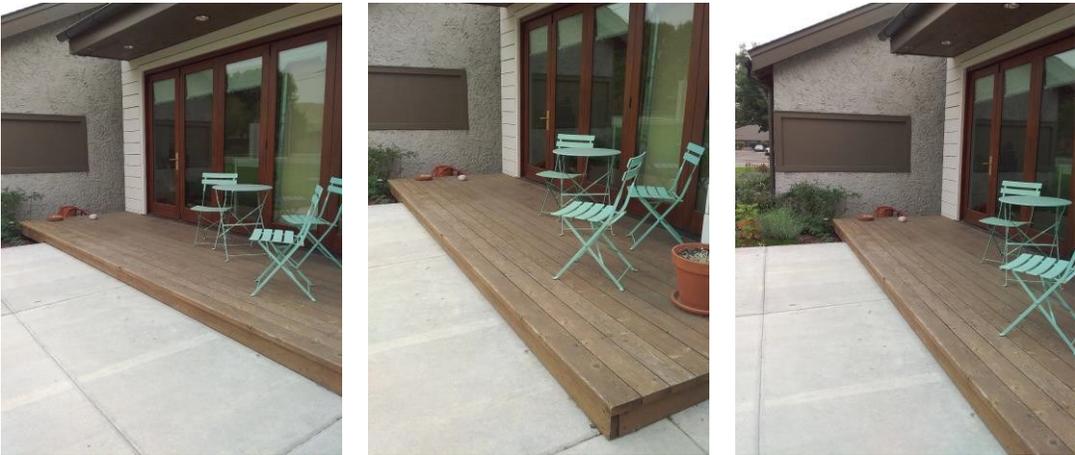
Location: Resident Deck
Schedule: 2023
Estimated Cost: \$1,000.00

2010 ADA Standards for Accessible Design Codes: §405
The deck facing Castle Drive is only accessible via a step from the exterior.

Consider adding a vertical access to this amenity by constructing a ramp.
If a ramp is added, ensure that the slope does not exceed 8.3%, handrails are provided, and there is sufficient room for a level landing at the top and bottom of the ramp.

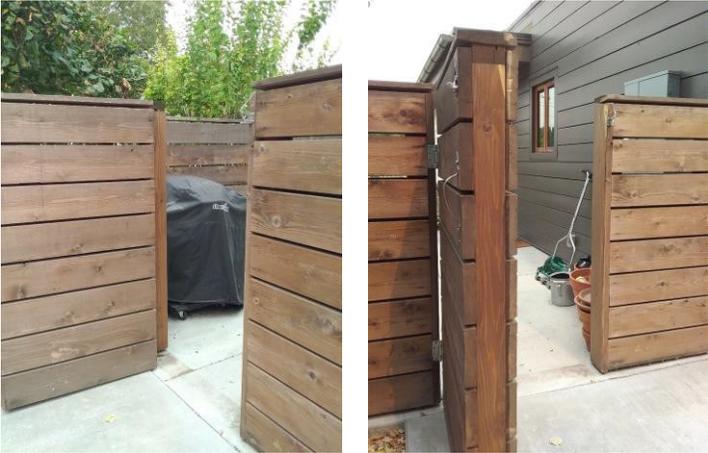
Location: Resident Entrance
Schedule: 2023
Estimated Cost: \$100.00

2010 ADA Standards for Accessible Design Codes: §308.2.1
The gate latch is outside of the unobstructed forward reach range at 58" above the floor.

Lower the gate latch by 10" to meet the accessible reach range of 15" minimum and 48" maximum above the floor. Ensure the gate latch can be opened from both ends.

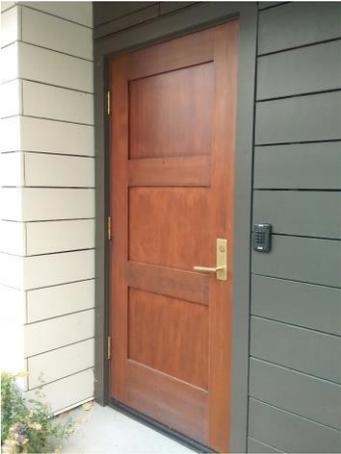
Location: Resident Entrance
Schedule: 2021
Estimated Cost: \$100.00

2010 ADA Standards for Accessible Design Codes: §216.2, §703
There is no tactile sign identifying the permanent room.

Install tactile signage on the latch side of the doorway at a height of 48" minimum to 60" maximum above the floor, identifying room by name or room number.
Signs shall be Braille with raised lettering and should be placed on the wall in the center of an 18"x18" clear floor space.

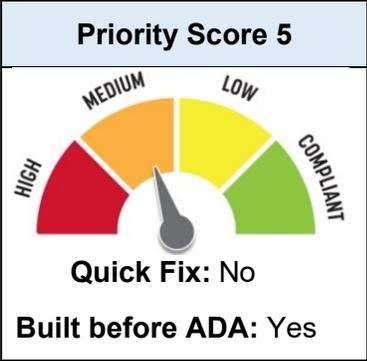
ID: 3263 **Facility:** James Castle House

Location: Resident Entrance
Schedule: 2022
Estimated Cost: \$1,000.00

2010 ADA Standards for Accessible Design Codes: §404.2.3
 The gate is not wide enough to allow wheelchair accessibility at only 29" wide.

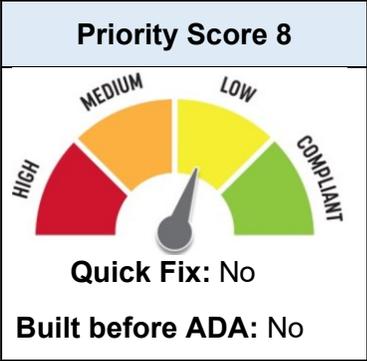
ID: 3779 **Facility:** James Castle House

Location: Resident Kitchen
Schedule: 2023
Estimated Cost: \$1,000.00

2010 ADA Standards for Accessible Design Codes: §804.3.2
 The height of the kitchen work surface is 35.5" above the floor

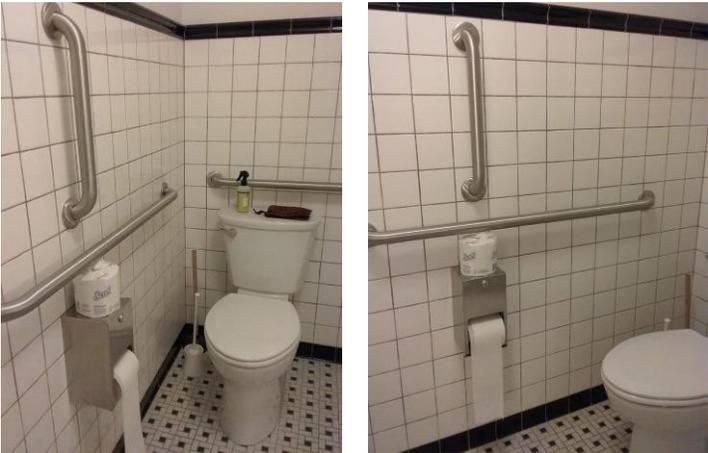
Location: Resident Restroom
Schedule: 2022
Estimated Cost: \$100.00

2010 ADA Standards for Accessible Design Codes: §604.7

The toilet paper dispenser is not located in an accessible position at 12" in front of the

Remount the toilet paper dispenser so that the centerline is located 7" minimum to 9" maximum in front of the toilet.

Ensure that the height is within the accessible reach range of 15" minimum to 48" maximum above the floor.

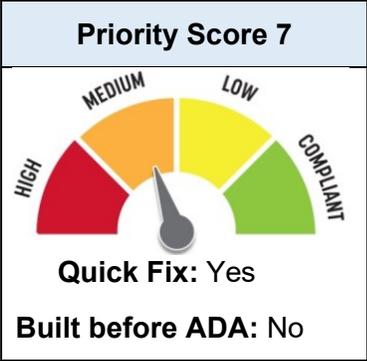
ID: 3054 **Facility:** James Castle House

Location: Resident Restroom
Schedule: 2022
Estimated Cost: \$100.00

2010 ADA Standards for Accessible Design Codes: §606.5
 The pipes under the sink are not covered.

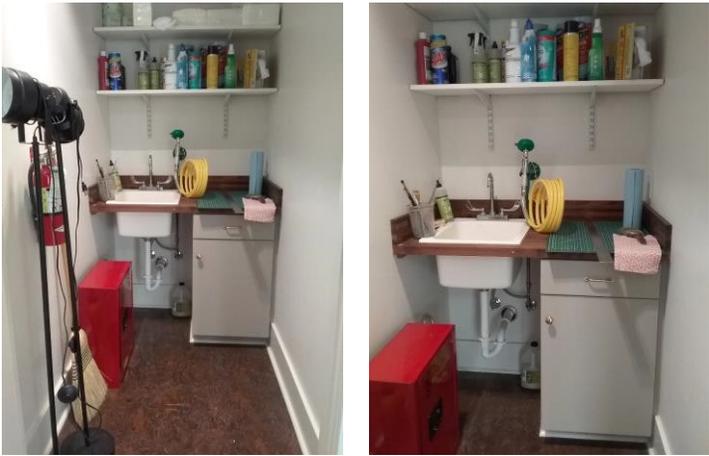
Location: Resident Studio
Schedule: 2022
Estimated Cost: \$100.00

2010 ADA Standards for Accessible Design Codes: §606.5
The sink located in the resident studio has no pipes covers underneath.

Wrap the pipes beneath the sink with soft protective wrap or plastic.

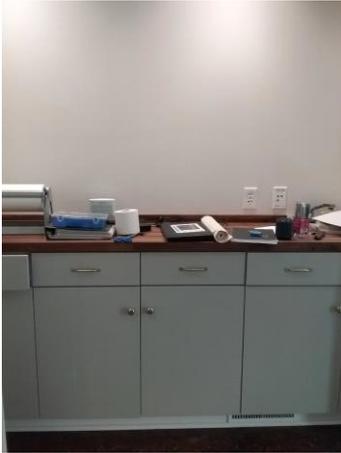
Location: Resident Studio
Schedule: 2023
Estimated Cost: \$1,000.00

2010 ADA Standards for Accessible Design Codes: §902.3
 The work surface counter is 36" above the floor.

Ensure a 36" wide portion of the work surface is no higher than 34" above the floor.

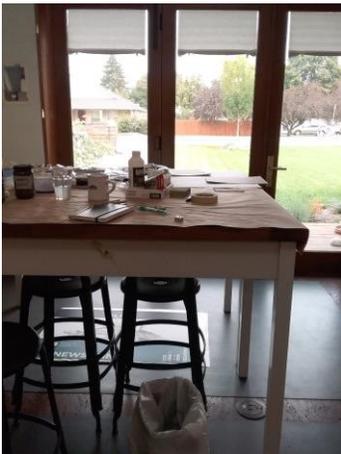
Location: Resident Studio

2010 ADA Standards for Accessible Design Codes: §902.3

The work table is 38" above the floor.

Lower the table to ensure a 36" wide portion of the work surface is no higher than 34" above the floor.

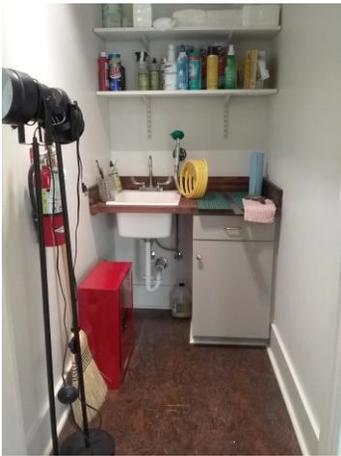
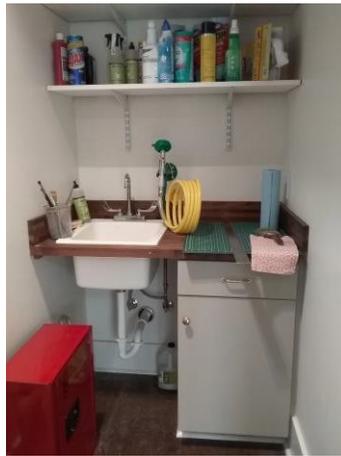
Location: Resident Studio

2010 ADA Standards for Accessible Design Codes: §902.3

The sink and work surface counter is 35.5" above the floor.

Lower the counter to ensure a 36" wide portion of the work surface is no higher than 34" above the floor.

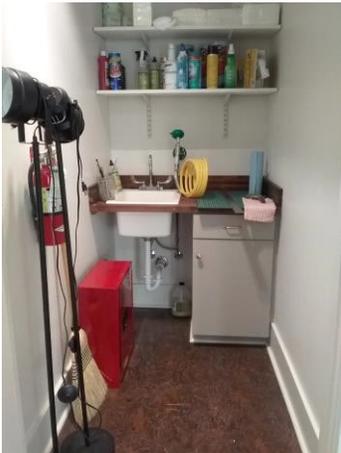
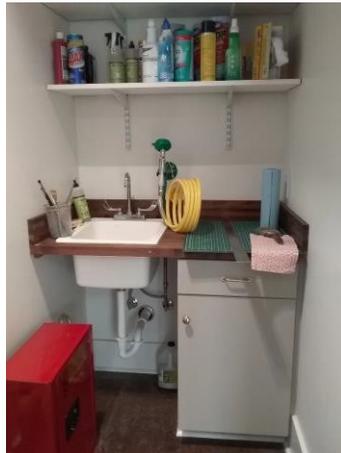
Location: Resident Studio

2010 ADA Standards for Accessible Design Codes: §404.2.4.3

The studio cleaning space is 44.5" wide, leaving no turning space.

Reconstruct the resident studio to provide a Circular or T-Shaped turning space. The circular turning space shall have a minimum diameter of 60".

The T-Shaped space shall be 60" square minimum with arms and base 36" wide minimum. Each arm shall be clear of obstructions 12" minimum in each direction. The base shall be clear of obstruction 24" minimum.

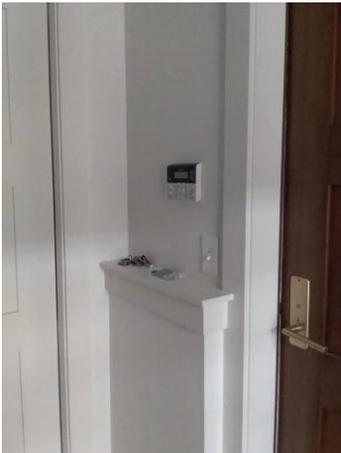
Location: Residential Space Alarm
Schedule: 2023
Estimated Cost: \$100.00

2010 ADA Standards for Accessible Design Codes: §308.2.1
The alarm is outside of the unobstructed forward reach range at 55" above the floor.

Lower the alarm by 7" to meet the accessible reach range of 15" minimum and 48" maximum above the floor.

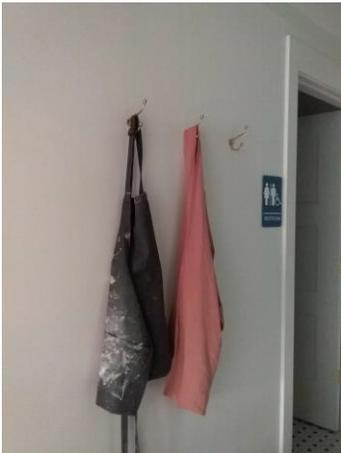
Location: Residential Space Hooks

2010 ADA Standards for Accessible Design Codes: §308.2.1

The coat hooks are outside of the unobstructed forward reach range at 68" above the floor.

Lower at least one coat hooks by 20" to meet the accessible reach range of 15" minimum and 48" maximum above the floor.

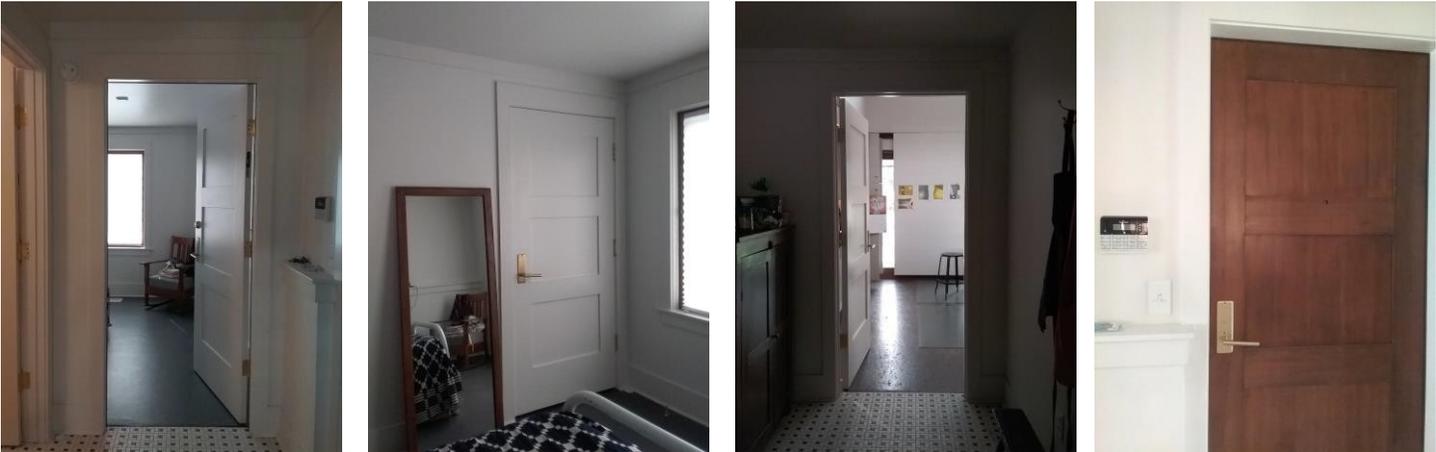
Location: Residential Studio Space
Schedule: 2021
Estimated Cost: \$600.00

2010 ADA Standards for Accessible Design Codes: §216.2, §703
There is no tactile sign identifying six permanent rooms in the residential studio space.

Install tactile signage on the latch side of the doorway at a height of 48" minimum to 60" maximum above the floor, identifying room by name or room number. Signs shall be Braille with raised lettering and should be placed on the wall in the center of an 18"x18" clear floor space.

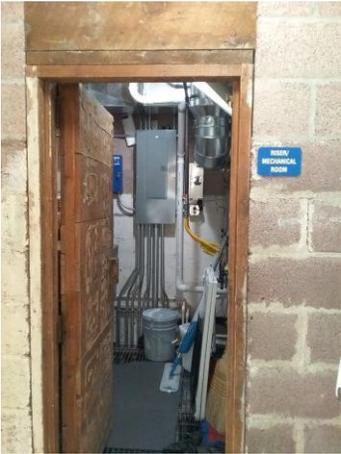
Location: Riser Room
Schedule: 2021
Estimated Cost: \$100.00

2010 ADA Standards for Accessible Design Codes: §216.2, §703
There is no braille sign identifying the permanent room.

Install braille signage on the latch side of the doorway at a height of 48" minimum to 60" maximum above the floor, identifying room by name or room number.
The sign shall have raised lettering and should be placed on the wall in the center of an 18"x18" clear floor space.

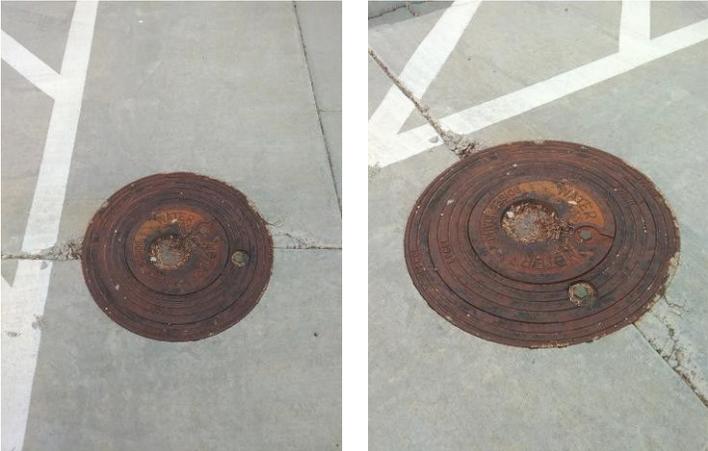
Location: Water Meter
Schedule: 2021
Estimated Cost: \$1,000.00

2010 ADA Standards for Accessible Design Codes: §302.3
There is a 1" open grate in the pathway posing a tripping hazard.

Replace the hole cover with one that has a gap less than 0.5".
