City of Boise
ADA Assessment

Appendix A – Library! At Collister

01/27/2021

Report # TO21-B015

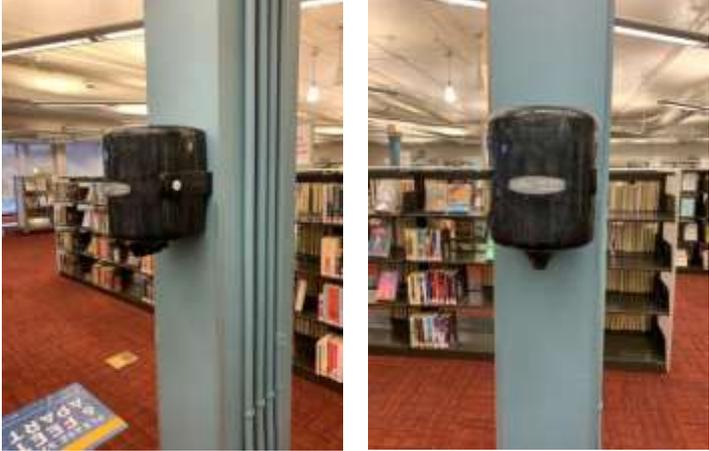
Location: Adult Mystery and Romance
Schedule: 2021
Estimated Cost: \$100.00

2010 ADA Standards for Accessible Design Codes §307.2, §308.2.1
The paper towel dispenser protrudes 9" into the circulation space at 49" above the floor.
The paper towel dispenser is outside of the unobstructed forward reach range at 49" above the floor.

Recess the paper towel dispenser so it protrudes a maximum of 4" or place a cane detectable object beneath it.
Lower the paper towel dispenser by 1" to meet the accessible reach range of 48" maximum above the floor.

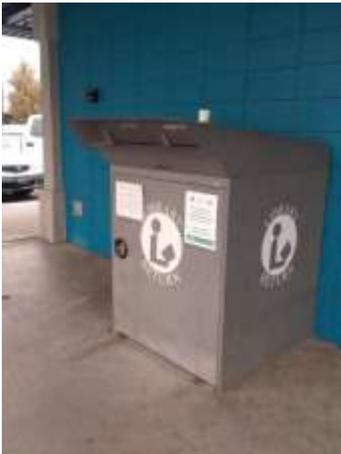
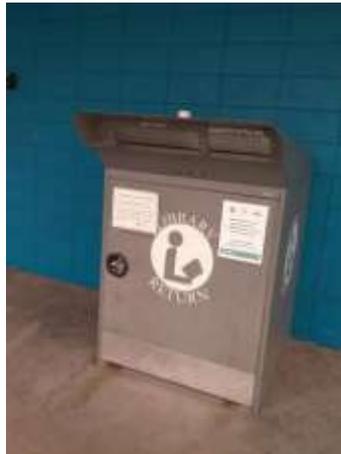
Location: Book Drop

The book drop is outside of the unobstructed forward reach range at 51" above the floor.

Lower the book drop by 3" to meet the accessible reach range of 48" maximum above the floor or install a secondary book drop within the accessible reach range.

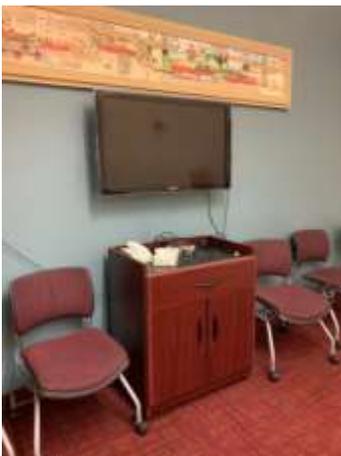
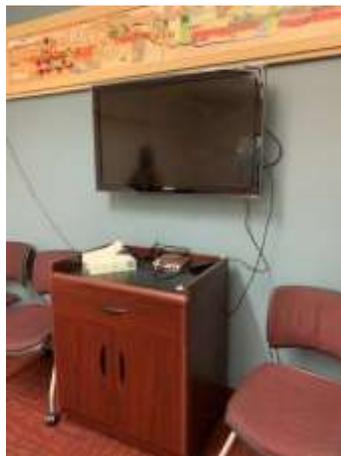
Location: Catalpa Conference Room

The TVs protrude 11" into the circulation space at 53" above the floor.

Ensure that the tables remain underneath the TVs to provide cane detectability.

Recess the TVs so they protrude a maximum of 4" or raise them so their bottom edges are 80" maximum above the floor.

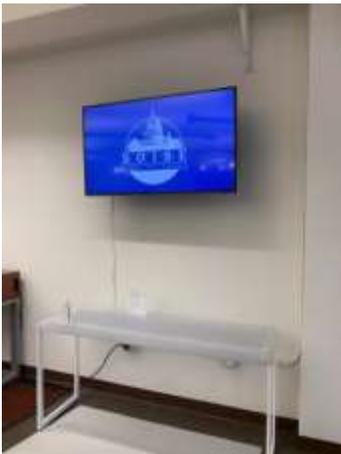
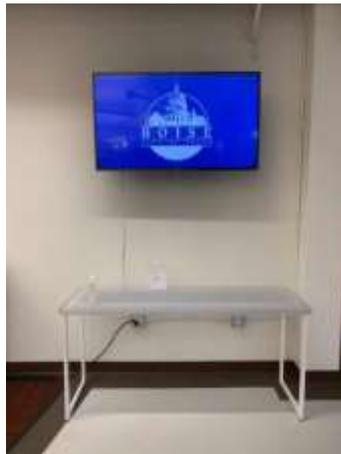
Location: Computer Lab

The TVs protrude 6" into the circulation space at 48.5" above the floor.

Ensure that the tables remain underneath the TVs to provide cane detectability.

Recess the TVs so they protrude a maximum of 4" or raise them so their bottom edges are 80" maximum above the floor.

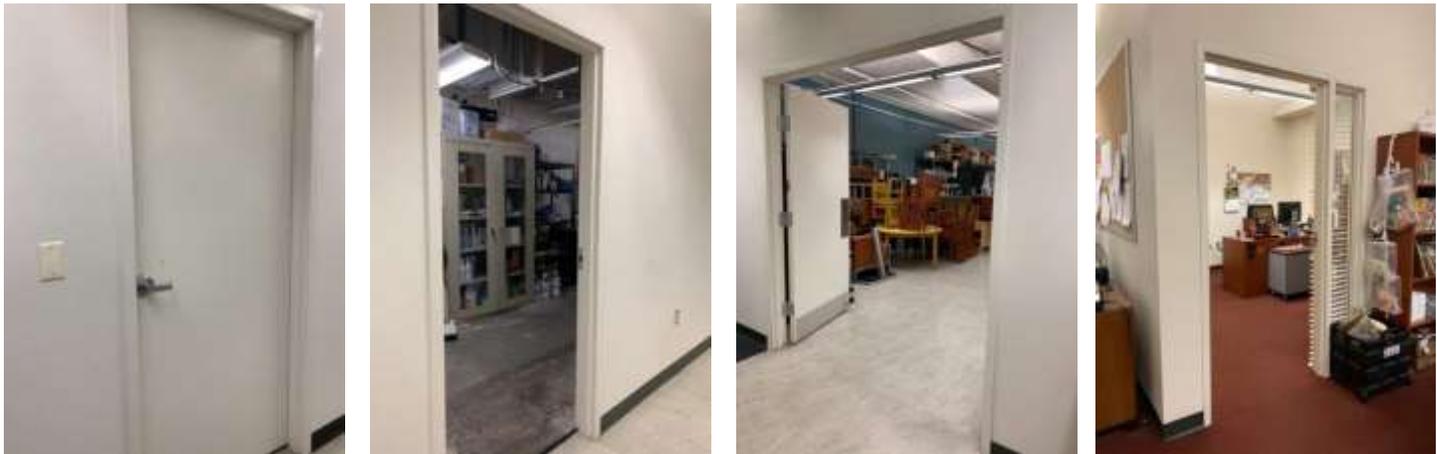
Location: Entire Facility

There are no tactile signs identifying seven permanent rooms.

Install tactile signage on the latch side of the doorway at a height of 48" minimum to 60" maximum above the floor, identifying room by name or room number.

Signs shall be Braille with raised lettering and should be placed on the wall in the center of an 18"x18" clear floor space

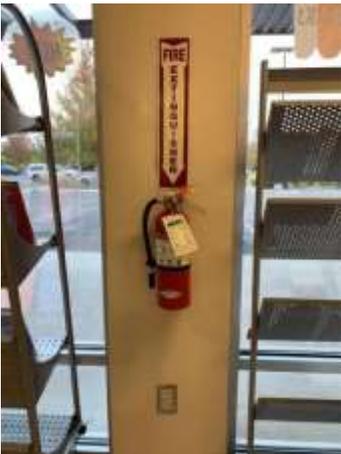
Location: Entrance Area
Schedule: 2021
Estimated Cost: \$100.00

2010 ADA Standards for Accessible Design Codes §307.2
The fire extinguisher protrudes 4.25" into the circulation space at 33" above the floor.

Recess the fire extinguisher so it protrudes a maximum of 4", lower it so the bottom edge is 27" maximum above the floor, or place a cane detectable object beneath it.

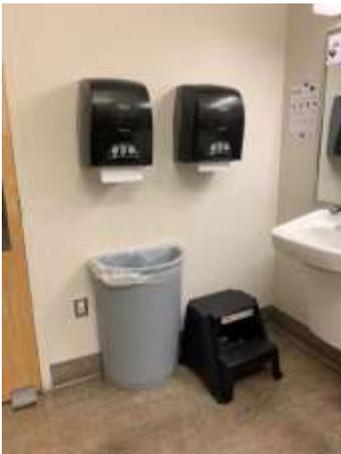
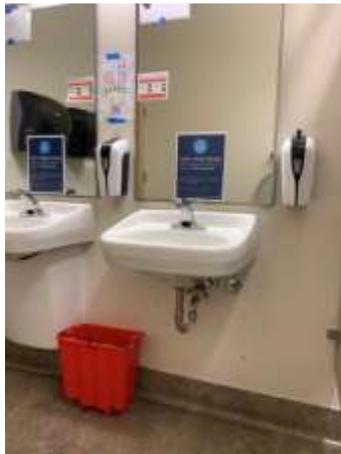
Location: Men's Restroom

The paper towel dispensers protrude 8.5" into the circulation space at 48" above the floor.

Ensure the garbage can remains underneath the paper towel dispensers or recess the paper towel dispensers so they protrude a maximum of 4".

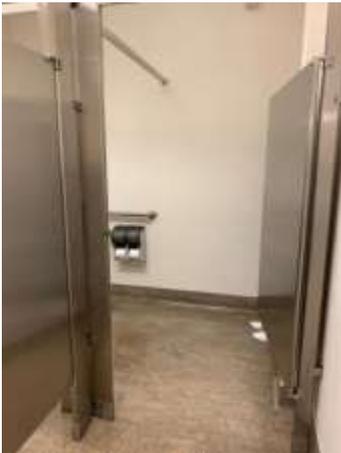
2010 ADA Standards for Accessible Design Codes §604.8.1.2
The door to the accessible water closet is not self closing. Either self-closing hinges are not installed on the door or if installed, they are defective.

Install or reinstall self-closing hinges on the door to ensure that the door is self-closing per the ADA requirements.

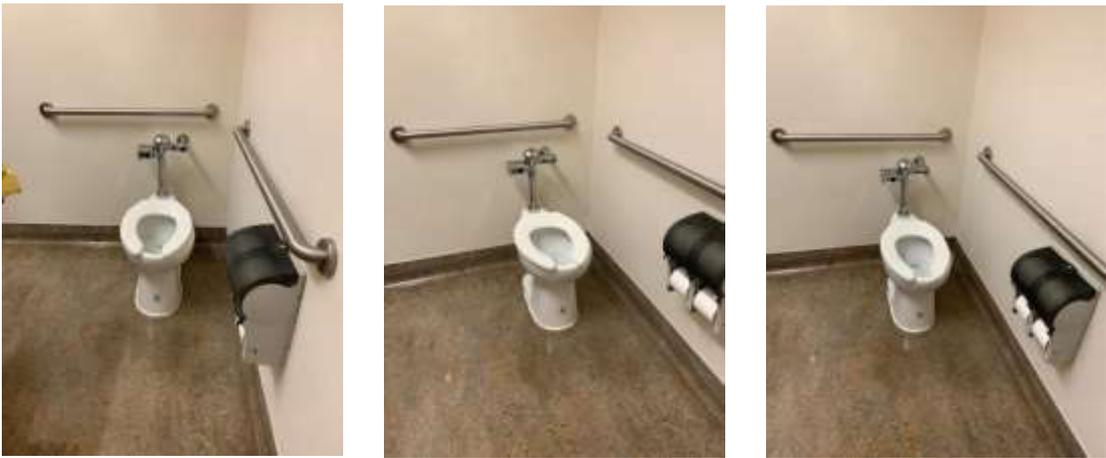
Location: Men's Restroom
Schedule: 2021
Estimated Cost: \$100.00

2010 ADA Standards for Accessible Design Codes §604.7
The toilet paper dispenser is located out of the accessible reach range.

Remount the toilet paper dispenser to 7" minimum and 9" maximum in front of the water closet measured to the centerline of the dispenser.
The outlet of the dispenser shall be 15" minimum and 48" maximum above the floor and shall not be located behind.

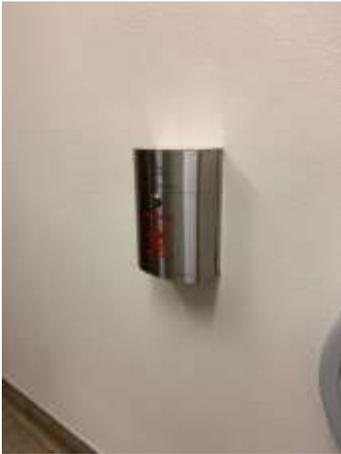
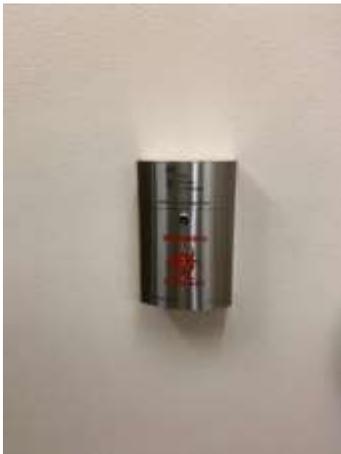
Location: Men's Restroom
Schedule: 2021
Estimated Cost: \$100.00

2010 ADA Standards for Accessible Design Codes §307.2
The sharps container protrudes 4.75" into the circulation space at 40" above the floor.

Recess the sharps container so it protrudes a maximum of 4", lower it so the bottom edge is 27" maximum above the floor, or place a cane detectable object beneath it.

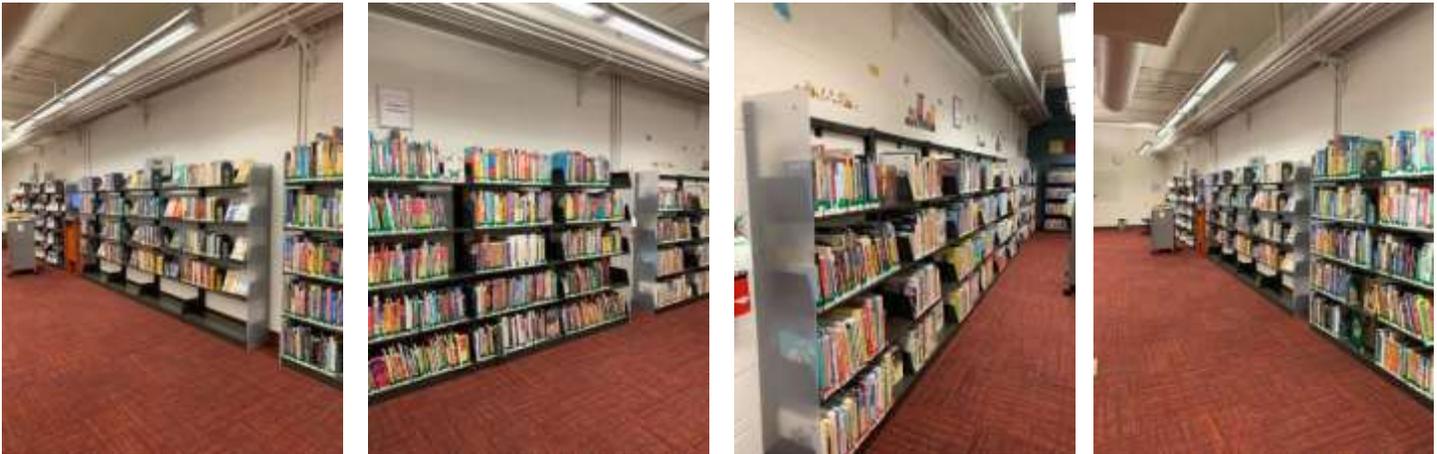
Location: New Books, Children’s Nonfiction, and Fiction
Schedule: 2021
Estimated Cost: \$100.00

2010 ADA Standards for Accessible Design Codes §308.2.1
The top shelves are outside of the unobstructed forward reach range between 54" to 63" above the floor.

Ensure that the library has a policy requiring employees and volunteers to assist patrons by obtaining books on inaccessible shelves.

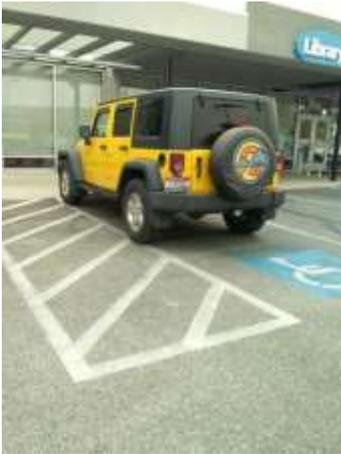
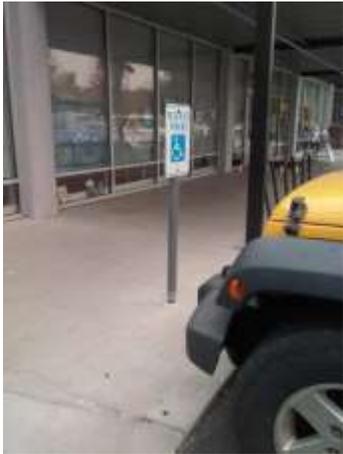
Location: Parking
Schedule: 2021
Estimated Cost: \$100.00

2010 ADA Standards for Accessible Design Codes §502.6
The accessible parking sign is 36" above the ground.

Remount the accessible parking sign at a minimum height of 60" above the ground.

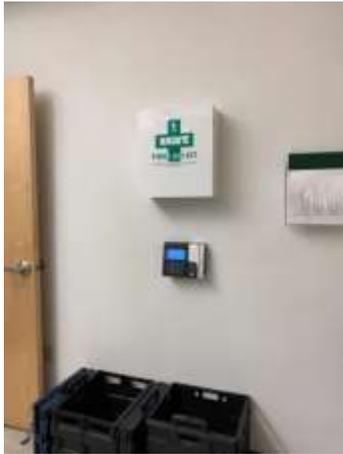
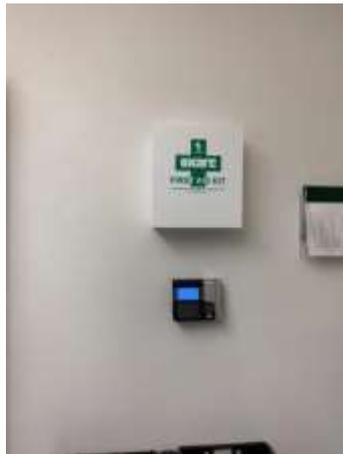
Location: Staff Area
Schedule: 2021
Estimated Cost: \$100.00

The first aid box is outside of the obstructed forward reach range at 56.75" above the floor. The first aid box protrudes 5.5" into the circulation space at 56.75" above the floor.

Lower the first aid box by 8.75" to 48" maximum if the reach depth is 20" and 44" if the reach depth exceeds 20" but does not exceed 25". Recess the first aid box so it protrudes a maximum of 4", lower it so the bottom edge is 27" maximum above the floor, or place a cane detectable object beneath it.

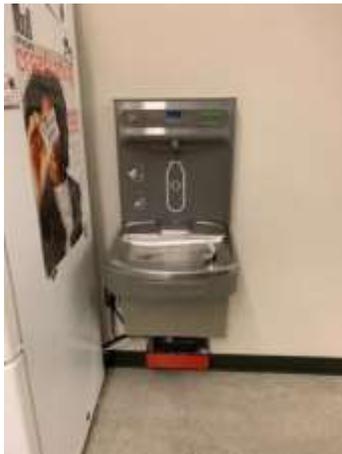
Location: Staff Area
Schedule: 2021
Estimated Cost: \$100.00

2010 ADA Standards for Accessible Design Codes §211.2, §602.7
There is only one drinking fountain provided and the spout is 31.5" above the floor.

Install an additional drinking fountain at a minimum spout height of 38" and maximum of 43" above the floor.

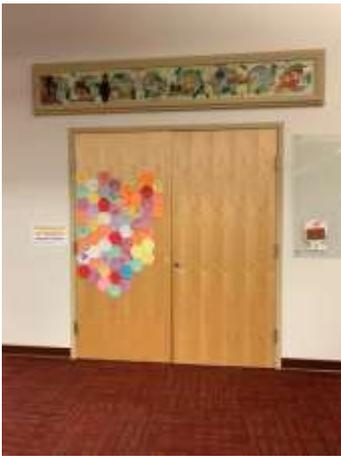
Location: Staff Area
Schedule: 2022
Estimated Cost: \$1,000.00

2010 ADA Standards for Accessible Design Codes §216.2, §703
There is no tactile sign identifying the permanent room.

Install tactile signage on the latch side of the doorway at a height of 48" minimum to 60" maximum above the floor, identifying room by name or room number. Signs shall be Braille with raised lettering and should be placed on the wall in the center of an 18"x18" clear floor space.

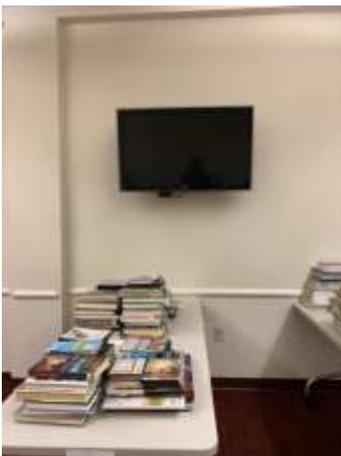
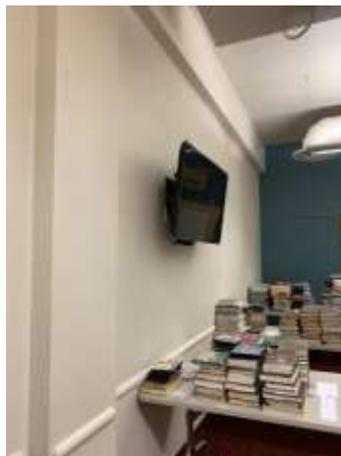
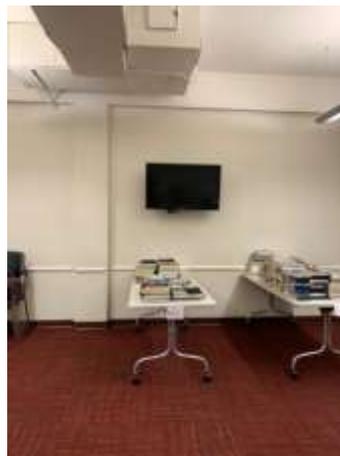
Location: Sycamore Conference Room

The TV protrudes 8" into the circulation space at 62.5" above the floor.

Recess the TV so it protrudes a maximum of 4", raise it so the bottom edge is 80" maximum above the floor, or place a cane detectable object beneath it.

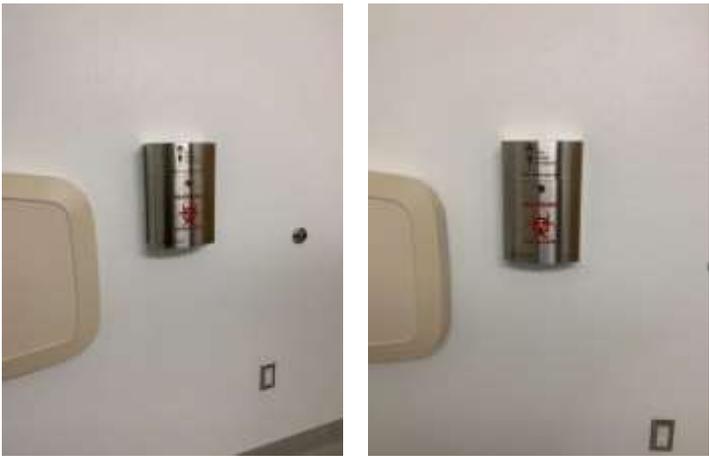
Location: Unisex Restrooms
Schedule: 2021
Estimated Cost: \$100.00

2010 ADA Standards for Accessible Design Codes §307.2
The sharps container protrudes 4.5" into the circulation space at 41" above the floor.

Recess the sharps container so it protrudes a maximum of 4", lower it so the bottom edge is 27" maximum above the floor, or place a cane detectable object beneath it.

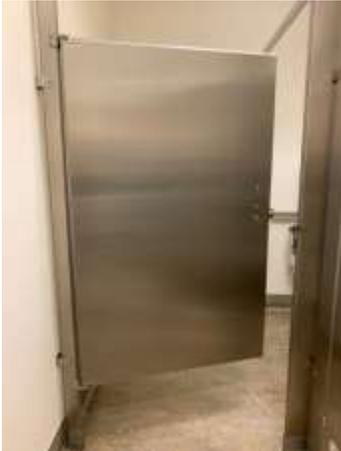
2010 ADA Standards for Accessible Design Codes §604.8.1.2
The door to the accessible water closet is not self closing. Either self-closing hinges are not installed on the door or if installed, they are defective.

Install or reinstall self-closing hinges on the door to ensure that the door is self-closing per the ADA requirements.

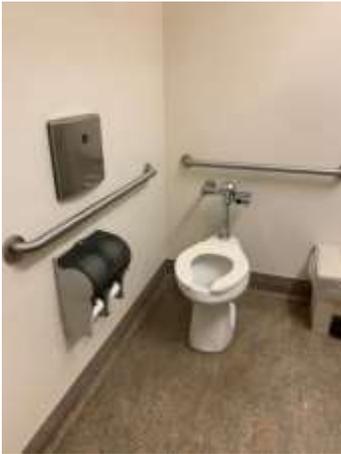
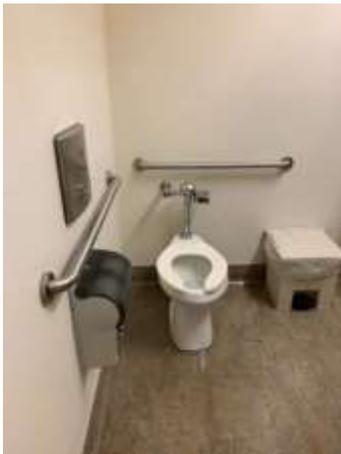
PHOTOGRAPH(S) OF THIS LOCATION

VIOLATIONS

Relocate the garbage can to a location that is at least a distance of 12" or greater away from the grab bar.

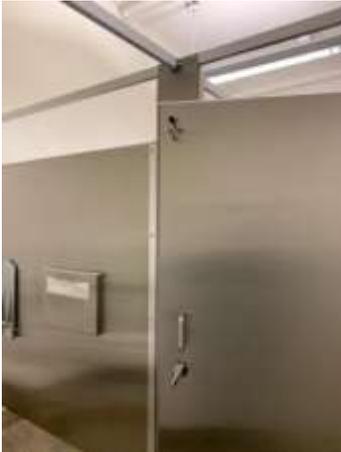
PHOTOGRAPH(S) OF THIS LOCATION

2010 ADA Standards for Accessible Design Codes §308.2.1
The hook is outside of the unobstructed forward reach range at 67.5" above the floor.

Lower the hook by 19.5" to meet the accessible reach range of 48" maximum above the floor.

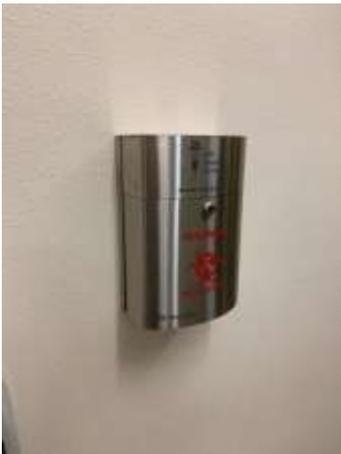
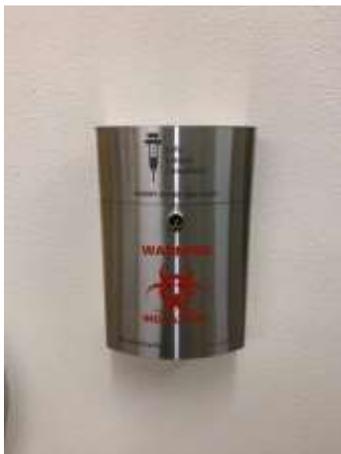
PHOTOGRAPH(S) OF THIS LOCATION

2010 ADA Standards for Accessible Design Codes §307.2

The sharps container protrudes 4.75" into the circulation space.

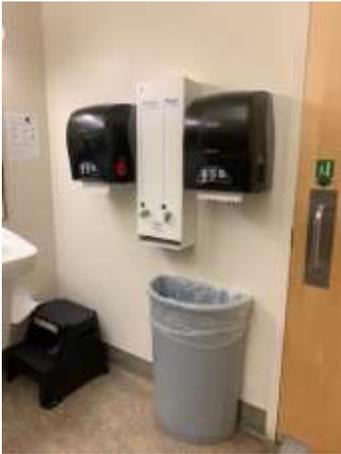
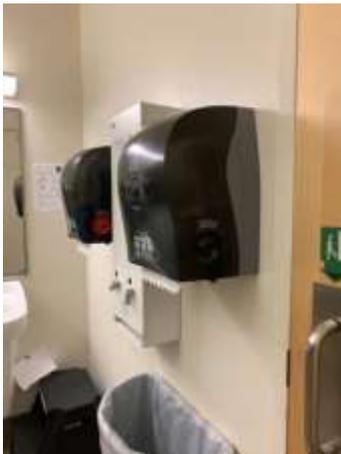
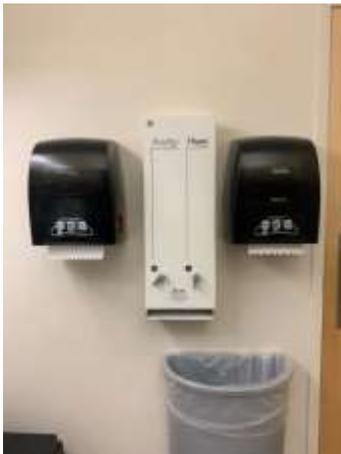
PHOTOGRAPH(S) OF THIS LOCATION

VIOLATIONS

RECOMMENDATIONS

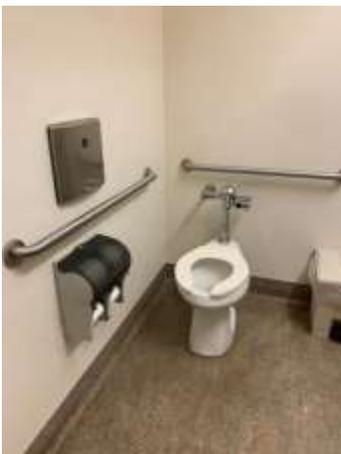
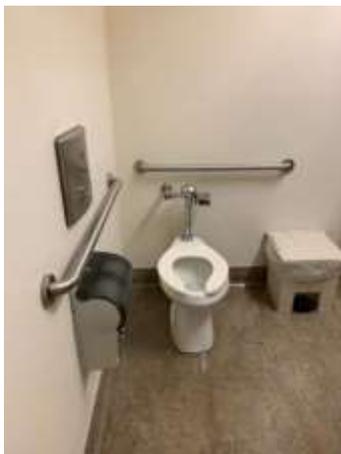
PHOTOGRAPH(S) OF THIS LOCATION

VIOLATIONS

RECOMMENDATIONS
