City of Boise ADA
Assessment

Appendix A-Library! Capitol

Report #TO20-B001

ID: 1258 **Facility:** Capitol Library

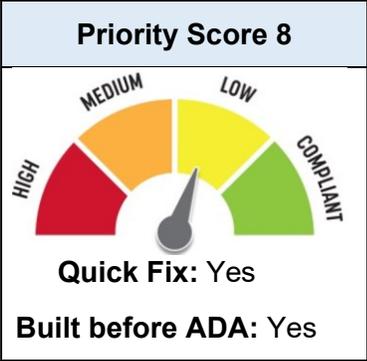
Location: Crosswalk by Book Returns
Schedule: 2021
Estimated Cost: \$0.00

2010 ADA Standards for Accessible Design Codes: §405
The pedestrian push button is located 43.5" above the floor. There is a step up adjacent to a ramped surface.

The reach range is accessible, however, for purposes of achieving greater accessibility, relocate the pedestrian push button to be adjacent to a level area.
If the accessible parking space is relocated, this improvement is not required unless requested by an employee with a disability.

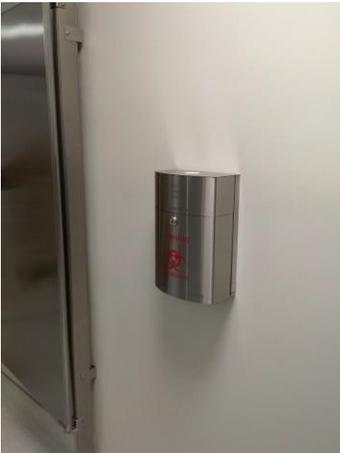
Location: 1st Floor Hays Auditorium Women's Restroom
Schedule: 2023
Estimated Cost: \$100.00

2010 ADA Standards for Accessible Design Codes: §307.2
The sharps container protrudes 4.75" into the circulation path at 38" above the floor.

Recess the sharps container so it protrudes a maximum of 4", lower it so the bottom edge is 27" maximum above the floor, or place a cane- detectable object beneath it.

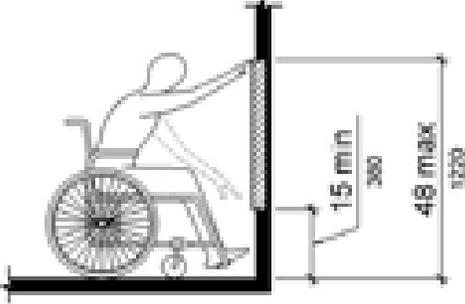
Location: 1st Floor Mail Room
Schedule: 2023
Estimated Cost: \$100.00

2010 ADA Standards for Accessible Design Codes: §308.2.1
The hangers are outside of the unobstructed forward reach range at 64" above the floor.

Lower the hangers by 16" to meet the accessible reach range of 15" minimum and 48" maximum above the floor. Or add a secondary lower railing located within the accessible reach range.

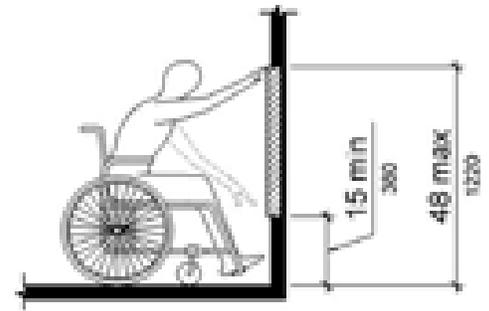
Location: 3rd Floor Women's Restroom

2010 ADA Standards for Accessible Design Codes: §308.2.1

Lower the hook by 15" to meet the accessible reach range of 48" maximum above the floor.

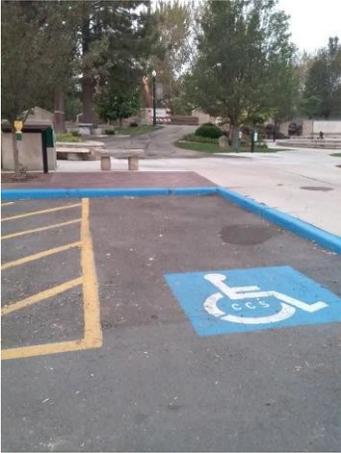
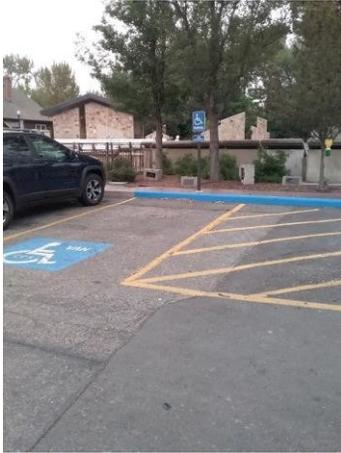
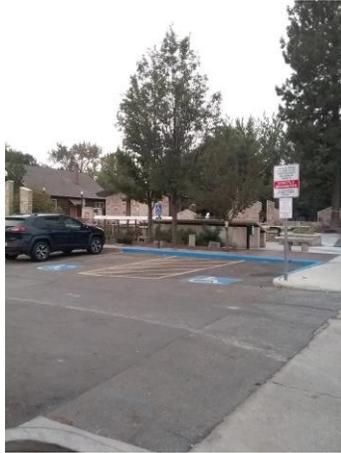
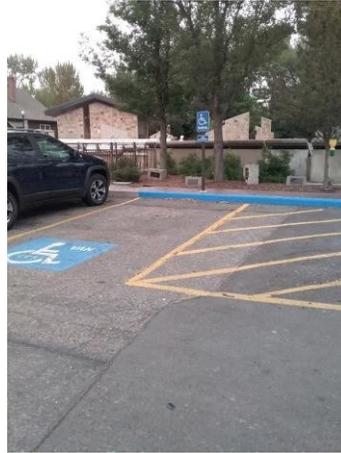
ID: 1245 **Facility:** Capitol Library

2010 ADA Standards for Accessible Design Codes: §502.6
One parking space is missing the signage identifying the accessible parking spaces. The parking space is located near Idaho Anne Frank Human Rights Memorial.

Install an accessible parking sign at each accessible space at a minimum height of 60" above the ground.

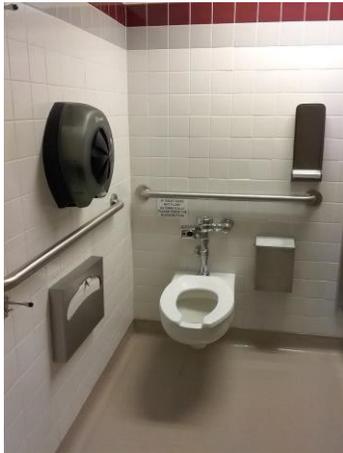
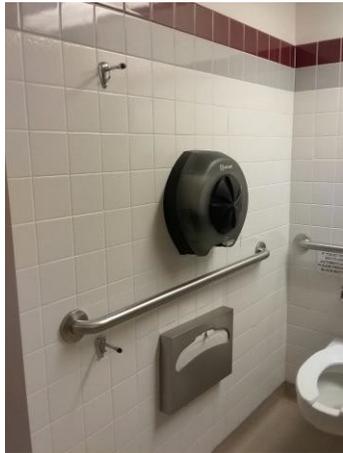
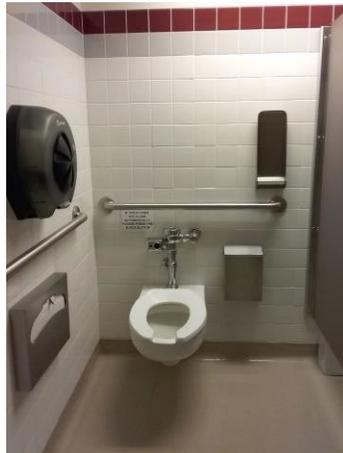
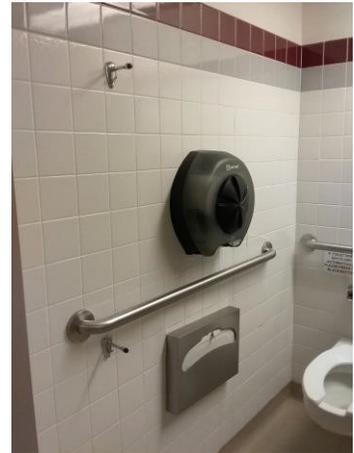
The door to the accessible water closet is not self closing. Either self-closing hinges are not installed on the door or if installed, they are defective.

Install or reinstall self-closing hinges on the door to ensure that the door is self-closing per ADA requirements.

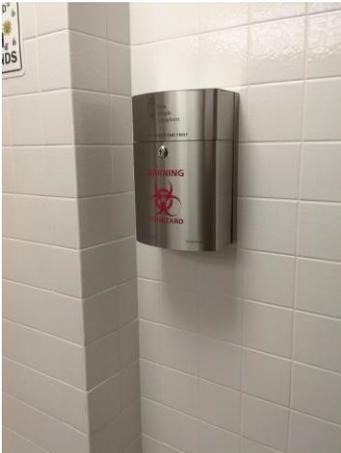
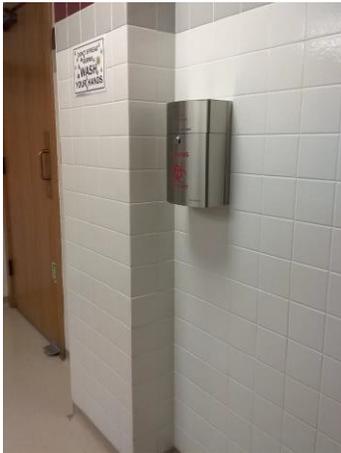
Location: 3rd Floor Women's Restroom
Schedule: 2022
Estimated Cost: \$100.00

2010 ADA Standards for Accessible Design Codes: §307.2
 The sharps dispenser protrudes 4.75" into the circulation space at 43" above the floor.

Recess the dispenser so it protrudes a maximum of 4", lower it so the bottom edge is 27" maximum above the floor, or place a cane-detectable object beneath it.

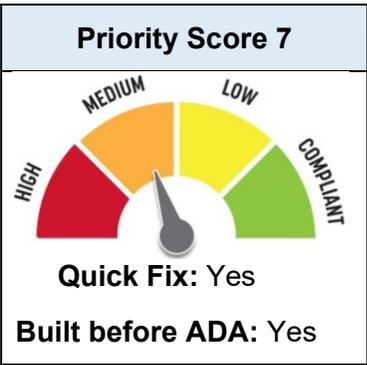
Location: 3rd Floor All Users Restroom
Schedule: 2022
Estimated Cost: \$100.00

2010 ADA Standards for Accessible Design Codes: §606.5
 The pipes under the sink are not covered.

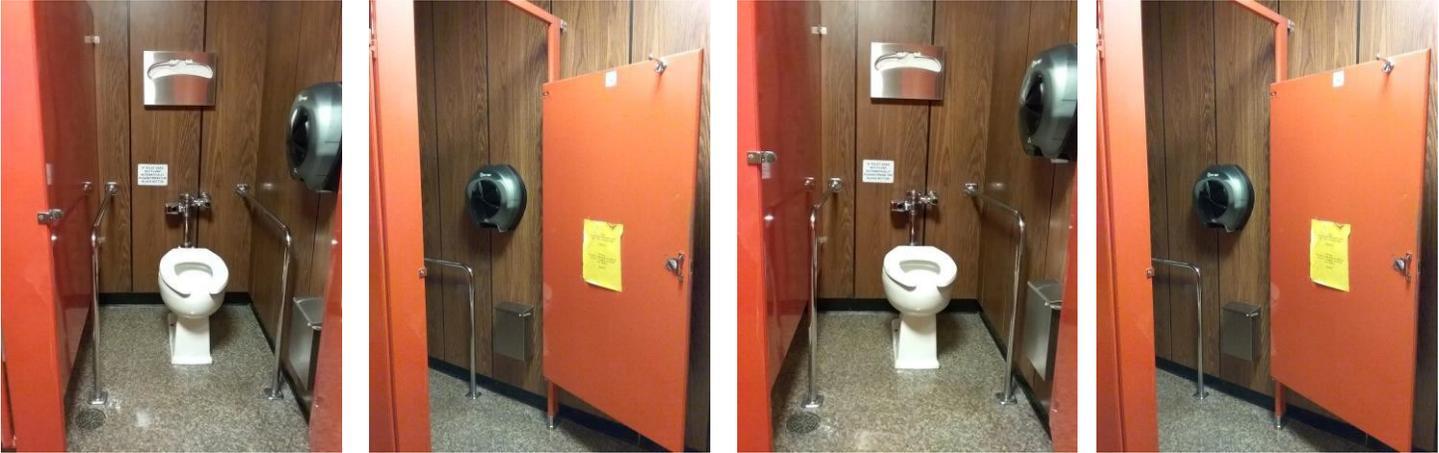
2010 ADA Standards for Accessible Design Codes: §604.8.1.2
The door to the accessible water closet is not self closing. Either self-closing hinges are not installed on the door or if installed, they are defective.

Install or reinstall self-closing hinges on the door to ensure that the door is self-closing per the ADA requirements.

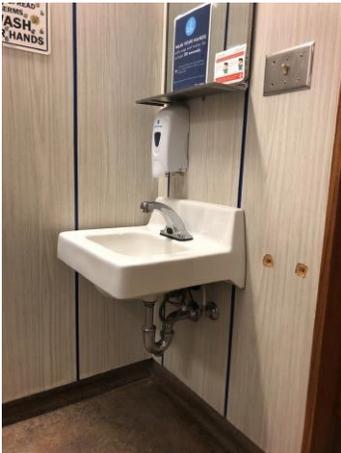
Location: 1st Floor Youth Services Boy's Restroom
Schedule: 2022
Estimated Cost: \$100.00

2010 ADA Standards for Accessible Design Codes: §606.5
 The pipes under the sink are not covered.

Wrap the pipes beneath the sink with soft protective wrap or plastic.

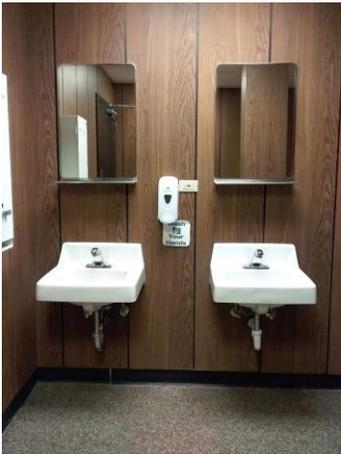
Location: 4th Floor Women's Ambulatory Restroom
Schedule: 2022
Estimated Cost: \$200.00

2010 ADA Standards for Accessible Design Codes: §603.3
 The mirrors are too high to be accessible at 52" above the floor.

Lower the mirrors so the bottom edge is at a maximum height of 40" above the floor.

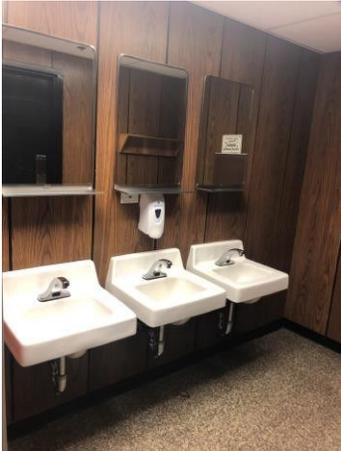
Location: 4th Floor Men's Restroom
Schedule: 2022
Estimated Cost: \$300.00

2010 ADA Standards for Accessible Design Codes: §603.3
 The mirrors are too high to be accessible at 52" above the floor.

Lower the mirrors to the maximum height of 40" above the floor.

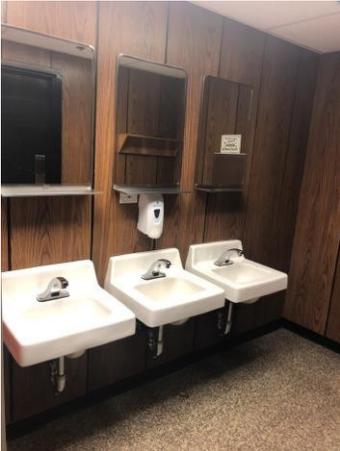
Location: 4th Floor Men's Restroom
Schedule: 2022
Estimated Cost: \$300.00

2010 ADA Standards for Accessible Design Codes: §606.5
 The pipes under the sink are not covered.

Wrap the pipes beneath the sink with soft protective wrap or plastic.

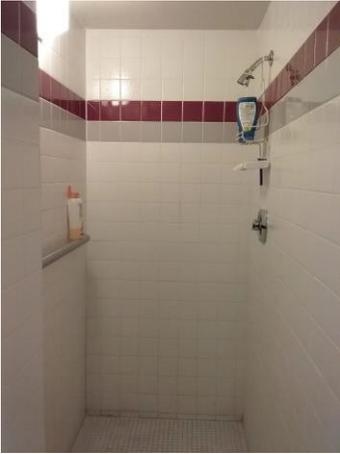
Note: inside finished dimensions measured at the center points of opposing sides

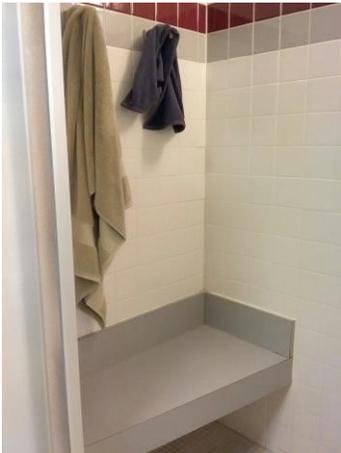
Location: 3rd Floor All Users Restroom
Schedule: 2022
Estimated Cost: \$500.00

2010 ADA Standards for Accessible Design Codes: §903.3
 The bench is located 16" above the floor and 11" deep.

Install a new bench that is 20" to 24" inches deep.

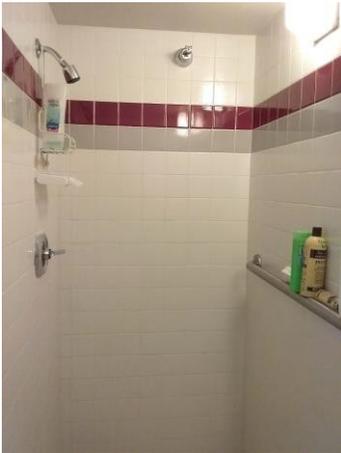
Location: 3rd Floor All Users Restroom
Schedule: 2022
Estimated Cost: \$1,000.00

2010 ADA Standards for Accessible Design Codes: §610.3.1, §610.3.2
 The shower does not have a seat.

Install a permanent shower seat between 17" and 19" above the floor. The shower seat dimensions and shape shall comply with §610.3.

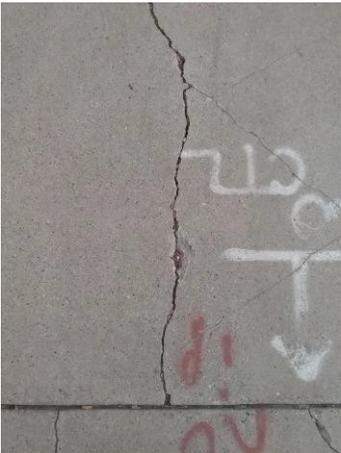
2010 ADA Standards for Accessible Design Codes: §303.2
The crack in the pavement is 2.5" wide and 1.5" deep.

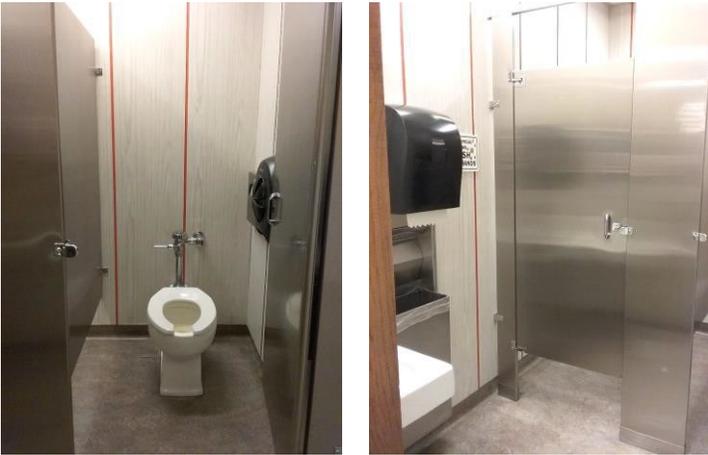
PHOTOGRAPH(S) OF THIS LOCATION

Location: 1st Floor Youth Services Girl's Restroom
Schedule: 2022
Estimated Cost: \$2,000.00

Combine the two non-accessible stalls into one 60" wide wheelchair accessible toilet stall. Add grab bars at a minimum height of 33" and 36" maximum above the floor.

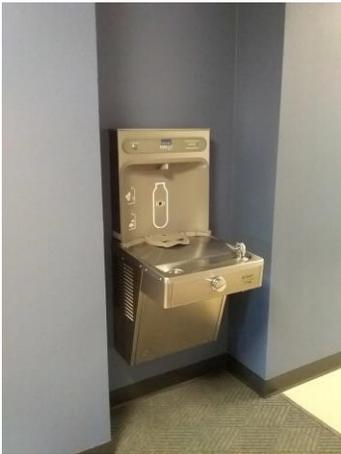
PHOTOGRAPH(S) OF THIS LOCATION

Location: 3rd Floor Drinking Fountain
Schedule: 2022
Estimated Cost: \$2,000.00

2010 ADA Standards for Accessible Design Codes: §211.2, §602.7
There is only one drinking fountain provided at a spout height of 33" above the floor.

Install an additional drinking fountain at a minimum spout height of 38" and maximum of 43" above the floor.

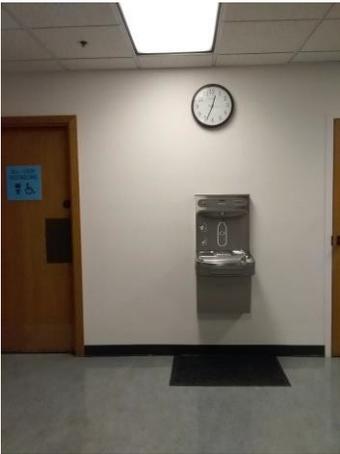
PHOTOGRAPH(S) OF THIS LOCATION

Location: 3rd Floor Staff Break Room
Schedule: 2022
Estimated Cost: \$2,000.00

Install an additional drinking fountain at a minimum height of 38" and maximum of 43" above the floor.

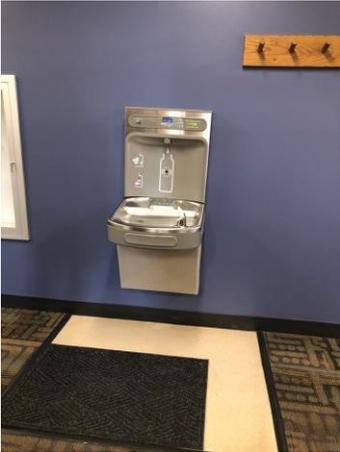
PHOTOGRAPH(S) OF THIS LOCATION

Location: 2nd Floor Drinking Fountain
Schedule: 2022
Estimated Cost: \$2,000.00

Install an additional drinking fountain at a minimum height of 38" and maximum of 43" above the floor.

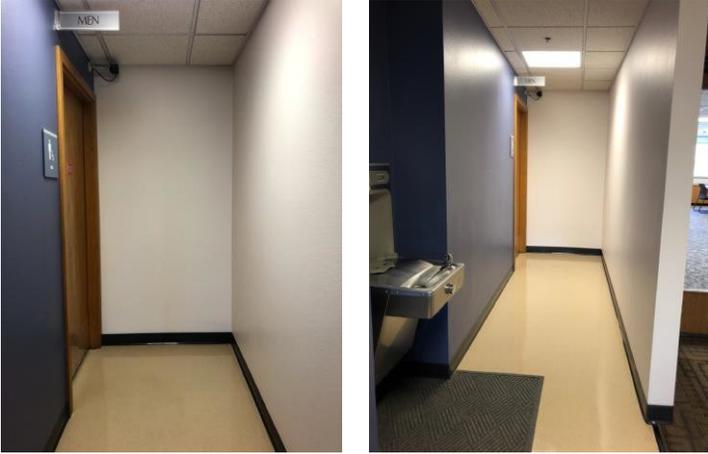
PHOTOGRAPH(S) OF THIS LOCATION

2010 ADA Standards for Accessible Design Codes: §404.2.4.1 (h)
The hallway width is 45.5" wide, providing inadequate maneuvering clearance in front of the door.

Remove the hallway to provide a minimum of 48" maneuvering clearance in front of the door. In the meantime, provide signage directing users to the nearest accessible restroom.
