City of Boise ADA
Assessment

Appendix A-Quail Hollow Golf Course

Report #TO21-B018

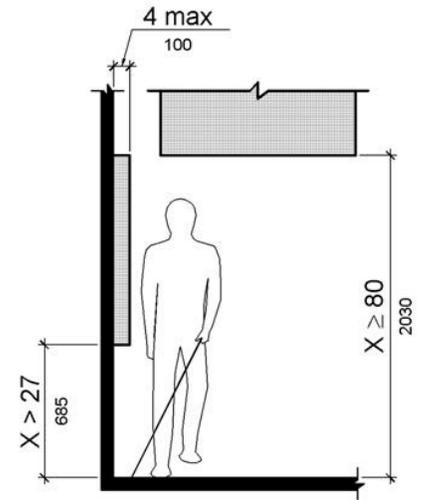
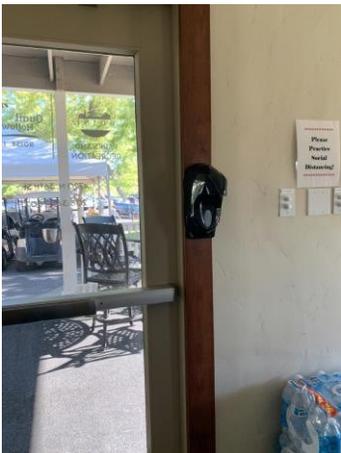
2010 ADA Standards for Accessible Design Codes §307.2, §308.2.1

The hand sanitizer dispenser is outside of the unobstructed forward reach range at 55" above the floor. The hand sanitizer dispenser protrudes 8" into the circulation space at 55" above the floor.

Lower the hand sanitizer dispenser by 7" to meet the accessible reach range of 48" maximum above the floor.

Recess or replace the hand sanitizer dispenser so it protrudes a maximum of 4" or place a cane detectable object beneath it.

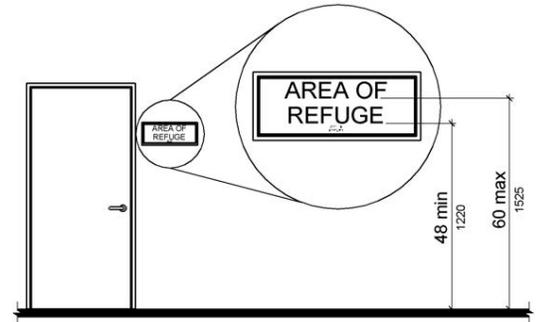
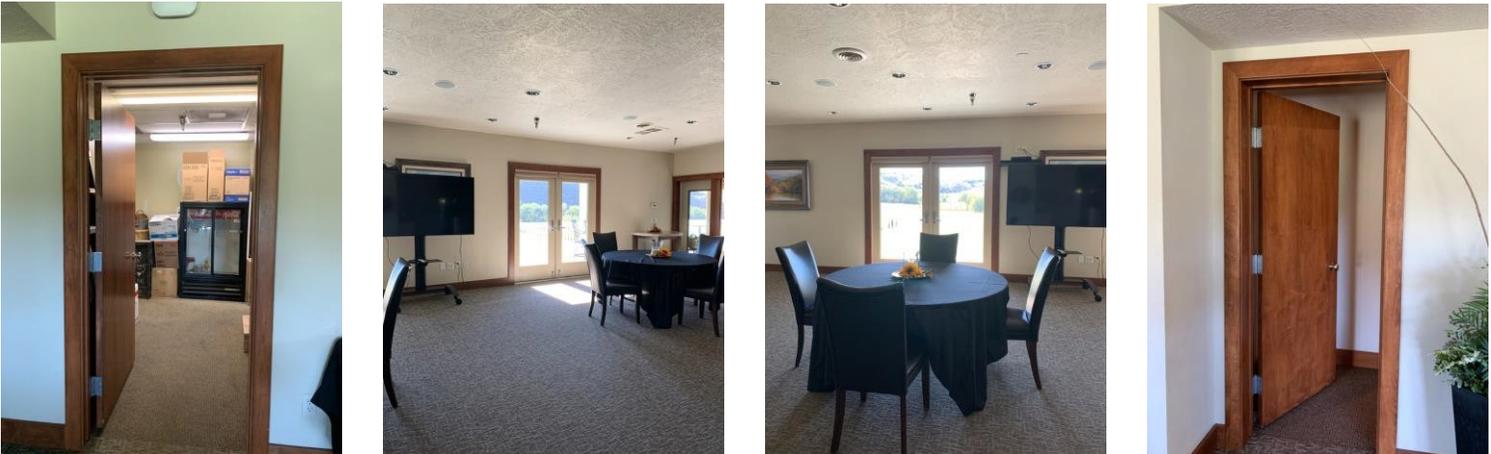
2010 ADA Standards for Accessible Design Codes §216.2, §703
There are no tactile signs identifying four permanent rooms.

Install tactile signage on the latch side of the doorway at a height of 48” minimum to 60” maximum above the floor, identifying room by name or room number. Signs shall be Braille with raised lettering and should be placed on the wall in the center of an 18"x18" clear floor space.

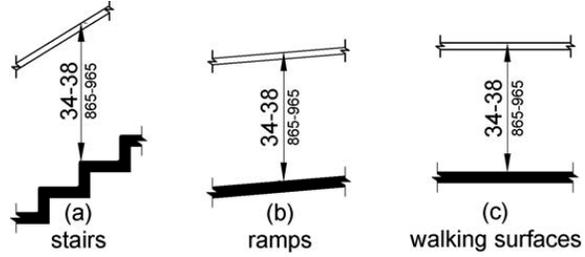
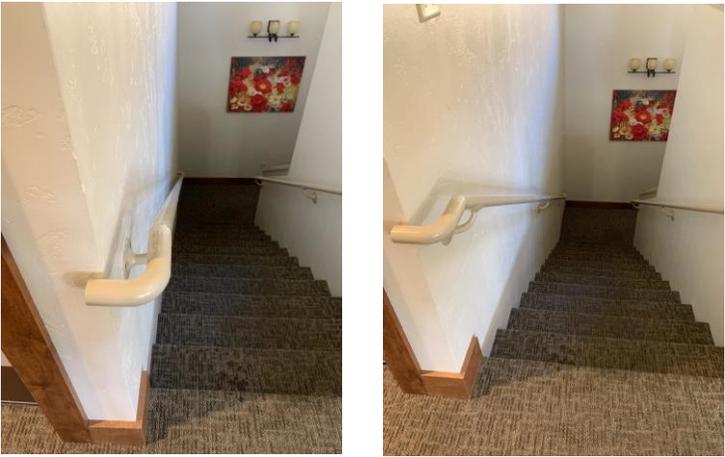
2010 ADA Standards for Accessible Design Codes §505.4
The handrails are 32" above stair nosings.

Raise the handrails to a minimum height of 34" and a maximum of 38" above the stair nosings. Ensure that the handrails are at a consistent height along the stair treads.

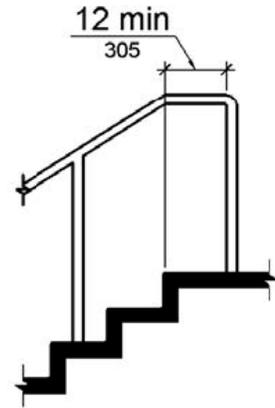
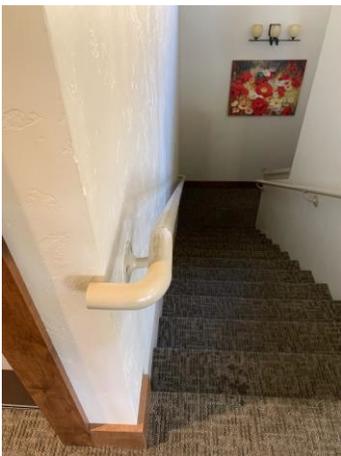
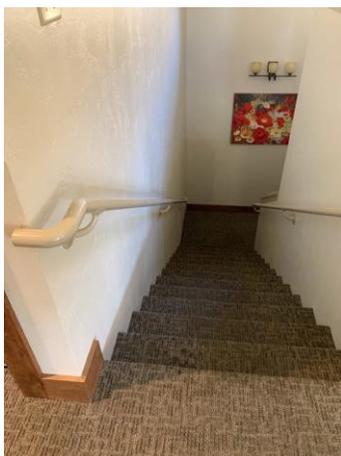
2010 ADA Standards for Accessible Design Codes §505.10.2

The handrail extensions are 6".

Install new handrails with extensions that extend at least 12" horizontally above the landing beginning directly above the first stair riser nosing.

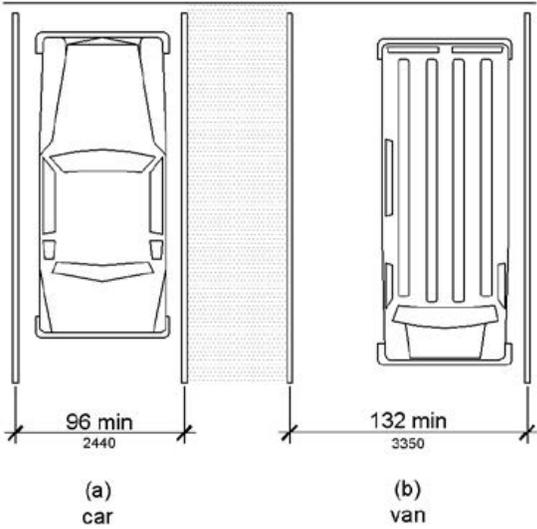
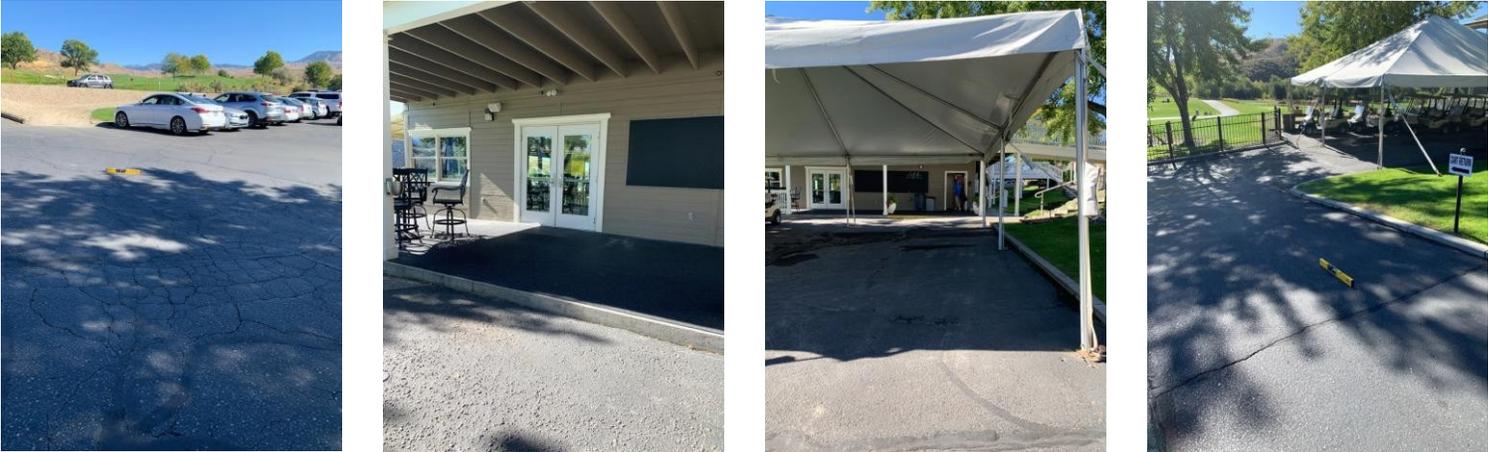
2010 ADA Standards for Accessible Design Codes §208.2
There are no marked accessible parking spaces to access the banquet room.
The only way to access the banquet room is by using one of two stairways, navigating a 5" step, or utilizing the vehicular travel lane with a 12.1% to 12.3% cross slope.

Install an accessible parking space that is a minimum of 132" wide and a 60" wide access aisle connecting to an accessible route. Relocate the golf cart pick up area to another location. Add vertical access to the banquet room by installing a ramp. Ensure that the ramp slope does not exceed 8.3%, handrails are provided, and there is sufficient room for a level landing at the top and bottom of the ramp. Enact a policy that addresses assisting persons with disabilities in getting golf carts.

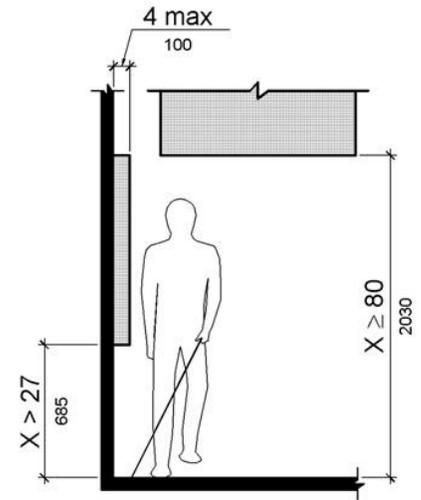
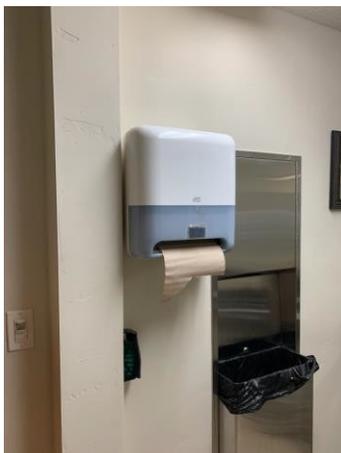
2010 ADA Standards for Accessible Design Codes §307.2, §308.2.1

The paper towel dispenser is outside of the unobstructed forward reach range at 53" above the floor. The paper towel dispenser protrudes 7" into the circulation space at 53" above the floor.

Lower the paper towel dispenser by 5" to meet the accessible reach range of 48" maximum above the floor.

Recess the paper towel dispenser so it protrudes a maximum of 4" or place a cane detectable object beneath it.

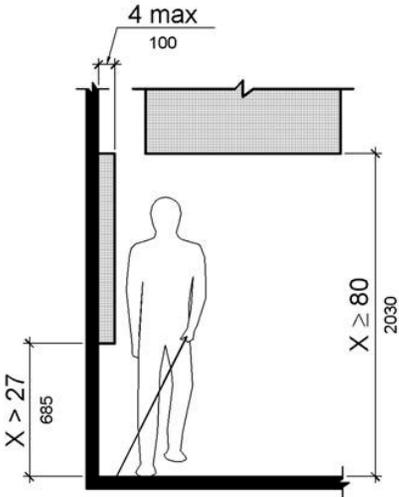
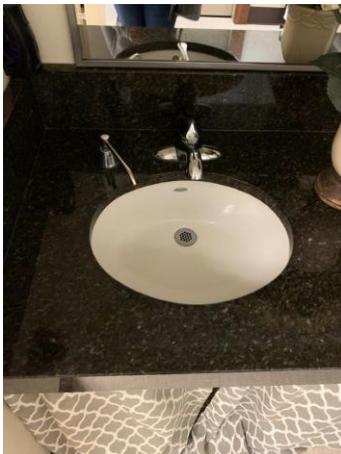
2010 ADA Standards for Accessible Design Codes §307.2, §308.2.1
The paper towel dispenser protrudes 7" into the circulation space at 54" above the floor.
The paper towel dispenser is outside of the unobstructed forward reach range at 54" above the floor.

Recess the paper towel dispenser so it protrudes a maximum of 4" or place a cane detectable object beneath it.
Lower the paper towel dispenser by 6" to meet the accessible reach range of 48" maximum above the floor.

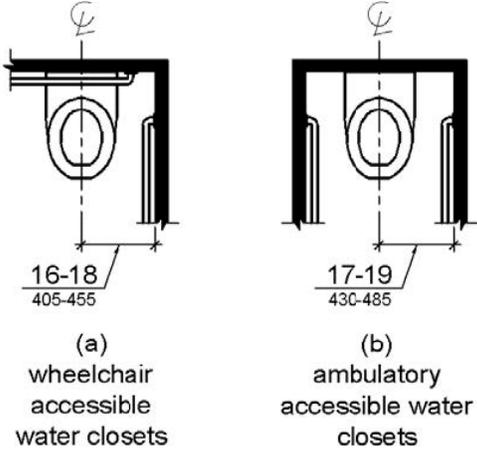
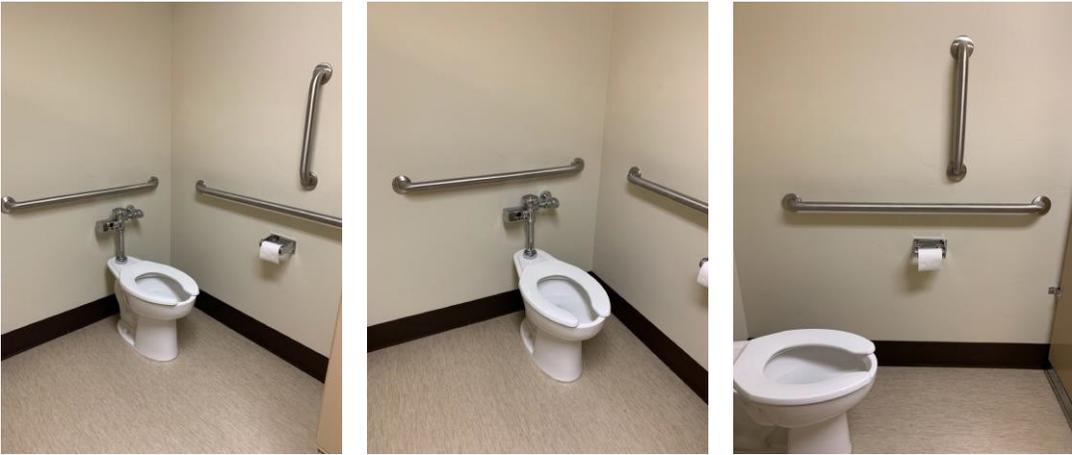
2010 ADA Standards for Accessible Design Codes §604.2
The centerline of the toilet is located 19" from the sidewall.

Reposition the centerline of the toilet to be within 16" minimum and 18" maximum from the sidewall.

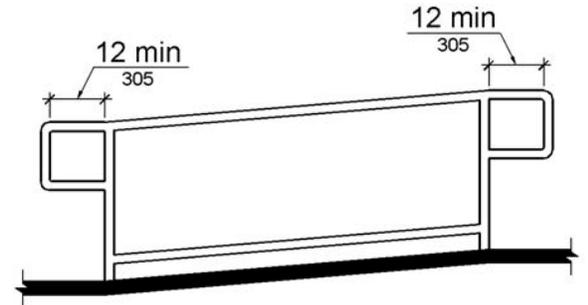
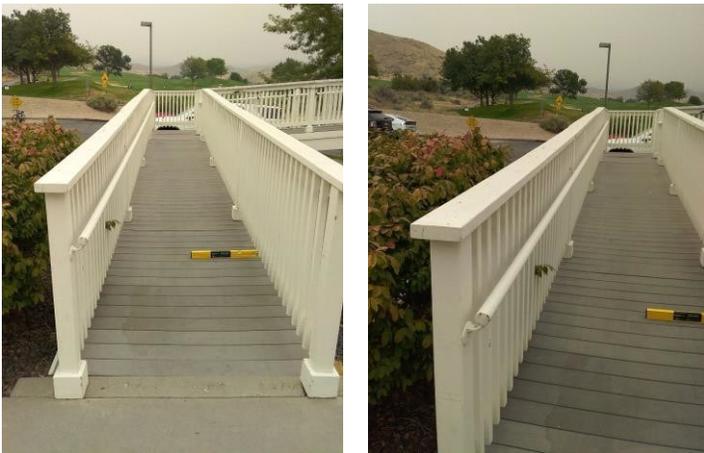
2010 ADA Standards for Accessible Design Codes §505.10

There are no handrail extensions for the ramp.

Extend the ramp handrails 12" horizontally beyond the top and bottom of ramp runs.

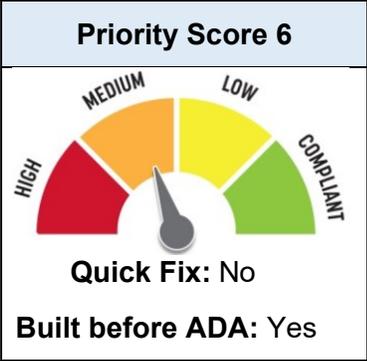
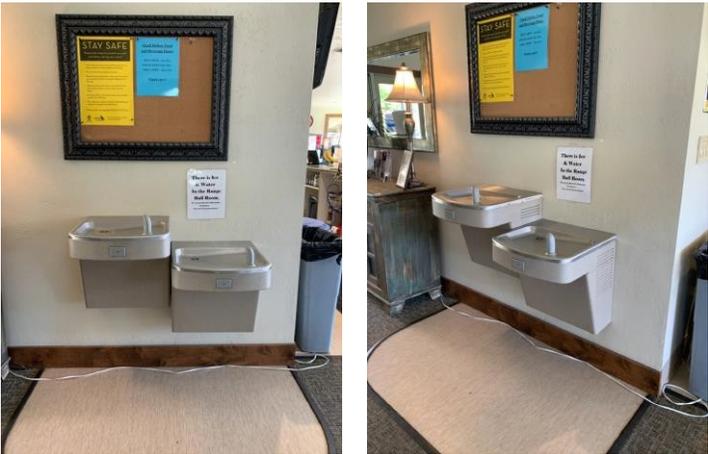
2010 ADA Standards for Accessible Design Codes §602.7
The spout heights of the drinking fountains are not compliant at 31" and 37" above the floor.

Raise the existing tall drinking fountain to a minimum spout height of 38" and maximum spout height of 43" above the floor.

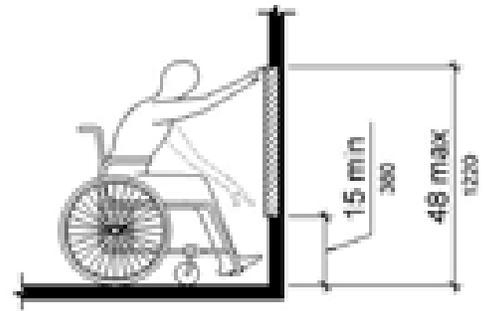
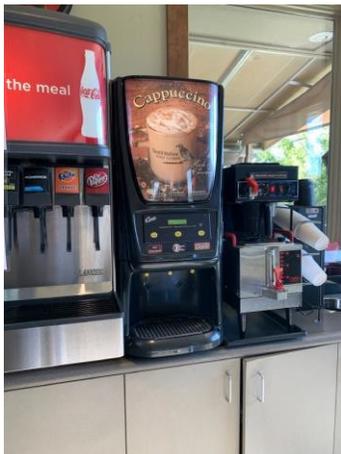
2010 ADA Standards for Accessible Design Codes §308.2.1

The coffee maker is outside of the unobstructed forward reach range at 50" above the floor.

Lower the coffee maker by 2" to meet the accessible reach range of 15" minimum and 48" maximum above the floor.

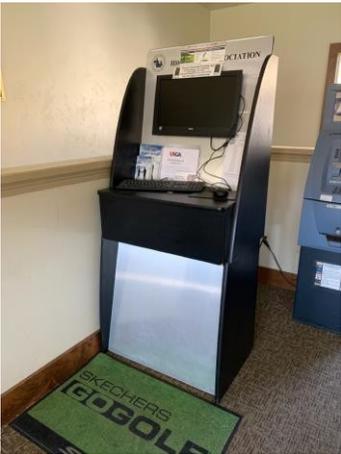
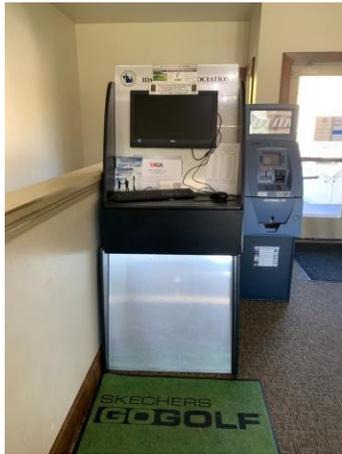
2010 ADA Standards for Accessible Design Codes §904.4.1
 The counter is 38.5" above the floor.

A portion of the service counter must be no higher than 36" above the floor for a horizontal distance of 36".

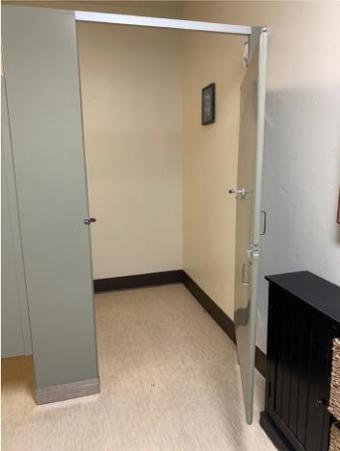
2010 ADA Standards for Accessible Design Codes §604.8.1.2
The door to the accessible water closet is not self closing. Either self-closing hinges are not installed on the door or if installed, they are defective.

Install or reinstall self-closing hinges on the door to ensure that the door is self-closing per the ADA requirements.

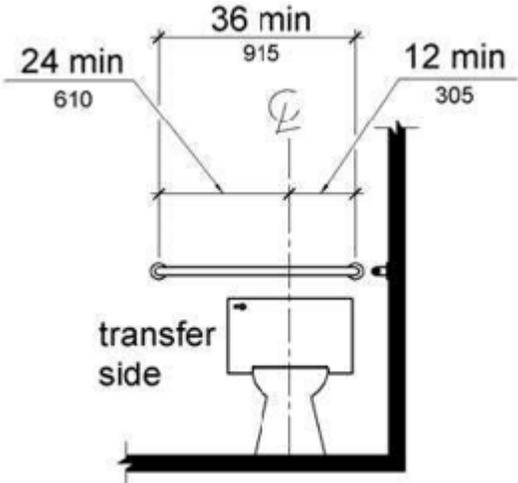
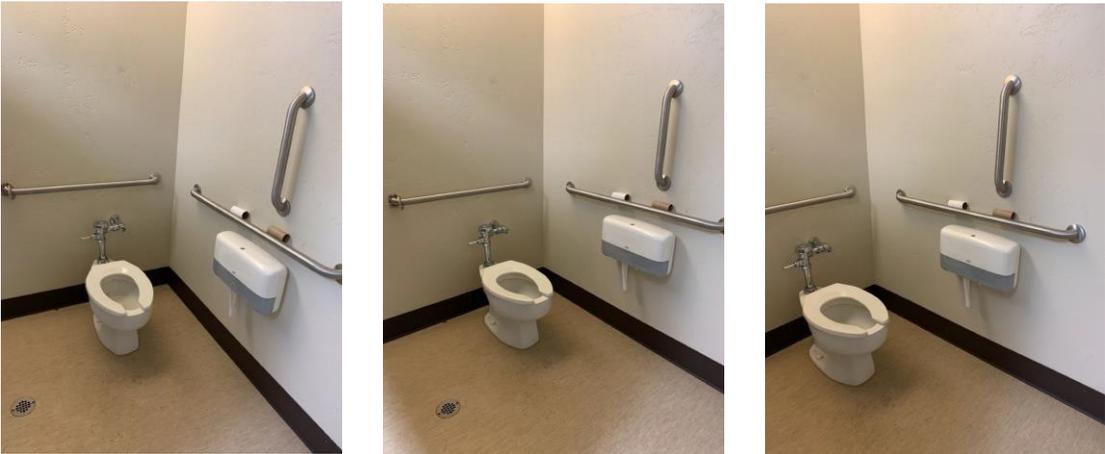
2010 ADA Standards for Accessible Design Codes §604.5.2
The rear grab bar is located 9" to the center of the toilet.

Remount the rear grab bar 12" from the centerline of the water closet minimum on one side and 24" minimum on the other.

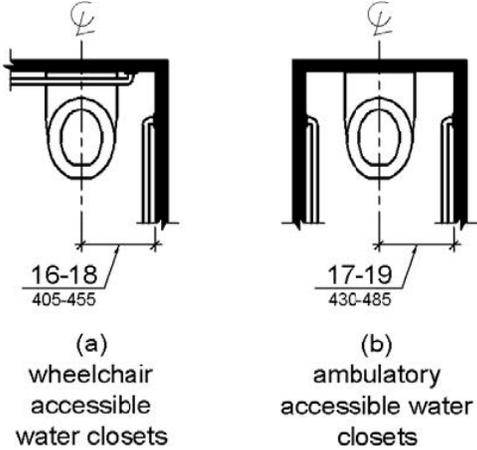
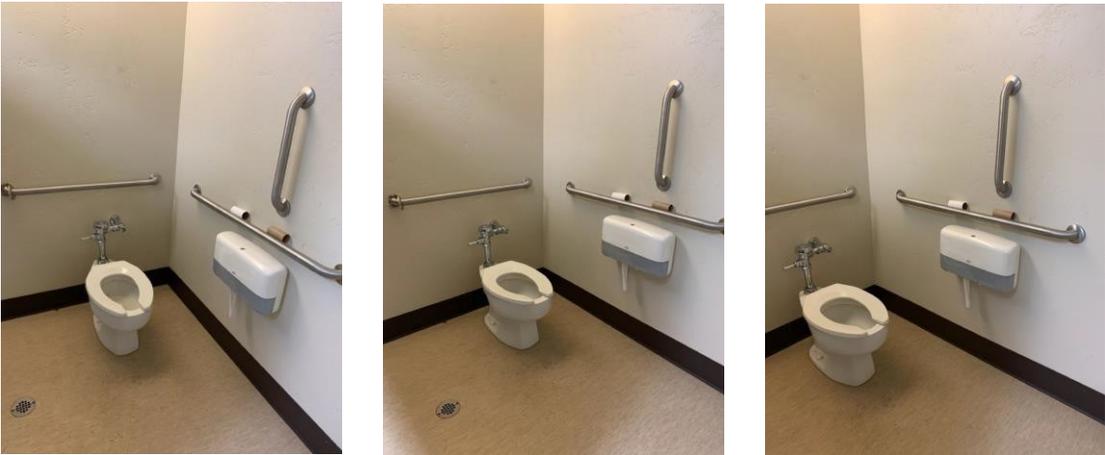
2010 ADA Standards for Accessible Design Codes §604.2
The centerline of the toilet is located 22" from the sidewall.

Reposition the centerline of the toilet to be within 16" minimum and 18" maximum from the sidewall.

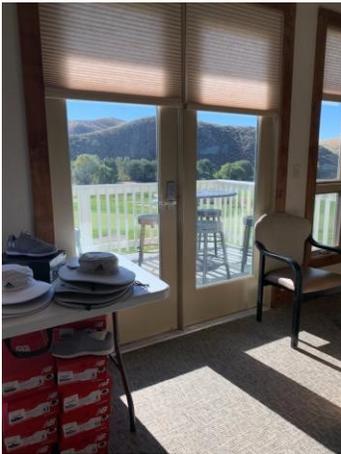
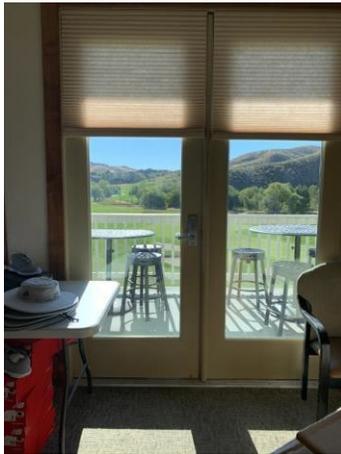
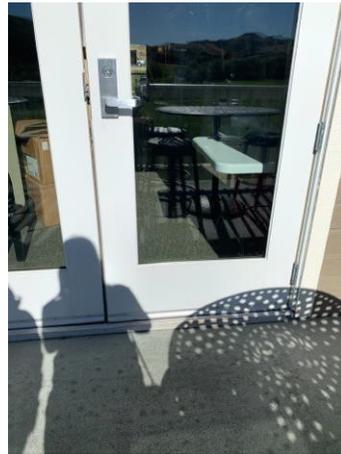
2010 ADA Standards for Accessible Design Codes §404.2.5

The threshold at the doorway is 1.5" tall.

Reduce the metal lip on the door to no more than 0.5" to 0.75" if beveled on each side.

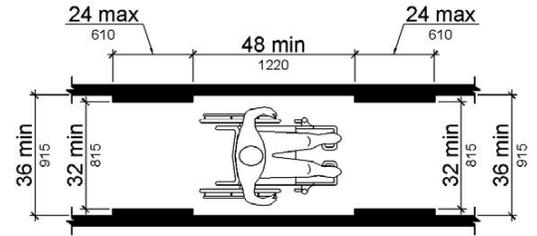
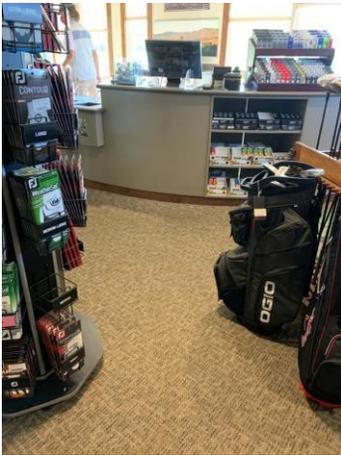
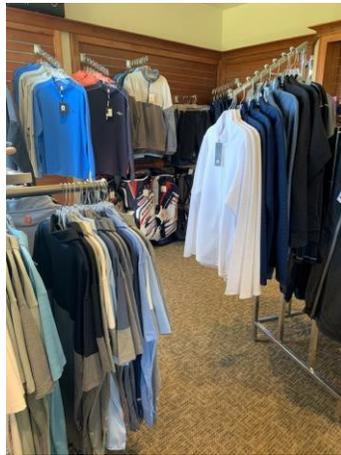
2010 ADA Standards for Accessible Design Codes §403.5.1

There is not a clear 36" width for wheelchairs to pass between the merchandise.

Relocate some of the merchandise to different parts of the shop to allow for circulation paths that are a minimum of 36" wide.

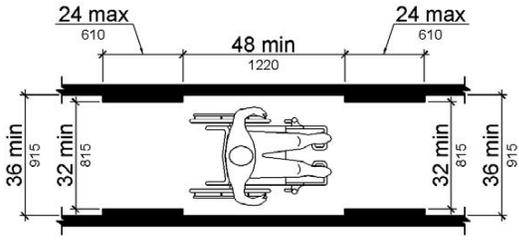
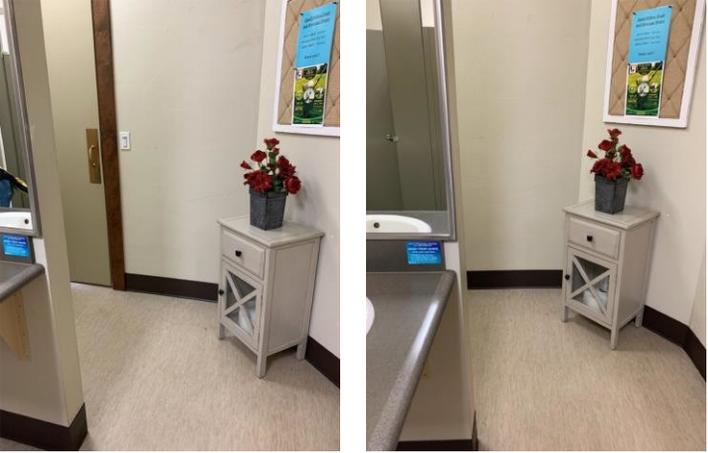
2010 ADA Standards for Accessible Design Codes §403.5.1
The entrance into the Women's Restroom is 34" between the corner and cabinet.

Relocate the cabinet.

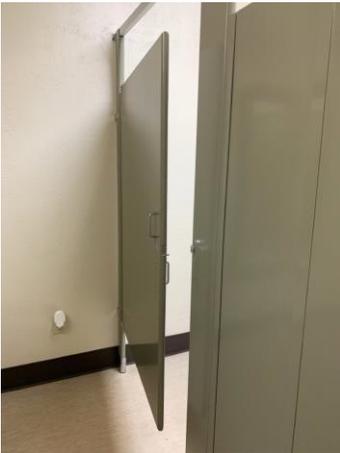
2010 ADA Standards for Accessible Design Codes §604.8.1.2
The door to the accessible water closet is not self closing. Either self-closing hinges are not installed on the door or if installed, they are defective.

Install or reinstall self-closing hinges on the door to ensure that the door is self-closing per the ADA requirements.

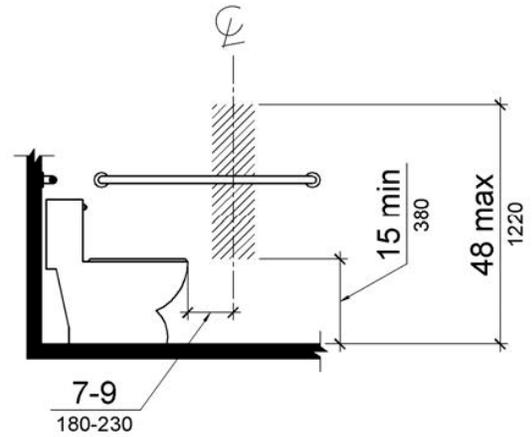
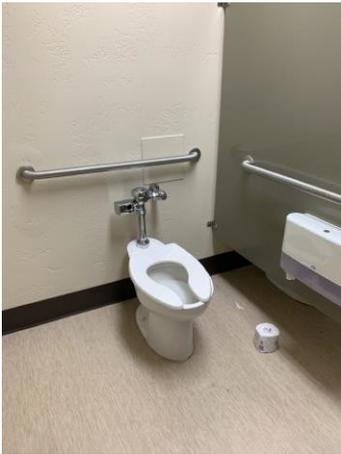
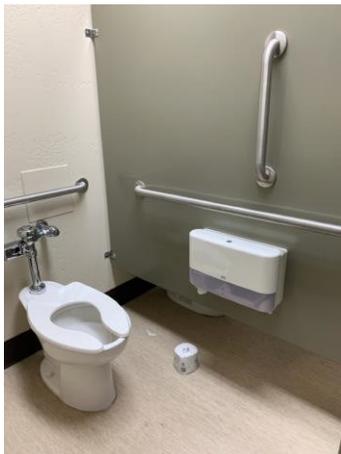
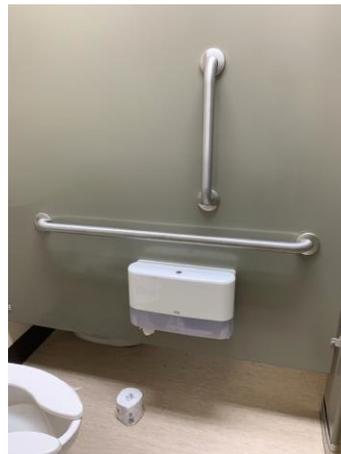
2010 ADA Standards for Accessible Design Codes §604.7

The toilet paper dispenser is located out of the accessible reach range.

Remount the toilet paper dispenser to 7" minimum and 9" maximum in front of the water closet measured to the centerline of the dispenser.

The outlet of the dispenser shall be 15" minimum and 48" maximum above the floor and shall not be located behind.

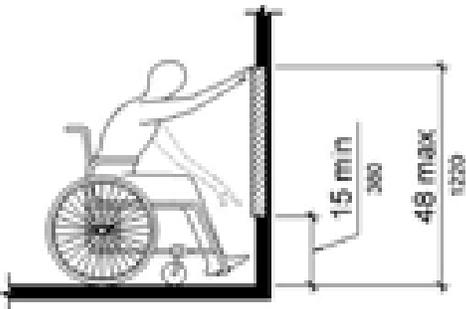
2010 ADA Standards for Accessible Design Codes §308.2.1
The paper towel dispenser is outside of the unobstructed forward reach range at 50.25" above the floor.

Lower the paper towel dispenser by 2.25" to meet the accessible reach range of 48" maximum above the floor.

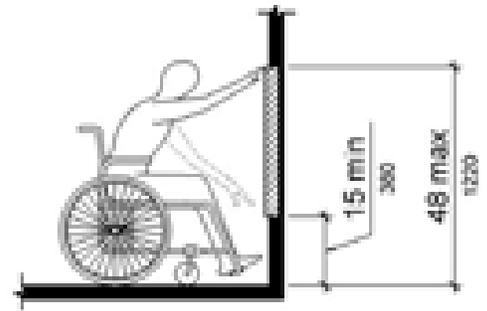
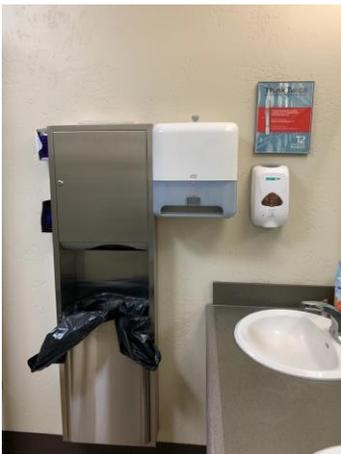
2010 ADA Standards for Accessible Design Codes §308.2.1

The soap dispenser is outside of the unobstructed forward reach range at 49" above the floor.

Lower the soap dispenser by 1" to meet the accessible reach range of 48" maximum above the floor.

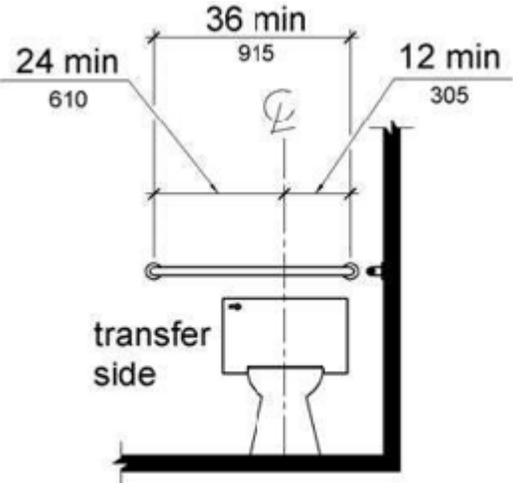
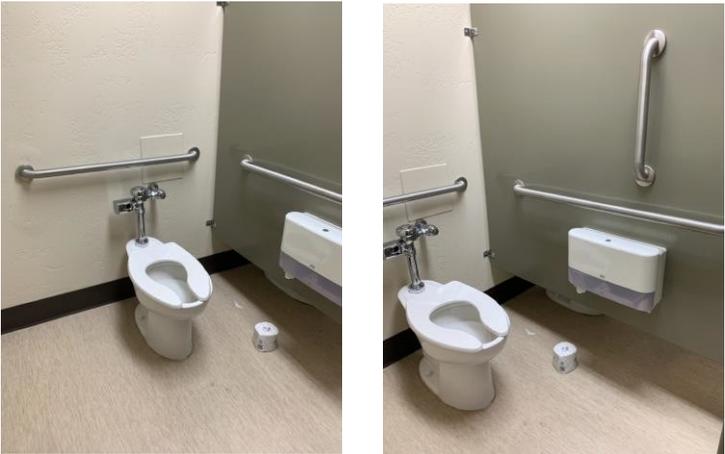
2010 ADA Standards for Accessible Design Codes §604.5.2
The rear grab bar is located 10" to the center of the toilet.

Remount the rear grab bar 12" from the centerline of the water closet minimum on one side and 24" minimum on the other.

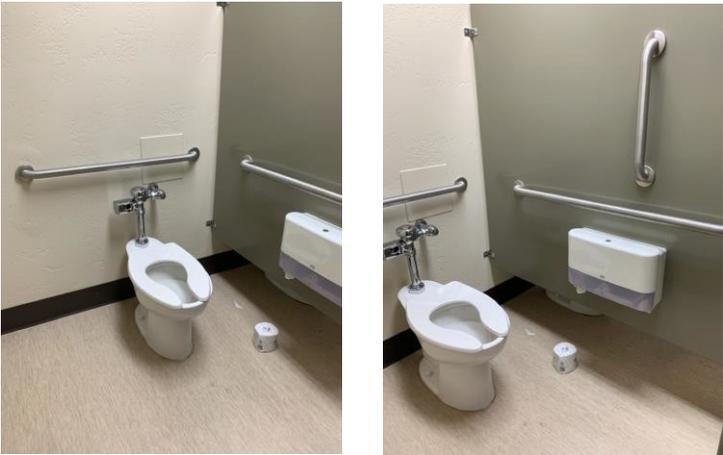
2010 ADA Standards for Accessible Design Codes §604.2
The centerline of the toilet is located 21.5" from the sidewall.

Reposition the centerline of the toilet to be within 16" minimum and 18" maximum from the sidewall.

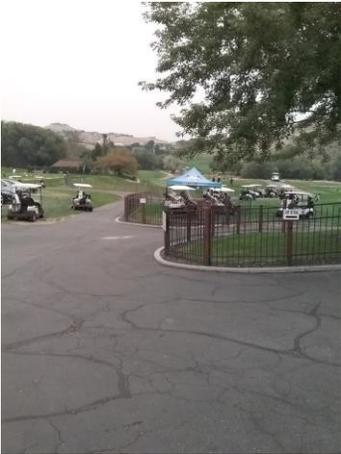
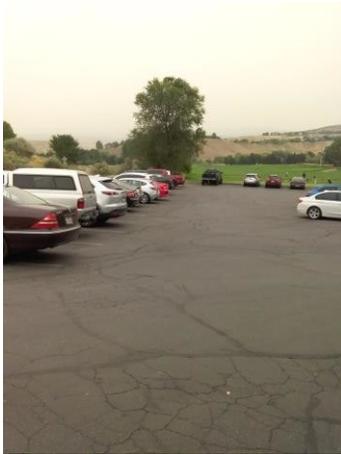
2010 ADA Standards for Accessible Design Codes §208.2
 There are no marked accessible parking spaces near the driving range or golf carts.

Install an accessible parking space that is a minimum of 96" wide. Ensure at least one accessible parking space is marked as "van" accessible.
 Install a 60" wide access aisle connecting to an accessible route. Install a sign 60" above the ground.
