City of Boise ADA
Assessment

Appendix A-Senior Citizen Center

Report #TO20-B013

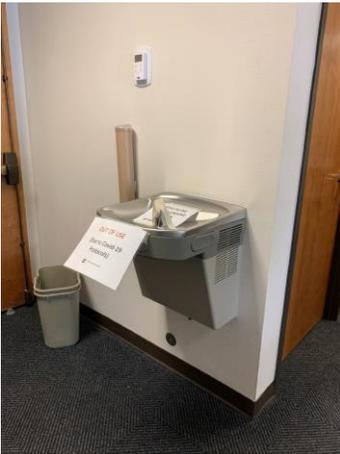
ID: 2846 **Facility:** Senior Citizen Center

2010 ADA Standards for Accessible Design Codes: §211.2, §602.4
There is only one drinking fountain provided and the spout is 38.5" above the floor.

Install an additional drinking fountain at a maximum spout height of 36" above the floor.

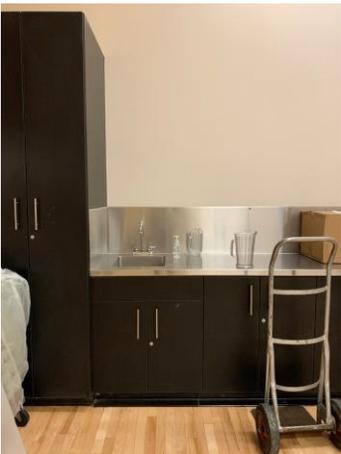
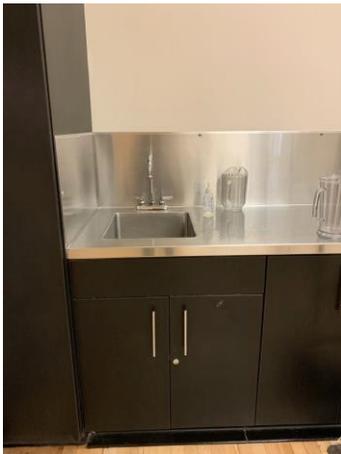
ID: 2847 **Facility:** Senior Citizen Center

2010 ADA Standards for Accessible Design Codes: §306.3.3, §902.3
The dining and work surface counter height exceeds the maximum height of 34" above the floor. There is no knee clearance underneath the sink.

A 30" portion of the dining and work surface must be no higher than 34" above the floor. Lower the sink to the maximum height of 34" above the floor.
Provide knee clearance underneath the counter at the sink that is a minimum of 11" deep at 9" above the floor and 8" deep at 27" above the floor.

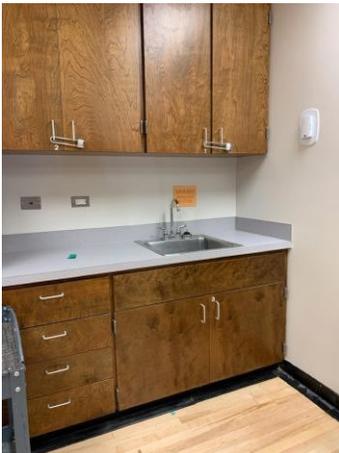
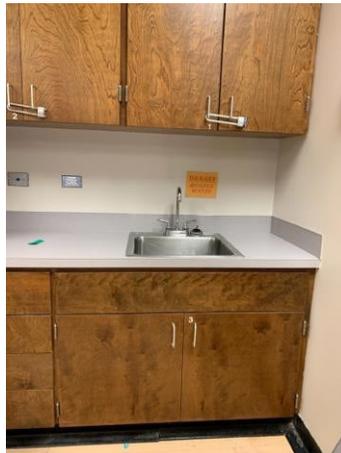
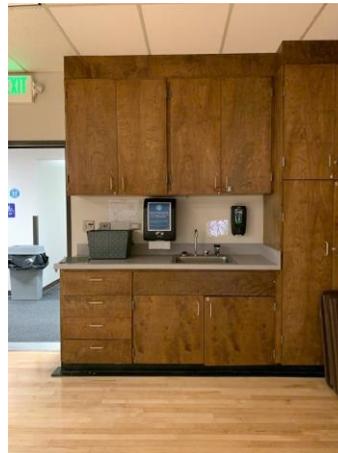
ID: 3 **Facility:** Senior Citizen Center

2010 ADA Standards for Accessible Design Codes: §306.3.3, §902.3, §606.3

The sink is 37" above the floor. The dining surface counter height is at 37" above the floor, exceeding the maximum height.

The dining surface counter height is at 37" above the floor, exceeding the maximum height.

Lower the sink to the maximum height of 34" above the floor. A 30" portion of the dining and work surface must be no higher than 34" above the floor.

Provide knee clearance underneath the counter at the sink that is a minimum of 11" deep at 9" above the floor and 8" deep at 27" above the floor.

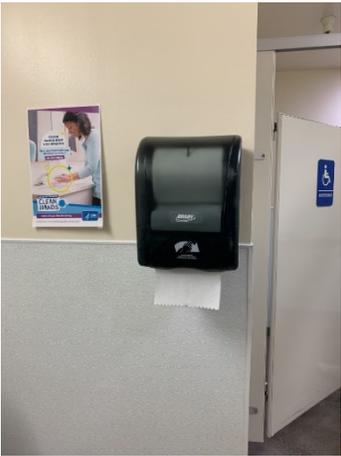
ID: 2834 **Facility:** Senior Citizen Center

2010 ADA Standards for Accessible Design Codes: §307.2
The paper towel dispenser protrudes 8.25" into the circulation space at 48" above the floor.

Recess the paper towel dispenser so it protrudes a maximum of 4", lower it so the bottom edge is 27" maximum above the floor, or place a cane detectable object beneath it.

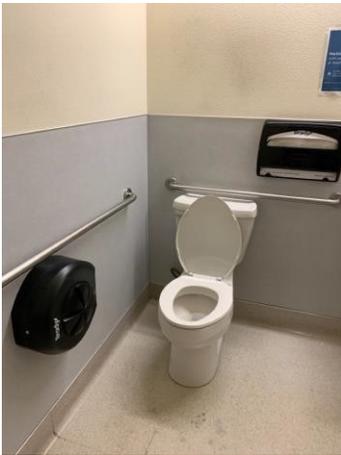
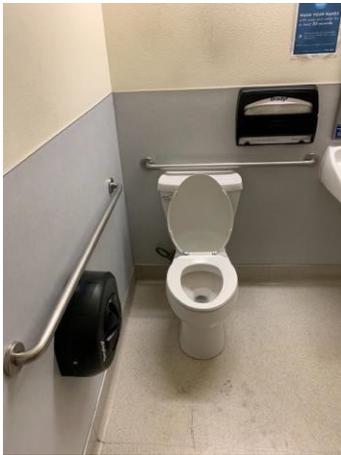
ID: 2838 **Facility:** Senior Citizen Center

2010 ADA Standards for Accessible Design Codes: §609.3
The space between the grab bar and the toilet seat cover dispenser is 4".

Relocate the toilet seat cover dispenser to a location that is at least a distance of 12" or greater away from the grab bar.
Ensure that the dispenser is at a maximum height of 48" above the floor.

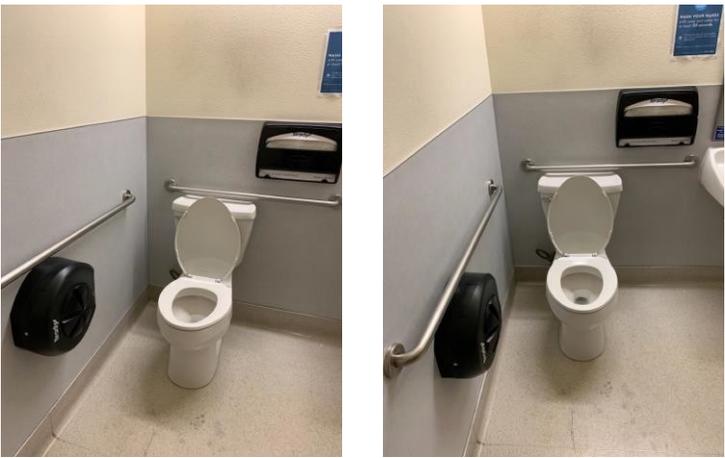
ID: 4475 **Facility:** Senior Citizen Center

2010 ADA Standards for Accessible Design Codes: ICC A117.1 §604.5.1
The accessible water closet does not have a vertical grab bar.

Install an 18" long (minimum) vertical grab bar on the side wall. The grab bar shall be mounted with the bottom located at 39" minimum and 41" maximum above the floor. The centerline of the vertical grab bar shall be 54" minimum and 58" maximum from the side wall. The centerline of the vertical grab bar shall be 42" minimum and 46" maximum from the toilet centerline. The centerline of the vertical grab bar shall be 1065" maximum from the toilet centerline.

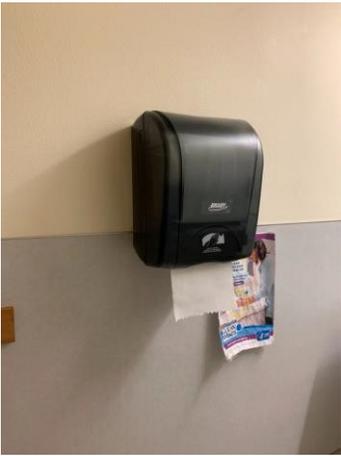
ID: 2840 **Facility:** Senior Citizen Center

2010 ADA Standards for Accessible Design Codes: §307.2
The paper towel dispenser protrudes 8" into the circulation space at 48" above the floor.

Recess the paper towel dispenser so it protrudes a maximum of 4", lower it so the bottom edge is 27" maximum above the floor, or place a cane detectable object beneath it.

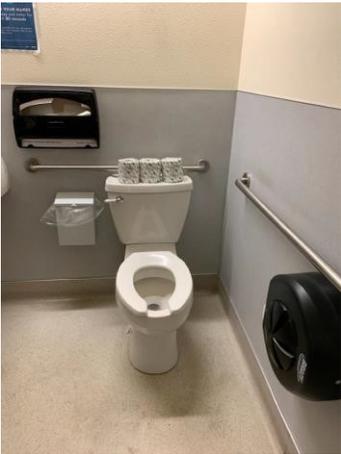
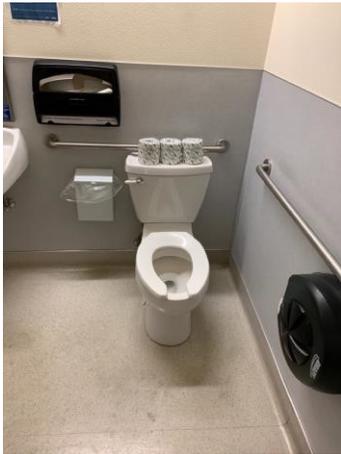
ID: 2844 **Facility:** Senior Citizen Center

2010 ADA Standards for Accessible Design Codes: §609.3
The space between the grab bar and the toilet seat cover dispenser is 4".

Relocate the toilet seat cover to a location that is at least a distance of 12" or greater away from the grab bar.

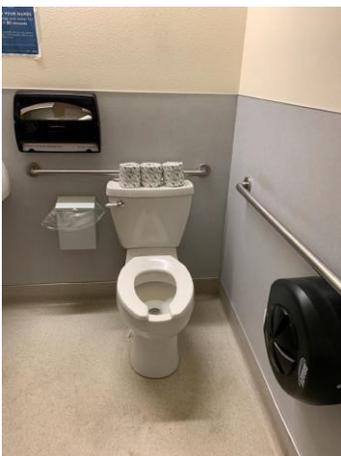
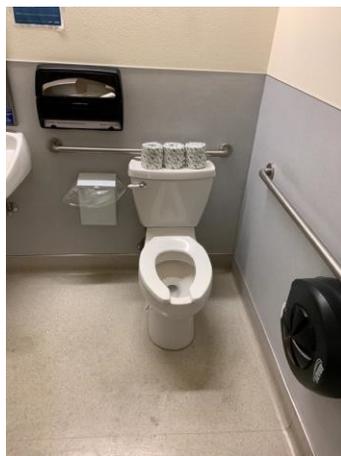
ID: 2841 **Facility:** Senior Citizen Center

The toilet is located 19" from the sidewall.

Reposition the toilet to be within 16" minimum and 18" maximum from the sidewall.

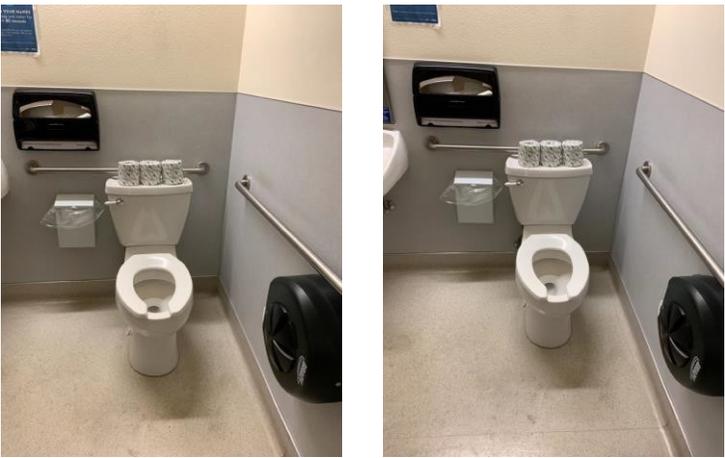
ID: 4476 **Facility:** Senior Citizen Center

2010 ADA Standards for Accessible Design Codes: ICC A117.1 §604.5.1
The accessible water closet does not have a vertical grab bar.

Install an 18" long (minimum) vertical grab bar on the side wall. The grab bar shall be mounted with the bottom located at 39" minimum and 41" maximum above the floor.

The centerline of the vertical grab bar shall be located 39" minimum and 41" maximum from the rear wall.

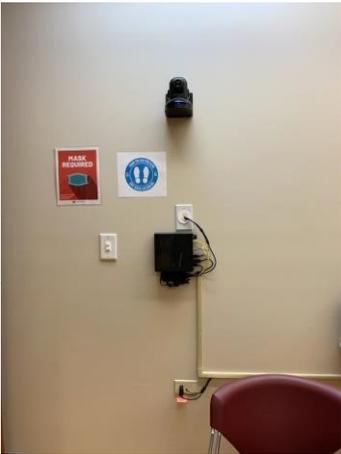
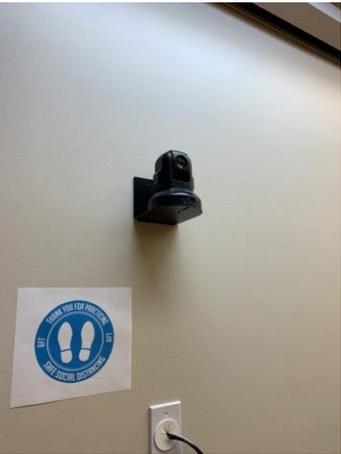
ID: 2830 **Facility:** Senior Citizen Center

2010 ADA Standards for Accessible Design Codes: §307.2
The camera protrudes 6" into the circulation space at 72" above the floor.

Recess the camera so it protrudes a maximum of 4", raise it so the bottom edge is 80" maximum above the floor, or place a cane detectable object beneath it.

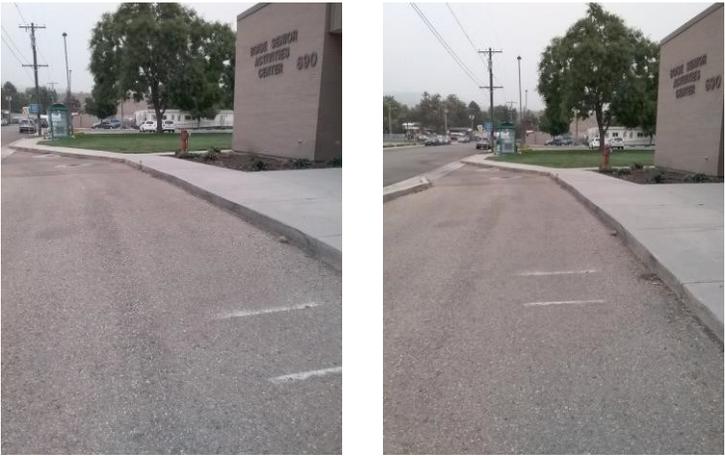
ID: 3023 **Facility:** Senior Citizen Center

There is no curb ramp to provide an accessible route from the access aisle to the accessible path. There is no access aisle.

The passenger loading zoning vehicular pull-up space does not meet the minimum dimensions required under the 2010 ADA Standards.

Install a curb ramp that is compliant with §406. Install an access aisle adjacent to the vehicle pull-up space that is 60" wide and extends the length of the space.

Expand the vehicular pull-up space to be a minimum of 96" wide and 20' long.

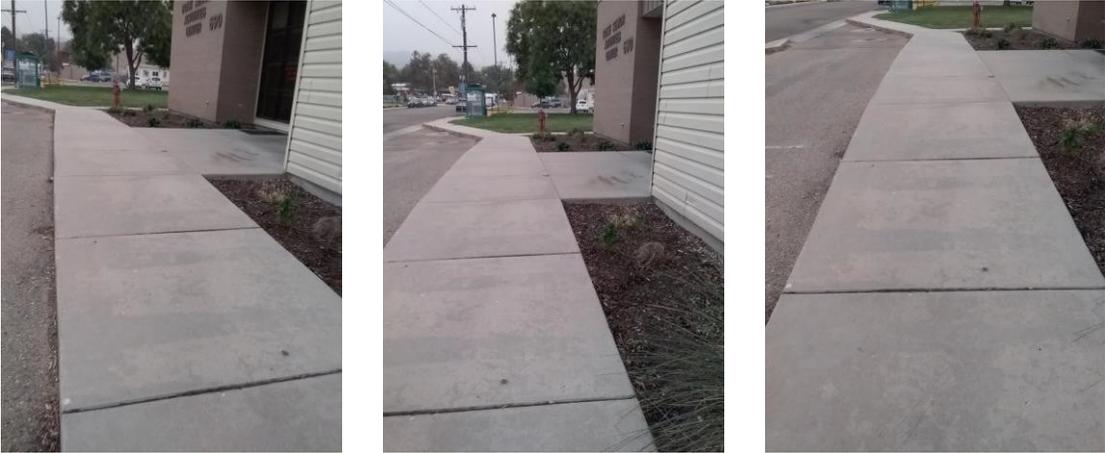
ID: 3074 **Facility:** Senior Citizen Center

2010 ADA Standards for Accessible Design Codes: §403.3
The running slope is 6.5% and the cross slope is 3%.

Reconstruct the sidewalk adjacent to the passenger loading zone to ensure that running slope and cross slope do not exceed 2% in any direction.

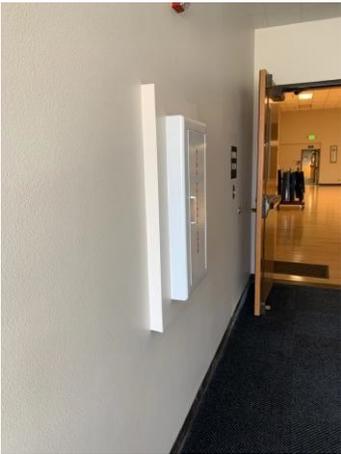
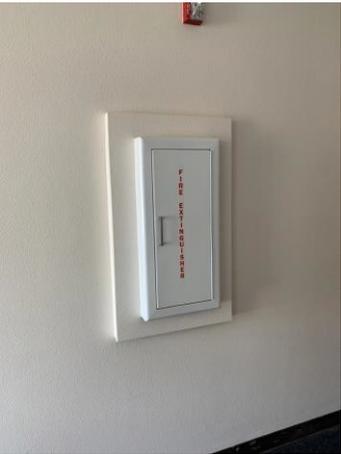
ID: 2833 **Facility:** Senior Citizen Center

2010 ADA Standards for Accessible Design Codes: §307.2
The fire extinguisher protrudes 4.5" into the circulation space at 33" above the floor.

Recess the fire extinguisher so it protrudes a maximum of 4", lower it so the bottom edge is 27" maximum above the floor, or place a cane detectable object beneath it.

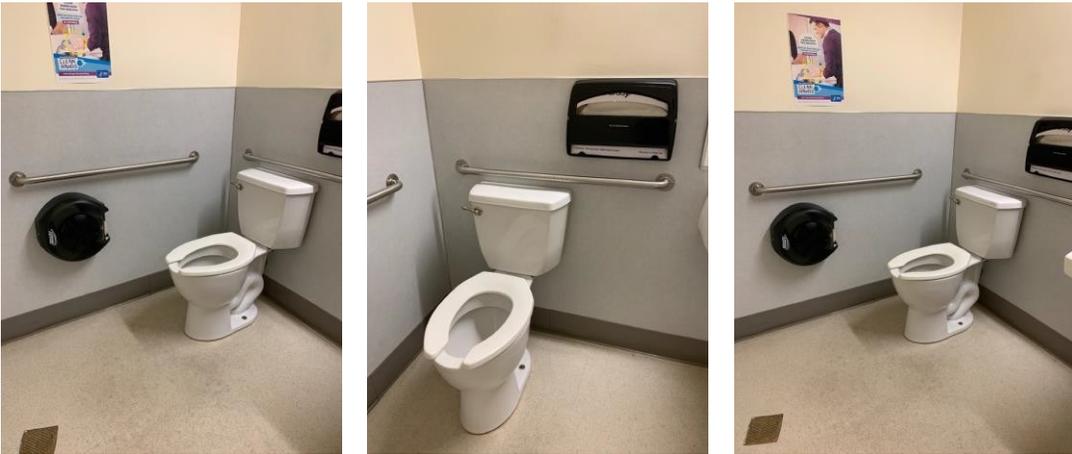
ID: 2812 **Facility:** Senior Citizen Center

2010 ADA Standards for Accessible Design Codes: §604.7
The toilet paper dispenser is located out of the accessible reach range.

Remount the toilet paper dispenser to 7" minimum and 9" maximum in front of the water closet measured to the centerline of the dispenser.
The outlet of the dispenser shall be 15" minimum and 48" maximum above the floor and shall not be located behind.

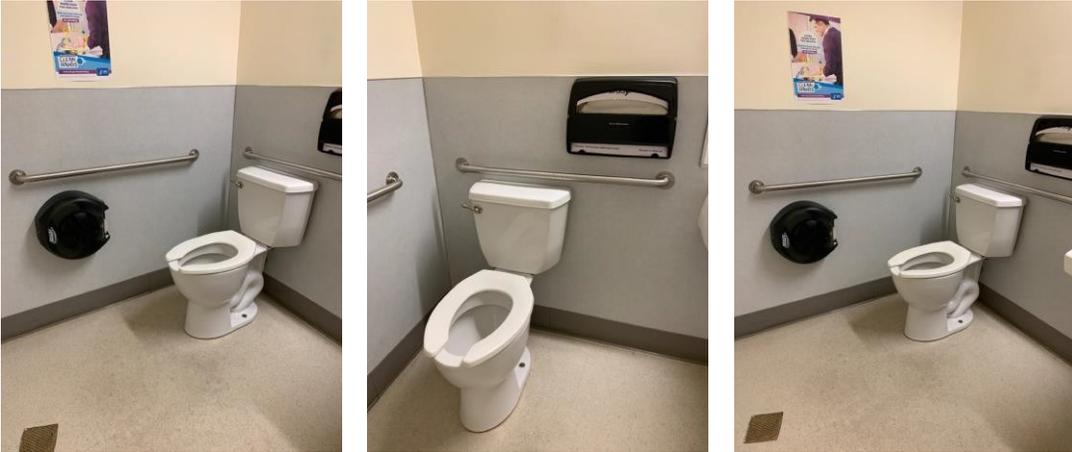
ID: 2813 **Facility:** Senior Citizen Center

2010 ADA Standards for Accessible Design Codes: §609.3
The space between the grab bar and the toilet seat cover dispenser is 4".

Relocate the toilet seat covers to a location that is at least a distance of 12" or greater away from the grab bar.

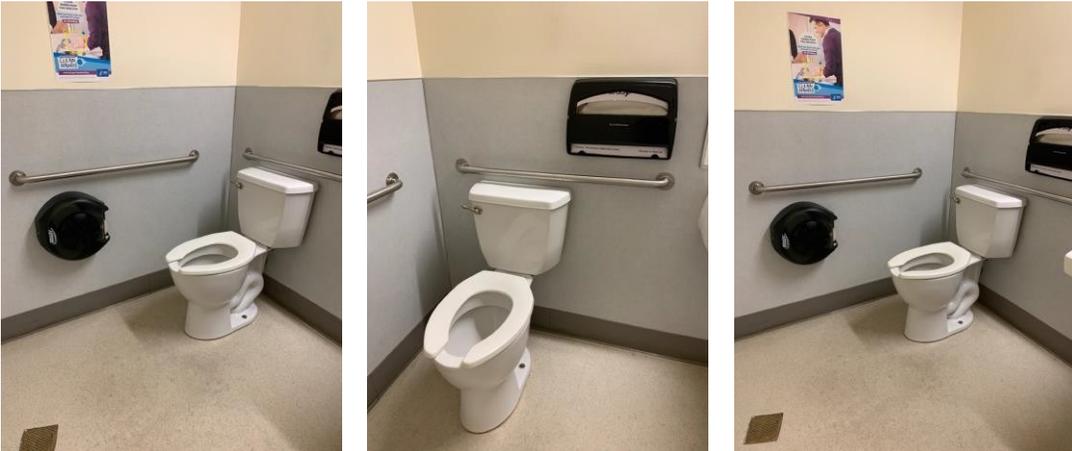
ID: 2809 **Facility:** Senior Citizen Center

2010 ADA Standards for Accessible Design Codes: §604.5.1
The side grab bar is located 11.5" from the rear wall.

Remount the side grab bar 12" maximum from the rear wall and extending 54" minimum from the rear wall.

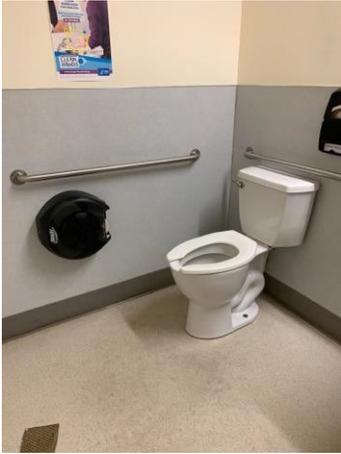
ID: 2810 **Facility:** Senior Citizen Center

The flush control is located on the wall side of the toilet.

Either make the toilet flush automatically or relocate the flush control to be operated on the open side of the toilet.

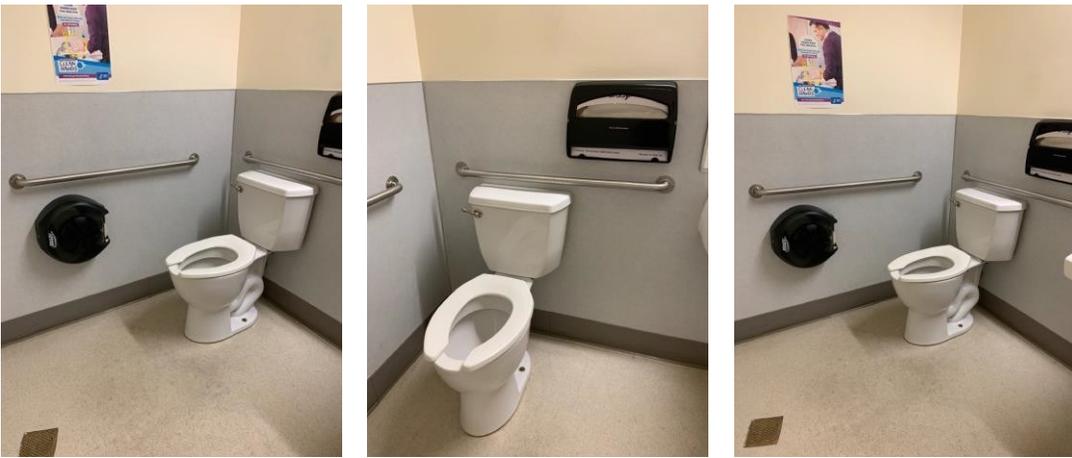
ID: 4477 **Facility:** Senior Citizen Center

2010 ADA Standards for Accessible Design Codes: ICC A117.1 §604.5.1
The accessible water closet does not have a vertical grab bar.

Install an 18" long (minimum) vertical grab bar on the side wall. The grab bar shall be mounted with the bottom located at 39" minimum and 41" maximum above the floor.
The centerline of the vertical grab bar shall be located 39" minimum and 41" maximum from the rear wall.

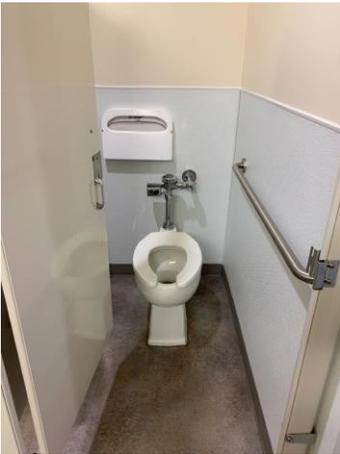
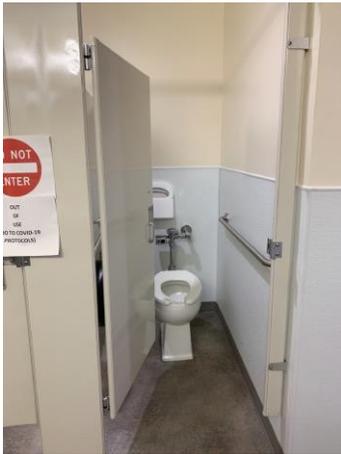
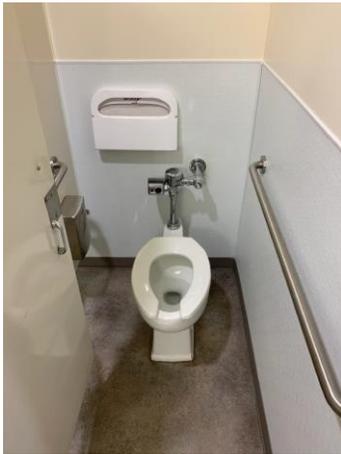
ID: 2825 **Facility:** Senior Citizen Center

2010 ADA Standards for Accessible Design Codes: §604.8.2.2
The door of the ambulatory restroom stall swings into the minimum required area.

Replace the hinges to allow for an outward swing instead of an inward swing.

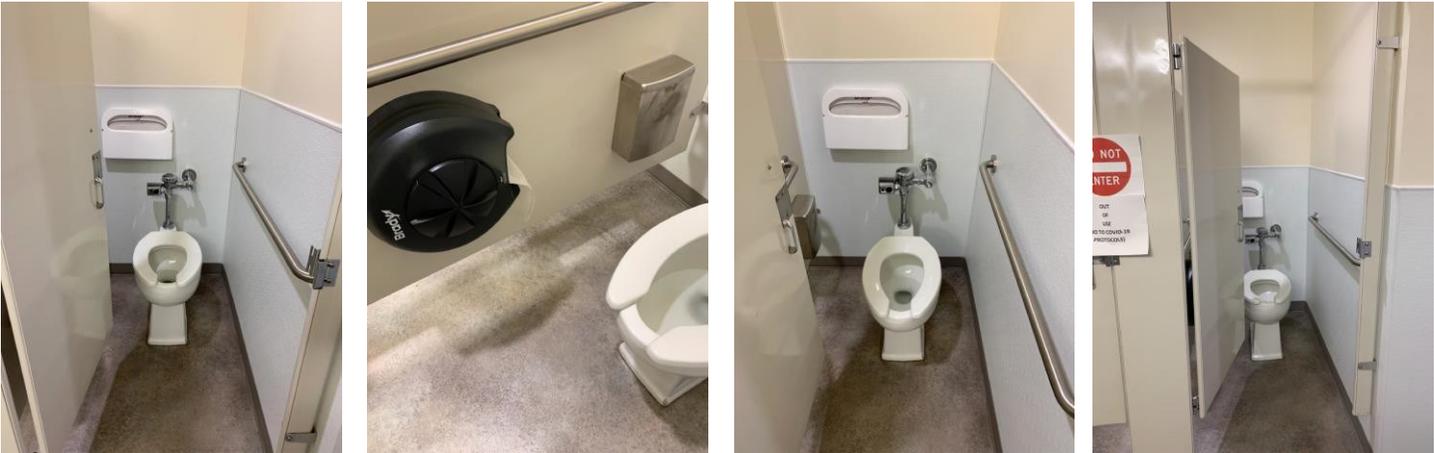
ID: 2823 **Facility:** Senior Citizen Center

2010 ADA Standards for Accessible Design Codes: §604.2
The toilet is located 20" from the sidewall.

Reposition the toilet to be within 17" minimum and 19" maximum from the sidewall.

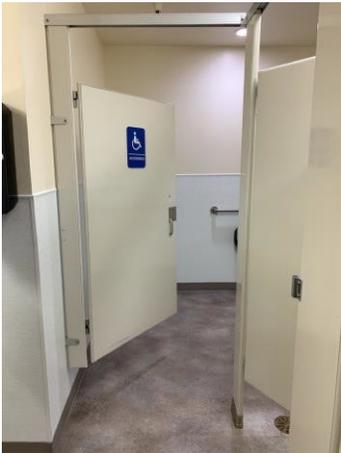
The door to the accessible water closet is not self closing. Either self-closing hinges are not installed on the door or if installed, they are defective.

Install or reinstall self-closing hinges on the door to ensure that the door is self-closing per the ADA requirements.

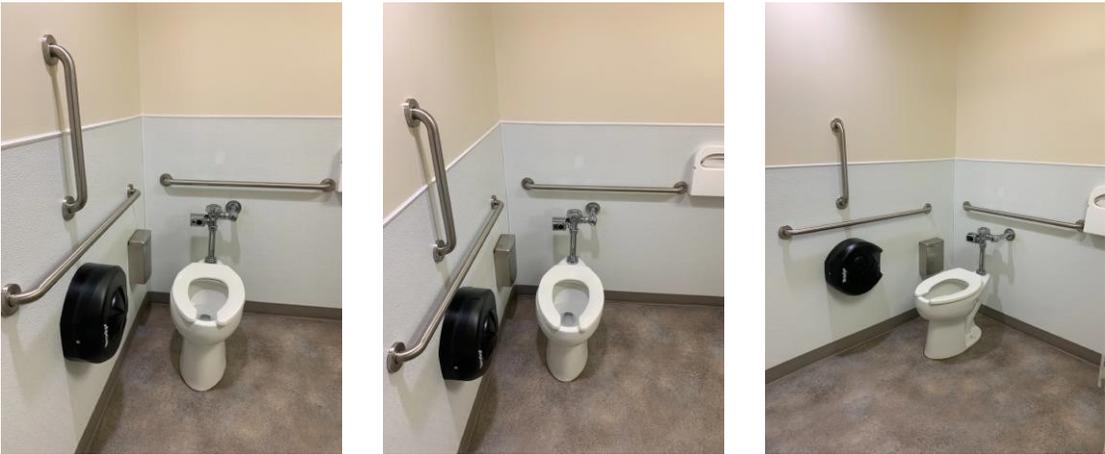
ID: 2820 **Facility:** Senior Citizen Center

2010 ADA Standards for Accessible Design Codes: §604.7
The toilet paper dispenser is located out of the accessible reach range.

Remount the toilet paper dispenser to 7” minimum and 9” maximum in front of the water closet measured to the centerline of the dispenser.
The outlet of the dispenser shall be 15” minimum and 48” maximum above the floor and shall not be located behind.

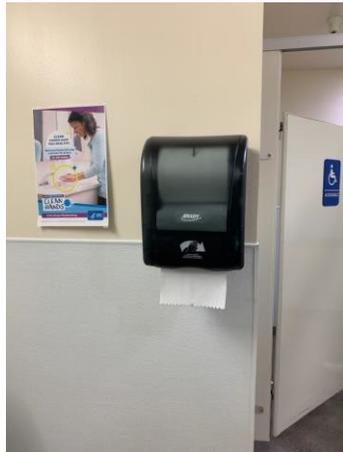
ID:2826

The paper towel dispensers protrude 8" into the circulation space at 42.25" above the floor.

Recess the paper towel dispensers so they protrude a maximum of 4" or place a cane detectable object beneath them.

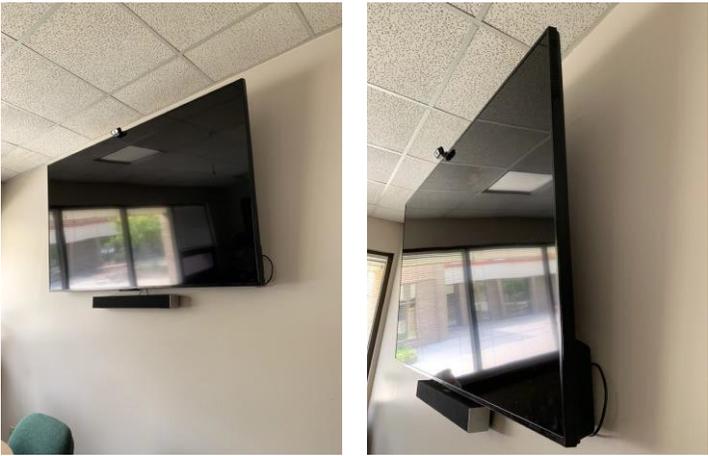
ID: 2807 **Facility:** Senior Citizen Center

2010 ADA Standards for Accessible Design Codes: §307.2
The TV protrudes 5" into the circulation space at 58" above the floor.

Recess the TV so it protrudes a maximum of 4", raise it so the bottom edge is 80" maximum above the floor, or place a cane detectable object beneath it.

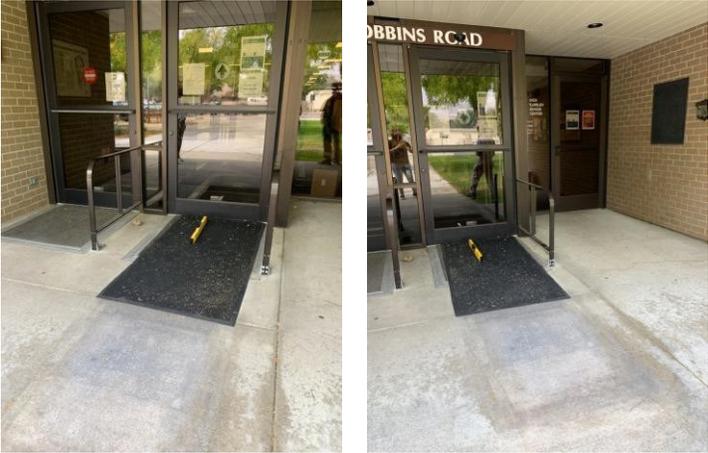
ID: 2806 **Facility:** Senior Citizen Center

2010 ADA Standards for Accessible Design Codes: §404.2.4.4, §304.2
The entrance has a 3.3% slope at the door and 2.8% slope in the turning space.

Reconstruct the entryway and the turning space to reduce the running slope to a maximum of 2% in all directions for a distance of 60".

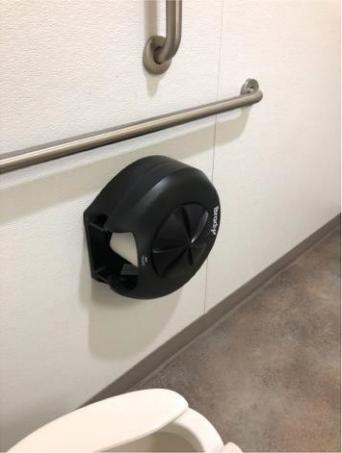
ID: 2270 **Facility:** Senior Citizen Center

2010 ADA Standards for Accessible Design Codes: General Guidance
The toilet paper dispenser is rotated 90 degrees.

For the purposes of achieving greater accessibility and Human Centric Design, rotate the toilet paper dispenser 90 degrees to the right.

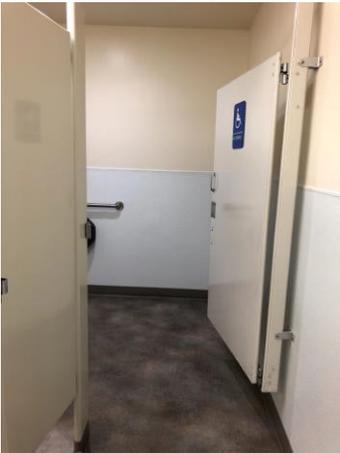
ID: 2272 **Facility:** Senior Citizen Center

2010 ADA Standards for Accessible Design Codes: §604.8.1.2
The door to the accessible water closet is not self closing. Either self-closing hinges are not installed on the door or if installed, they are defective.

Install or reinstall self-closing hinges on the door to ensure that the door is self-closing per the ADA requirements.

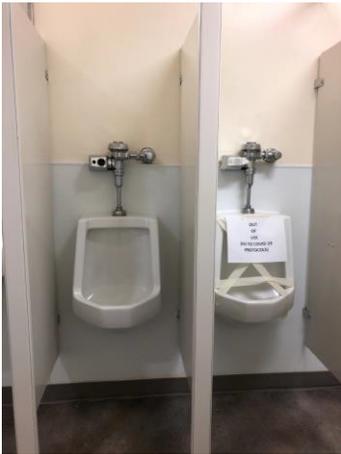
ID: 2273 **Facility:** Senior Citizen Center

2010 ADA Standards for Accessible Design Codes: §605.2
 The urinals are 24" above the floor.

Lower at least one of the urinals to a maximum height of 17" above the floor.

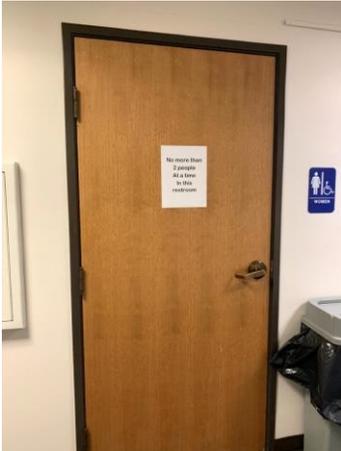
ID: 2814 **Facility:** Senior Citizen Center

2010 ADA Standards for Accessible Design Codes: §404.2.8.1
 The time required for the door to shut is 3.3 seconds.

Adjust the closing speed to a minimum of 5 or more seconds.
