City of Boise  
ADA Assessment

# Appendix A – Lander Street Water Pollution Control Facility

Report # TO21-B025

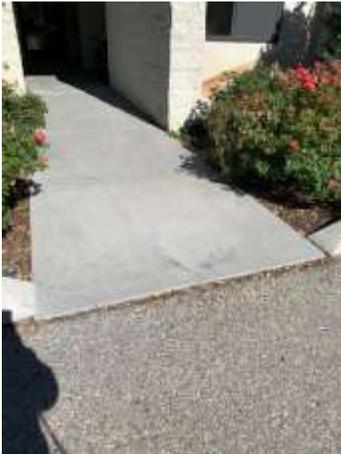
**ID:** 1554      **Facility:** Lander Street - Water Pollution Control Facility

**2010 ADA Standards for Accessible Design Codes** §303.2  
There is a change in level greater than 0.25".

Resurface the pathway to reduce the change in level to less than 0.25" or 0.5" if beveled.

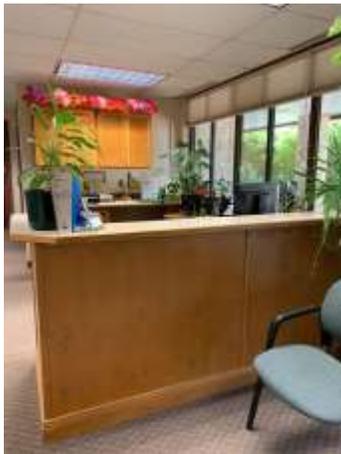
**ID:** 1555      **Facility:** Lander Street - Water Pollution Control Facility

**2010 ADA Standards for Accessible Design Codes** §904.4.1

The counter is 42" above the floor.

A portion of the service counter must be no higher than 36" above the floor for a horizontal distance of 36".

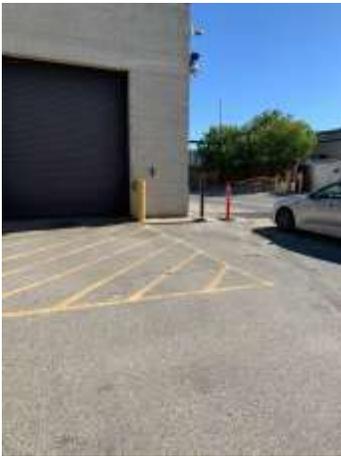
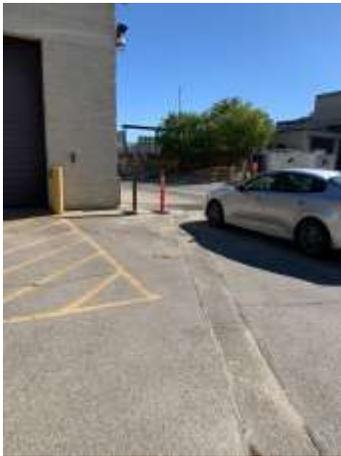
**ID:** 1553      **Facility:** Lander Street - Water Pollution Control Facility

**2010 ADA Standards for Accessible Design Codes §208.2**  
There are 27 parking spaces. None of the parking spaces are marked for accessibility.

Install two accessible parking spaces that are a minimum of 96" wide. Ensure that the accessible parking spaces are marked as "van" accessible.  
Install 60" wide access aisles connecting to an accessible route.  
Install signs 60" above the ground.

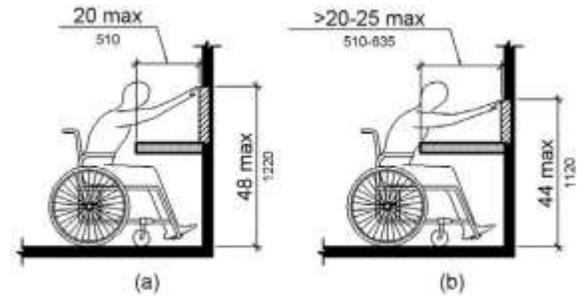
The microwaves are outside of the obstructed forward reach range at 63" above the floor.

Although the microwaves are too high to be accessible, since they are not permanently mounted, they are acceptable in their current location. However, one must be lowered if requested by a qualified employee.

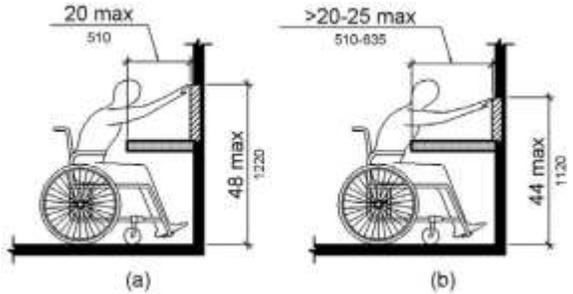
**2010 ADA Standards for Accessible Design Codes §308.2.2**  
The paper towel dispenser is outside of the obstructed forward reach range at 51.5" above the floor.

Lower the paper towel dispenser by 7.5" to meet the accessible reach range of 44" maximum above the floor.

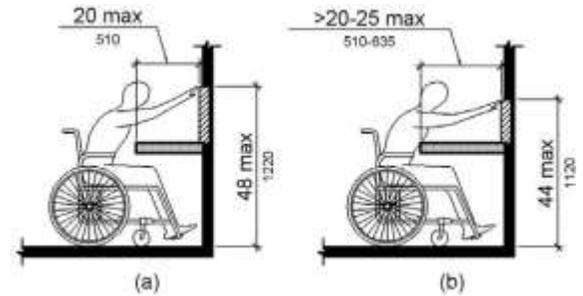
The soap dispenser is outside of the obstructed forward reach range at 64" above the floor.

Lower the soap dispenser by 20" to meet the accessible reach range of 44" maximum above the floor.

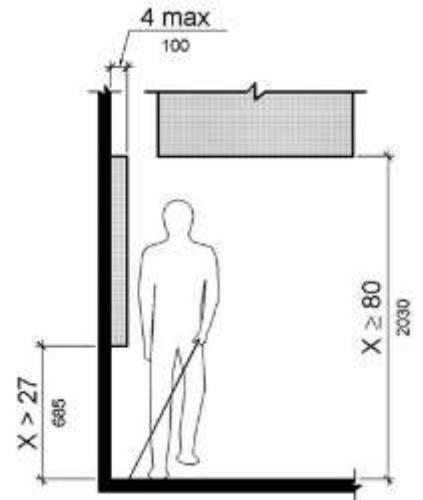
The computer box protrudes 5.25" into the circulation space at 32" above the floor.

Recess the computer box so it protrudes a maximum of 4" or place a cane detectable object beneath it.

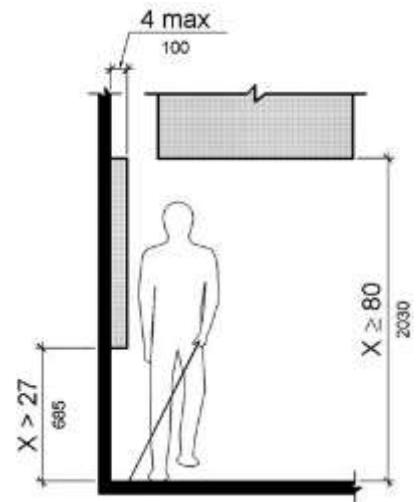
The TV protrudes 4.75" into the circulation space at 51" above the floor.

Recess the TV so it protrudes a maximum of 4", raise it so the bottom edge is 80" maximum above the floor, or place a cane detectable object beneath it.

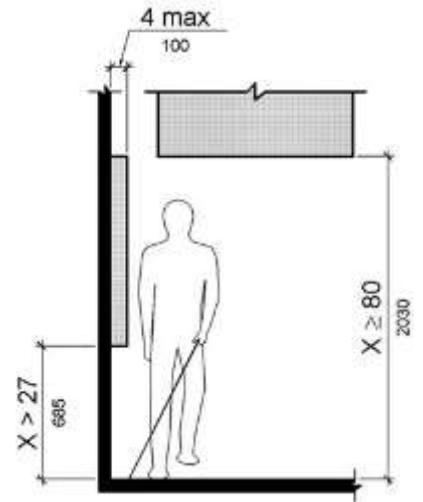
The first aid box protrudes 5" into the circulation space at 41.5" above the floor.

Recess the first aid box so it protrudes a maximum of 4" or place a cane detectable object beneath it.

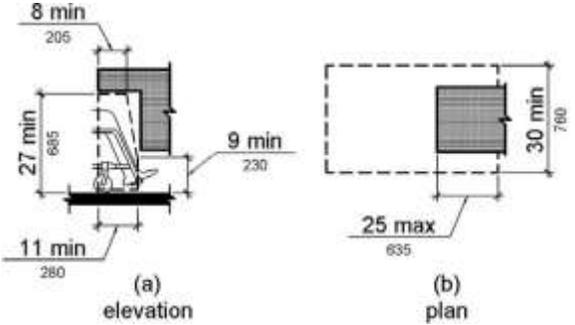
**2010 ADA Standards for Accessible Design Codes** §902.3, §606.3, §306.3.3  
There is no knee clearance underneath the sink.  
The dining and work surface counter is 36" above the floor. The sink is 36" above the floor.

Provide knee clearance underneath the counter at the sink that is a minimum of 11" deep at 9" above the floor and 8" deep at 27" above the floor.  
A portion of the dining and work surface must be no higher than 34" above the floor. Lower the sink to the maximum height of 34" above the floor.

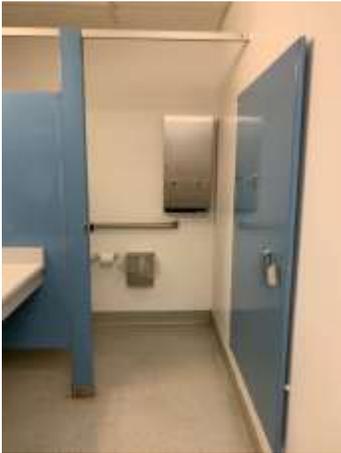
**2010 ADA Standards for Accessible Design Codes §604.8.1.2**  
The door to the accessible water closet is not self closing. Either self-closing hinges are not installed on the door or if installed, they are defective.

Install or reinstall self-closing hinges on the door to ensure that the door is self-closing per the ADA requirements.

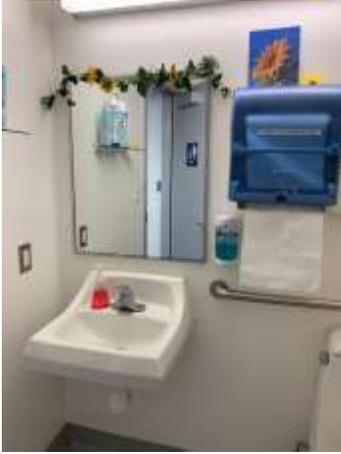
**2010 ADA Standards for Accessible Design Codes §603.3**  
The mirror is too high to be accessible at 40.5" above the floor.

Lower the mirror so its bottom edge is a maximum height of 40" above the floor.

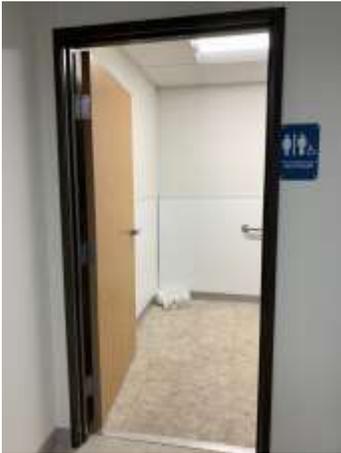
**2010 ADA Standards for Accessible Design Codes §604.8.1.2**  
The door to the accessible water closet is not self closing. Either self-closing hinges are not installed on the door or if installed, they are defective.

Install or reinstall self-closing hinges on the door to ensure that the door is self-closing per the ADA requirements.

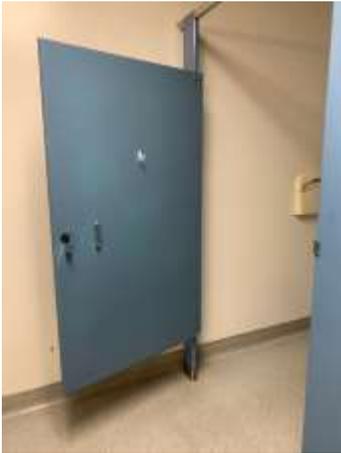
**PHOTOGRAPH(S) OF THIS LOCATION**

The door to the accessible water closet is not self closing. Either self-closing hinges are not installed on the door or if installed, they are defective.

Install or reinstall self-closing hinges on the door to ensure that the door is self-closing per the ADA requirements.
