# **Boise Parks and Recreation Department Stewardship Plan For the Riparian Corridor from Barber Park to Glenwood Bridge**

**Final  
October 2002**

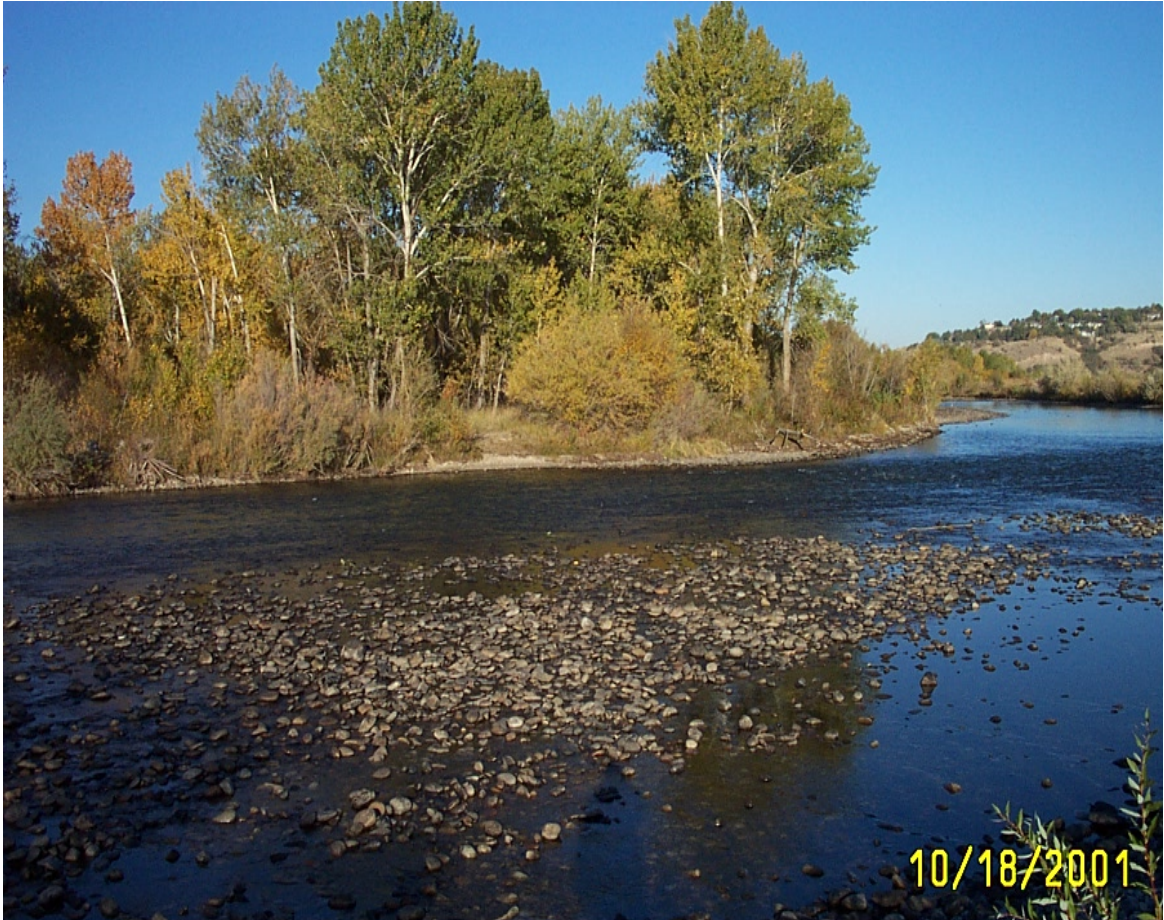
Photo 1: Cover Type 2, Background

Cover type 2 consists of mature cottonwoods over 6 m in height, with a diameter at breast height (dbh) greater than 25 cm. There may be young conifers that have not reached the forest canopy, or they may be entirely devoid of conifers. Shade controls the understory, which generally consists of shade-tolerant species or remnant vegetation that is being outcompeted by the dominant overstory trees. Maples occupied as much as 10 percent of the canopy in the study area. Woody debris of all sizes was found on the ground, which helps develop soils. This cover type provides horizontal cover above from its canopy and vertical cover from trunks and stems. Large mammals, such as deer, use these areas. Songbirds use the ground and various levels of canopy; and heron, owls, and raptors use the area for nesting and perching sites. Larger, more secluded areas are used by wintering bald eagles. This cover type represents the most mature riparian community. Mature riparian habitat cycles

nutrients, builds viable soils, and provides shade for the river that reduces water temperature and provides large woody debris to shape and create the river's unique habitat for fish and aquatic insects. Because it is the most mature stage of the riparian community, it is also the most difficult to reestablish. Mature cottonwoods serve as a measure of a systems health.

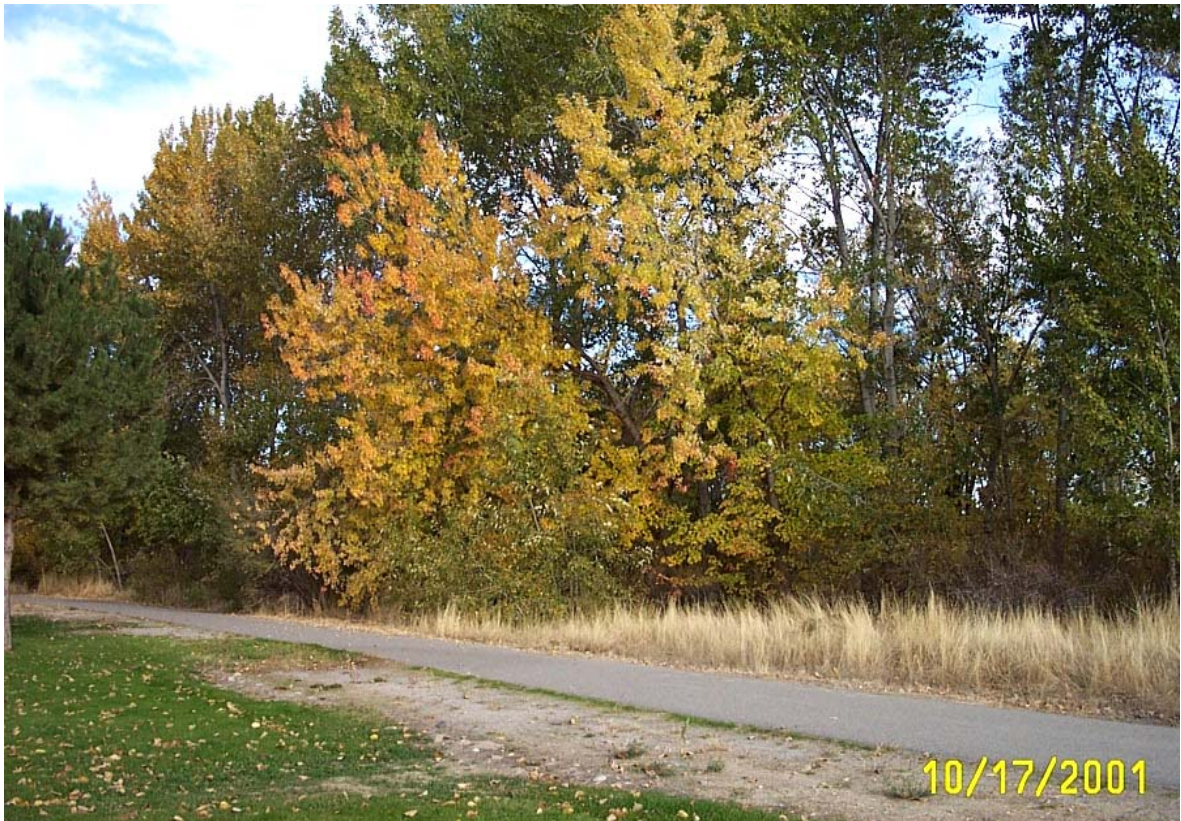
Photo 2: Cover Type 2a

Cover type 2a has mature cottonwoods greater than 6 m in height, with a dbh over 25 cm. It separates the river from park lands and developed areas. Since it is an "edge" and narrow in width, it contains a denser understory due to the availability of sunlight and water. These areas contain great plant diversity and a high percentage of non-native species because of their proximity to developed areas. This cover type functions as a buffer between the river and developed upland areas. It provides many of the same functions as cover type 2 (see paragraph 2.3.2). It cycles nutrients and builds viable soils, shades the river and reduces temperature, and provides large woody debris to shape and create the river's unique habitat for fish and aquatic insects. It also functions as a corridor, allowing fauna to move upstream and downstream and between large areas of habitat that provide life-cycle requirements. Aesthetically and biologically, it is a critical habitat for the park.

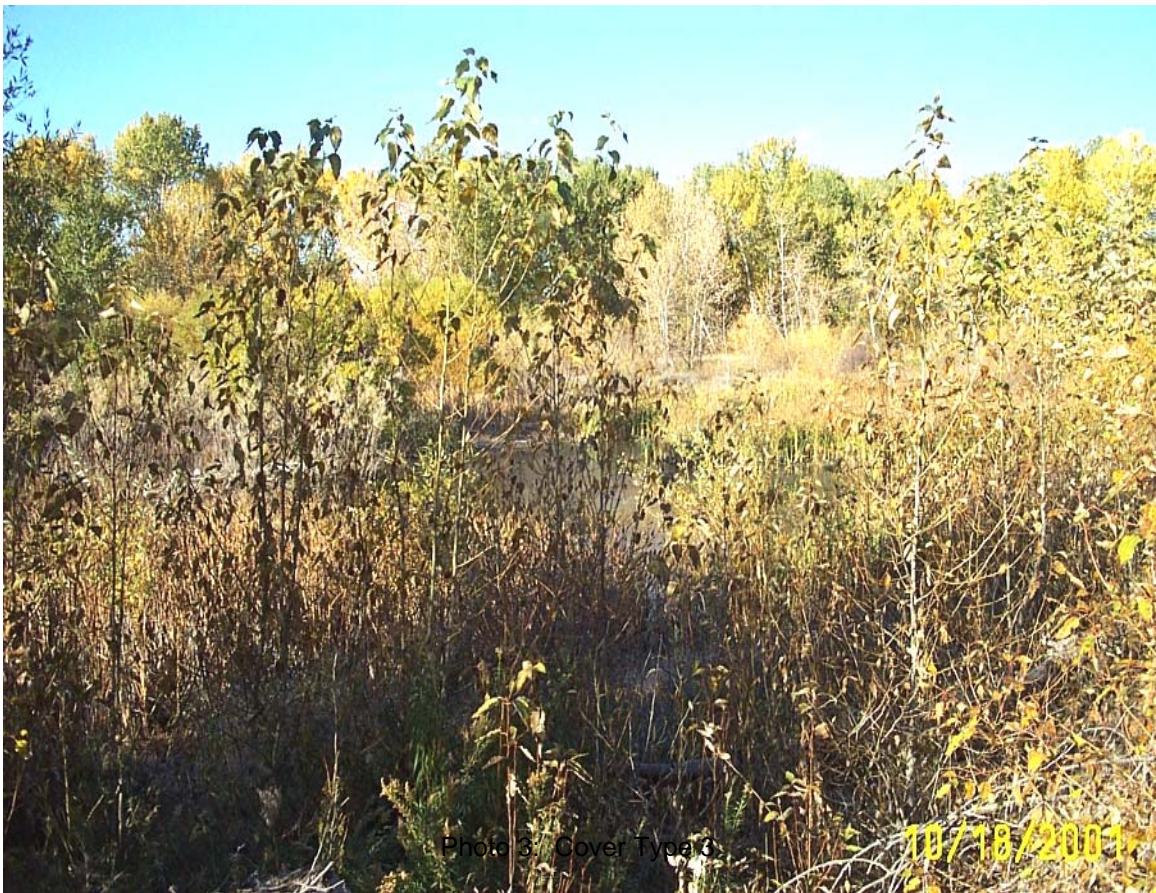
Photo 3: Cover Type 3

Cover type 3 provides immature pole cottonwood 2 to 6 m in height and less than 25 cm in dbh. It may also include a mixture of willow. Soils are generally cobble dominated, with fine sediments accumulating over the surface. This is an intermediate phase of floodplain development. Willow and cottonwood seedlings colonize newly eroded or deposited sediments. Herbaceous cover may occupy all or portions of the remaining exposed area. Willows are the first species to become established, and provide sediment traps to build soils. When conditions are favorable, cottonwoods gain control of the overstory and shade out competition. This cover type protects floodplain surfaces from erosion. Dense cottonwood stands with mixed shrubs and herbaceous cover provide excellent winter browse for big game (*i.e.*, deer and moose). Small mammals find refuge in the dense cover, and birds feed on seeds and insects.

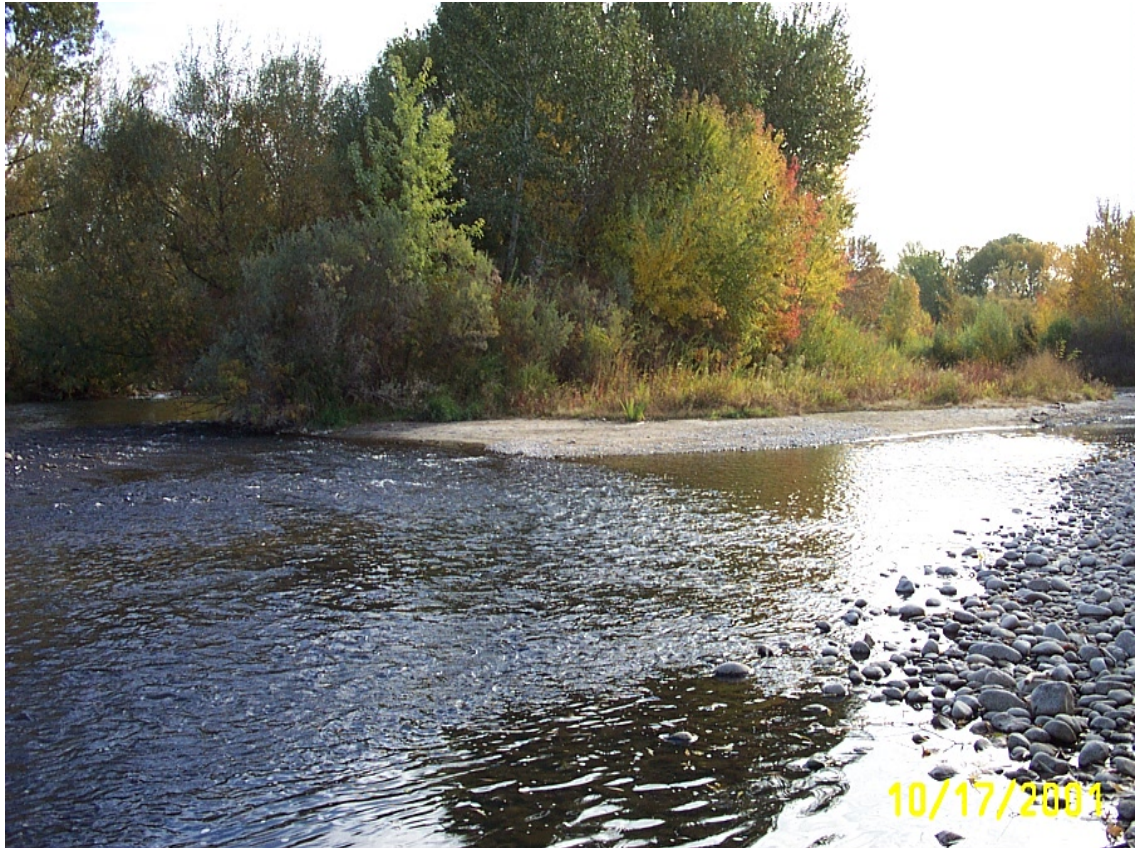
Photo 4: Cover Type 4

Cover type 4 consists of cottonwood or willow seedlings up to 2 m in height. Substrate soils often have exposed cobbles, but may also include deposited fines from flooding. Generally, soils are unstained by organics, thus indicating very early soil development. This cover type can develop within one growing season and be destroyed the next, but it will usually exist over several years with its growth dependent on moisture. Dry years will thin the stand, allowing other plants to grow larger. If protected from erosion, it may develop into cover type 3.

This habitat provides cover for fauna, but only limited food. It provides important escape cover for young birds (e.g., ducks) and even mammals (e.g., deer). Its most important function is trapping debris and sediments. This is the phase that separates herbaceous cover from woody riparian cover.

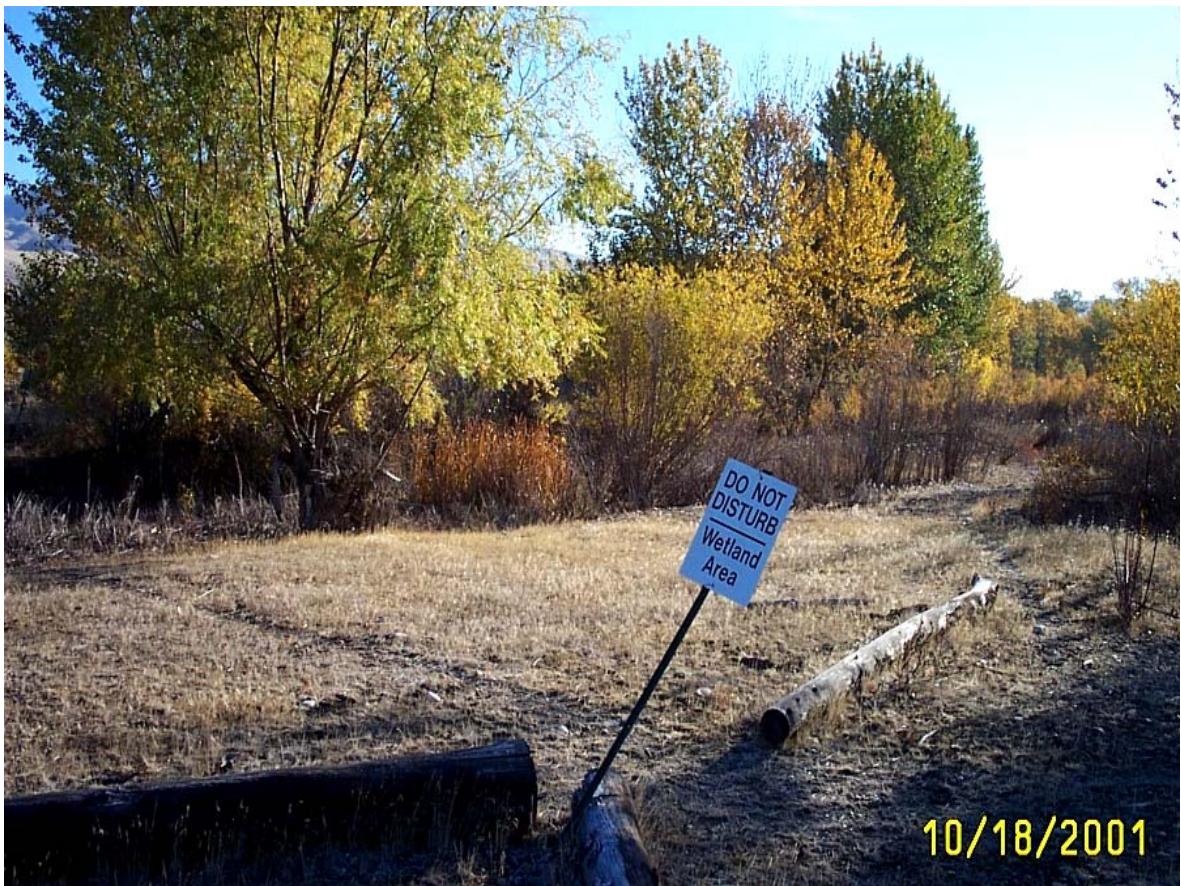
Photo 5: Cover Type 5

This cover type consists of filled and partially-filled abandoned channels dominated by mixed willows, alders, and shrubs, and interspersed with herbaceous cover. Cover type 5 is often the dominant cover type along the edge of backwaters. Soils are generally composed of deeper fines and development of a top soil horizon. These areas provide the greatest diversity and very high productivity, and are commonly referred to as shrub scrub or emergent wetlands. Settling organic matter is deposited in a hydric, or season-moist, environment. Depositing sediments usually provide a good seed bank for species found upstream. These are the herbaceous plants that provide important sources of nutrients. Shrubs, like alder, are nitrogen fixing and free nutrients for other terrestrial and aquatic plants. Shrubs, like silverberry, provide valuable food sources. Many of the floodplains mammals and birds use these areas for feeding. These areas will eventually progress to form the richest woody riparian plants due to their deep organic silts and water supply.

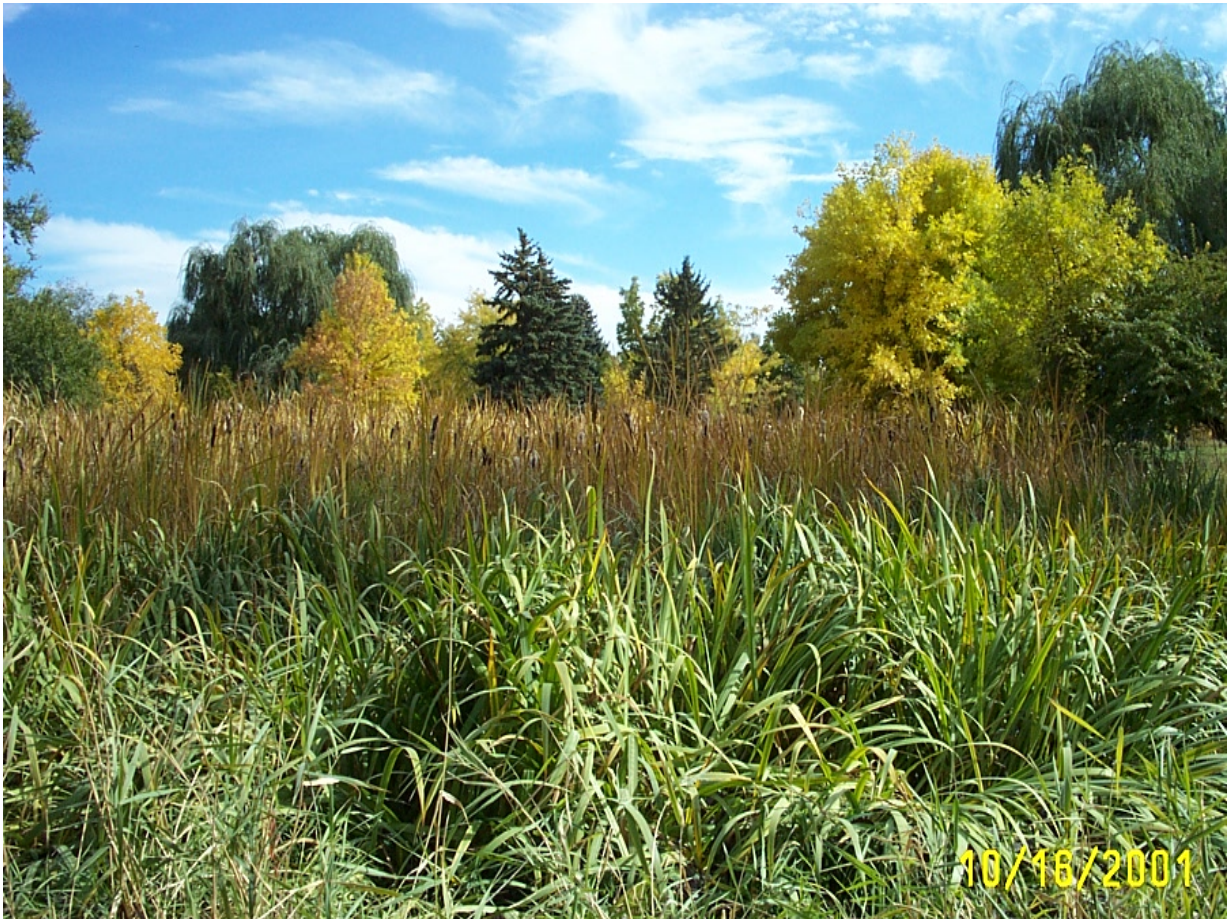
Photo 6: Cover Type 6

Herbaceous vegetation dominates cover type 6, but may have up to 10-percent shrub cover. This cover type is often associated with a naturally-filled side channel or abandoned back channel, but may also include non-depressional surfaces. It may be dominated by emergent vegetation, such as cattails or wet meadow-type grass and sedge. This cover type is very productive, and provides a wide range of wildlife value. If the area contains small pockets of open water, submergent and floating plants (e.g., duck weed), which are necessary to sustain a wide diversity of waterfowl, may be present. Water quality is enhanced by nitrate and phosphate cycles.

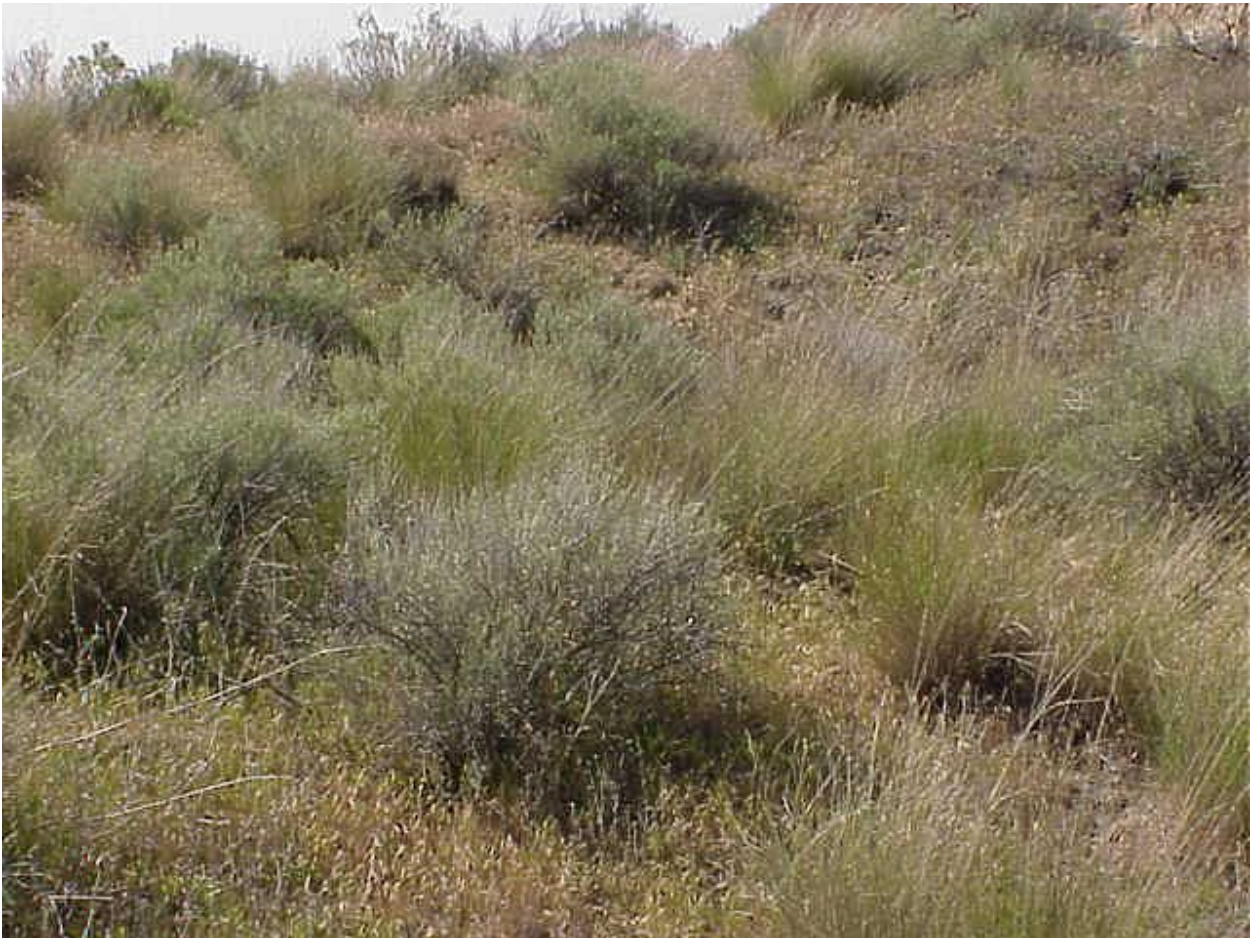
Photo 7: Cover Type 6a

Cover type 6a consists primarily of herbaceous vegetation (e.g., grasses) with dryland shrubs (i.e., rabbitbrush and sagebrush). This cover type is often associated with natural terraces which have not been altered by river flows. It is also associated with manmade fills that raise surface areas above the area influenced by river hydrology. This area receives moisture only from precipitation, not from surface or subsurface flows. This cover type adds species diversity and is extremely sensitive to surface impacts such as bicycles or foot traffic. Prairie grasses are critical for small mammals and seed-eating birds.

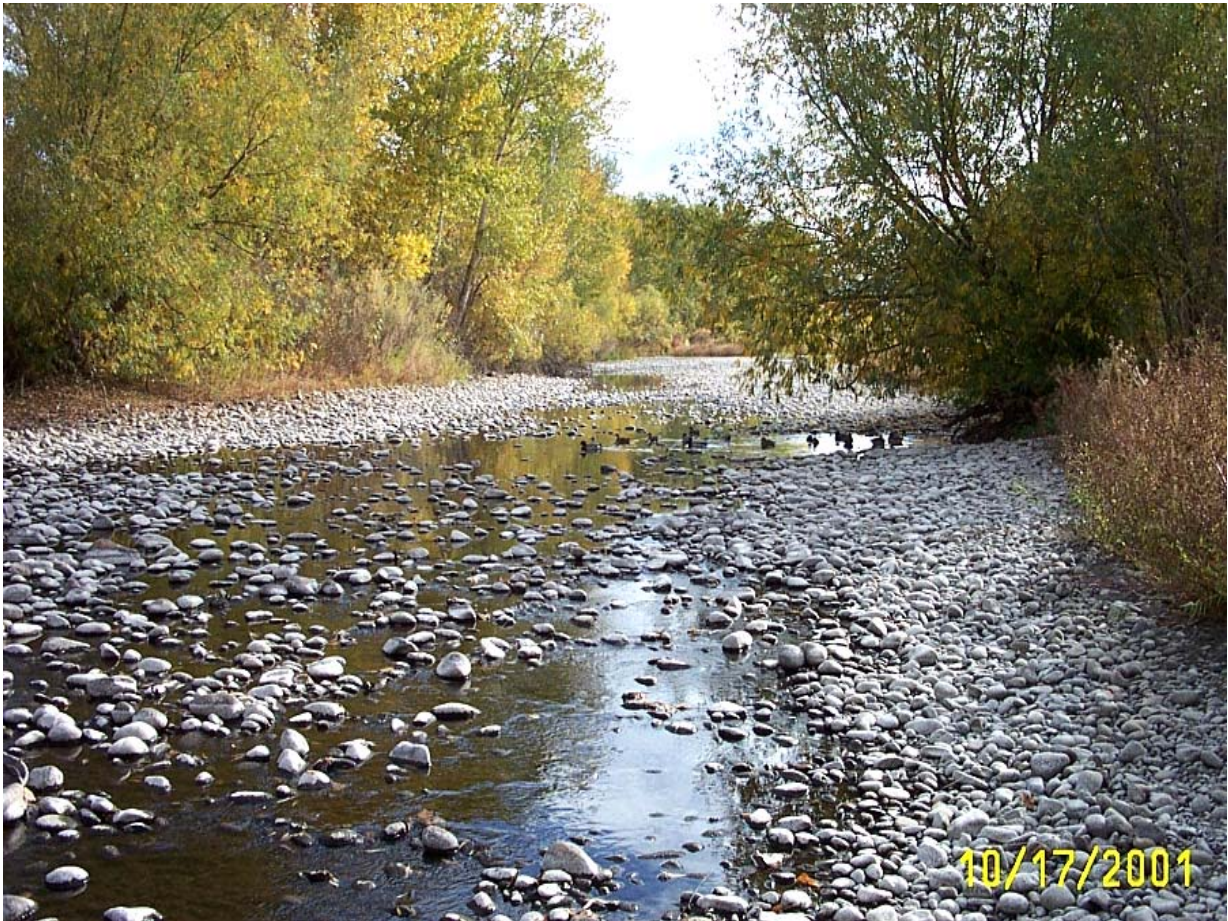
Photo 8: Cover Type 7

Cover type 7 has exposed cobble riverbed during base flow, which is inundated during most annual high flows. There may be very sparse herbaceous vegetation or an occasional cottonwood or willow seedling, composing less than 10 percent of the cover. These areas are usually well armored, and cause directional changes in flow. Exposed cobble shoals are used by waterfowl for resting and molting, and provide a good view of approaching predators.

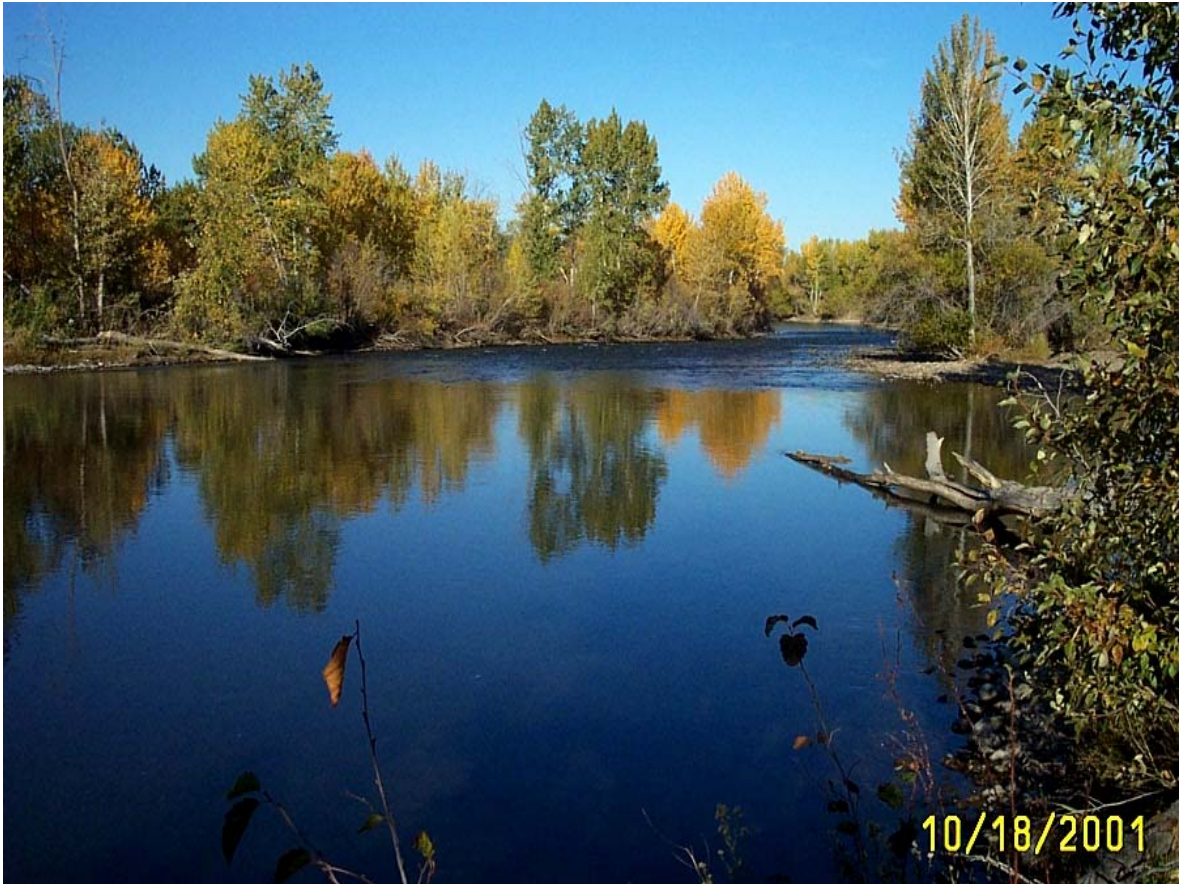
Photo 9: Cover Type 8

Cover type 8 consists of a main-channel surface during base flow, and may be single channel or braided with islands. Healthy, natural channels, as displayed in photo 9, consist of pools and riffles, have diverse vegetated shoreline, and contain woody debris. They may have small or large secondary channels. The channel depicted in the photo is a natural channel located in the vicinity of Barber Park. Many channel sections below the Warm Springs Golf Course have been channelized and, therefore, do not provide the same fisheries values as natural sections.

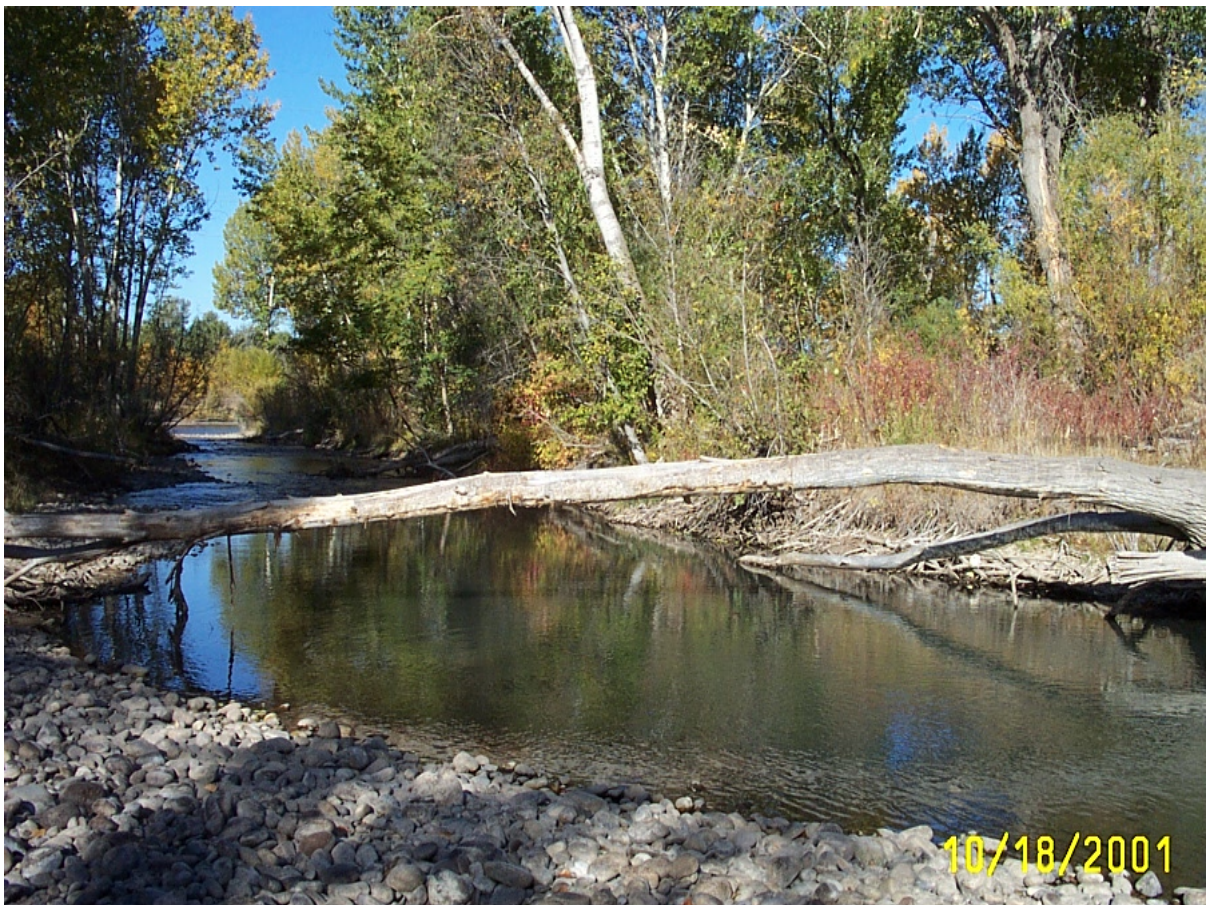
Photo 10: Cover Type 9

Cover type 9 provides off-channel water at the surface during base flow. This includes spring brooks, oxbows, scour depressions and ponds, and non-flowthrough downstream connected side channels and disconnected side channels. These are special habitats that provide a diversity of unique environments. Spring brooks or creeks are often spawning and rearing habitat for fish, such as cutthroat, brook, rainbow, and brown trout. Because these areas are fed by groundwater, they tend to maintain relatively constant temperatures. Quite often, they remain ice free, even in subfreezing temperatures. The constant high-quality water serves as a nursery area for many species of fish. Waterfowl seek out these areas when other waterways are frozen. The rich water provides many species of aquatic plants and benthic insects.

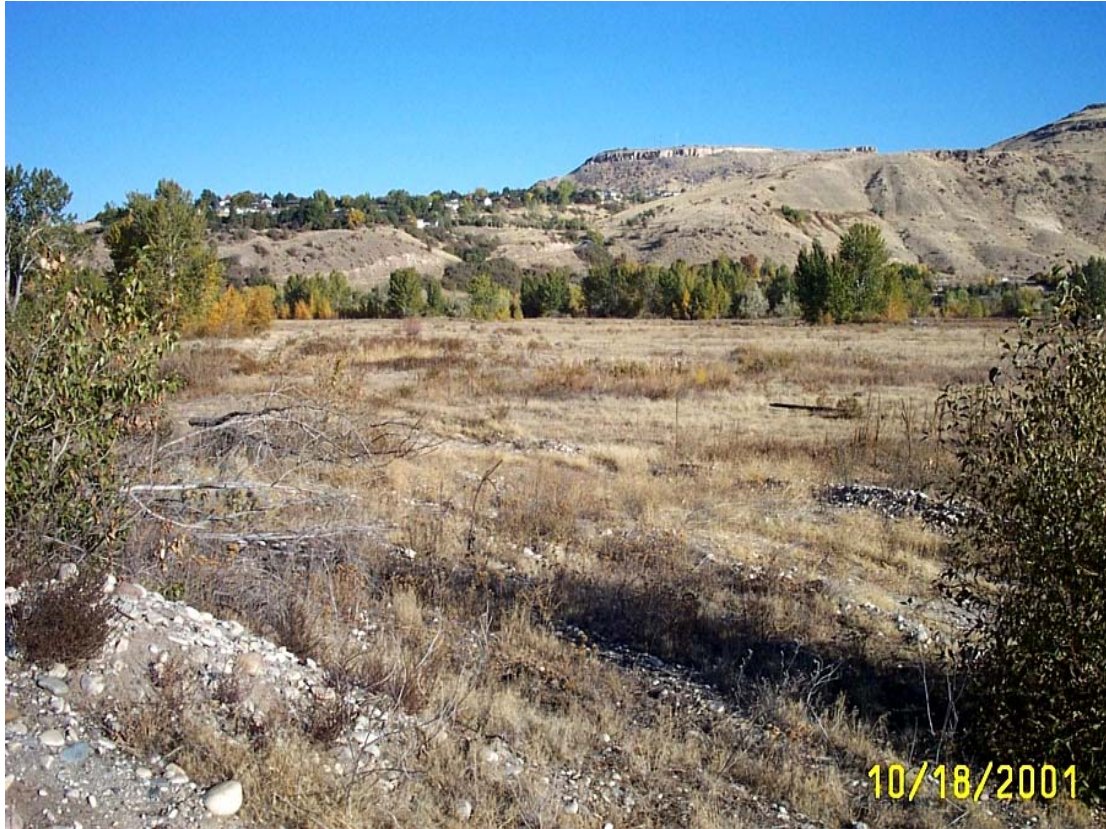
Photo 11: Cover Type 10

Agricultural field, cover type 10, may be a meadow or plowed, and are often planted and hayed. These areas may have originally been forested areas that were logged, or they may have been a natural meadow.

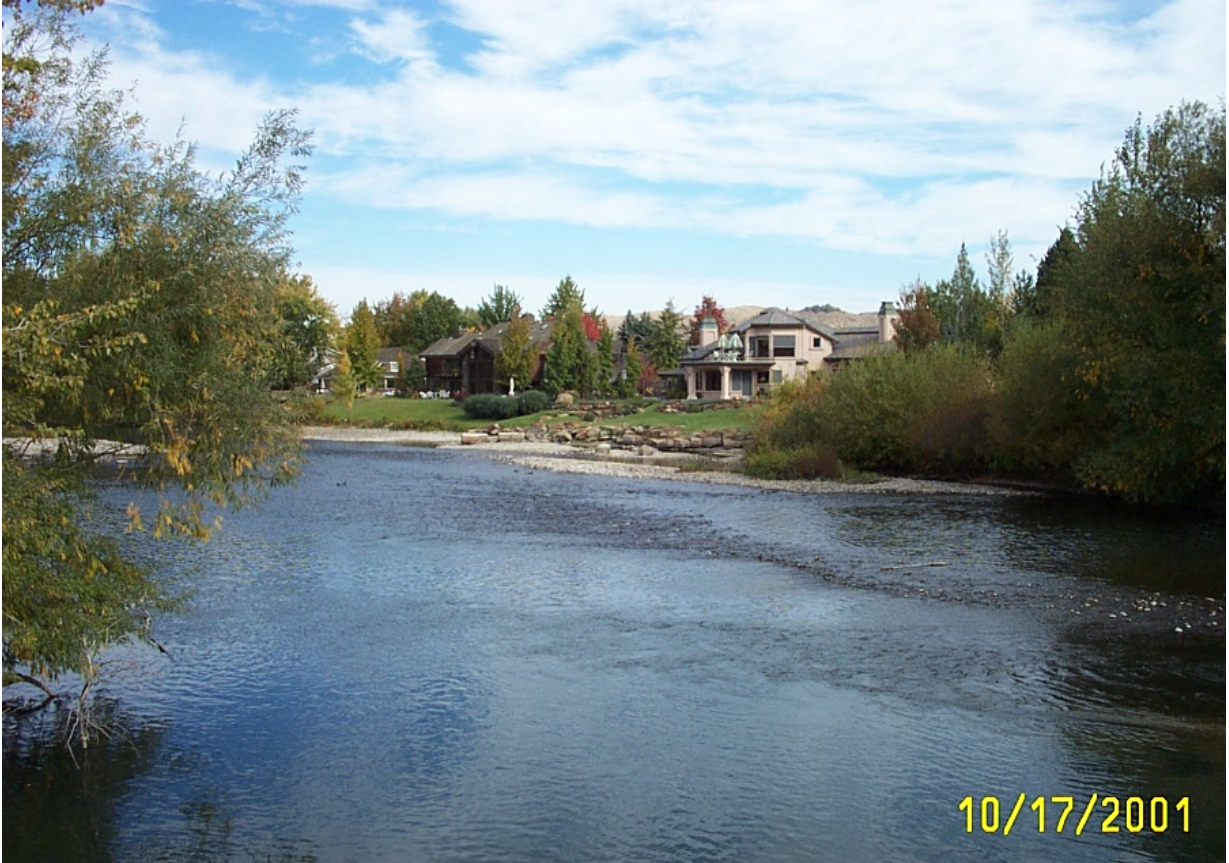
Photo 12: Cover Type 11

Cover type 11 has domestically or commercially developed land including homes, buildings, gravel pits, transportation corridors, *etc.*

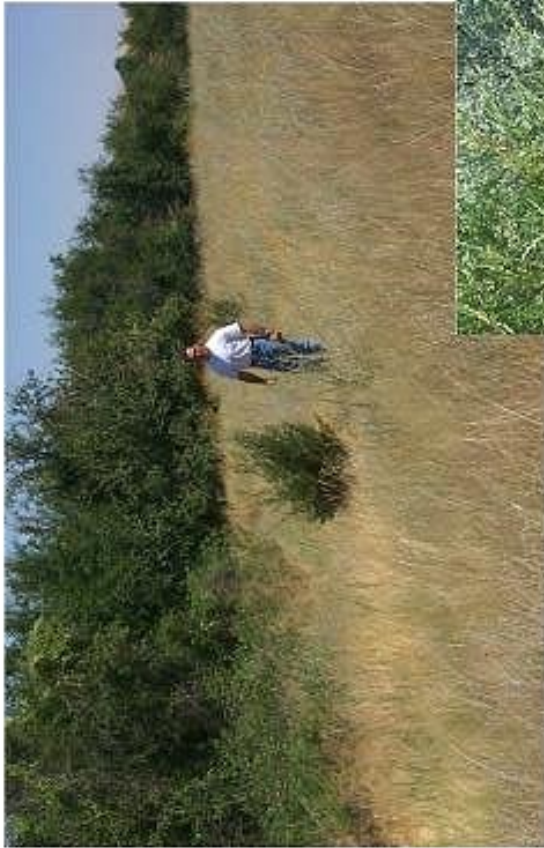
**Site 1. Passive approach**

- Irrigation: none (12" rainfall zone)
- Date planted: 1990
- Date photo taken: 1999
- Survival rate : <10%
- Tree height: 2-4 feet
- Species shown: Rocky Mountain Juniper

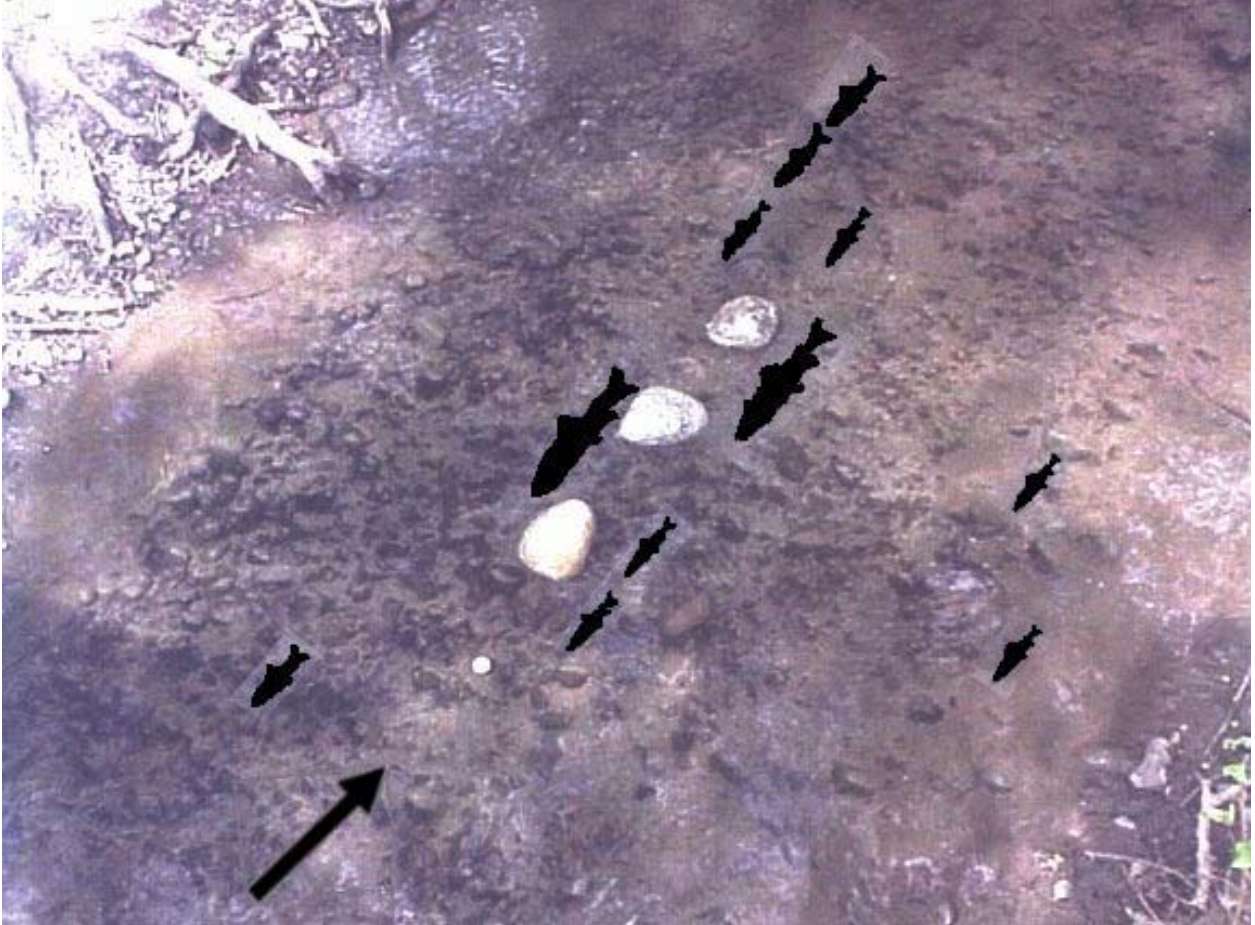
Figure D-3. "Max's Run"

Four or more resting and feeding pockets. Good cover.  
Three boulders, 2 to 5 tons each, placed in a line 6 to 8 feet apart.

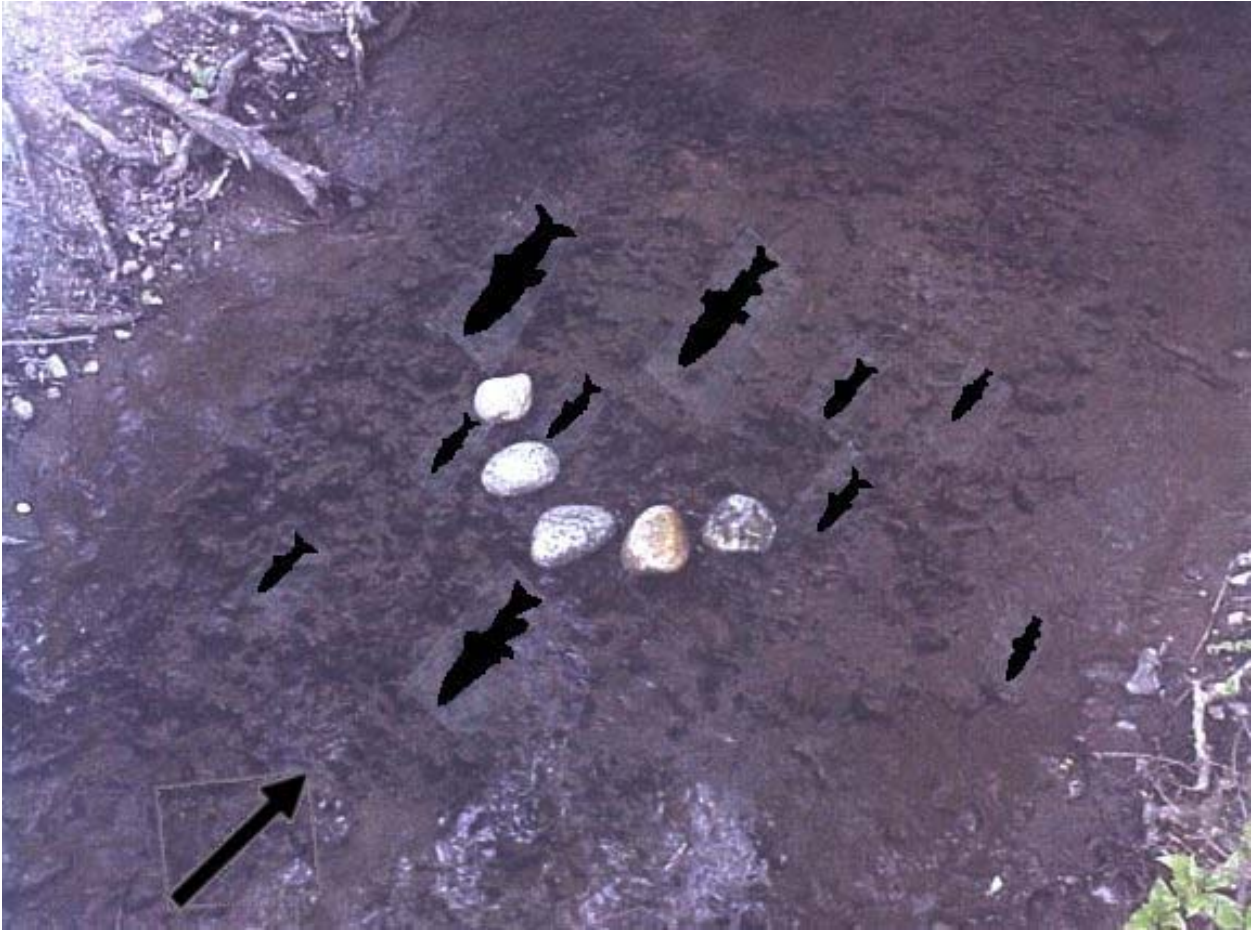
Figure D-4. "The Pocket"

Five boulders, 2 to 5 tons each, placed close together.

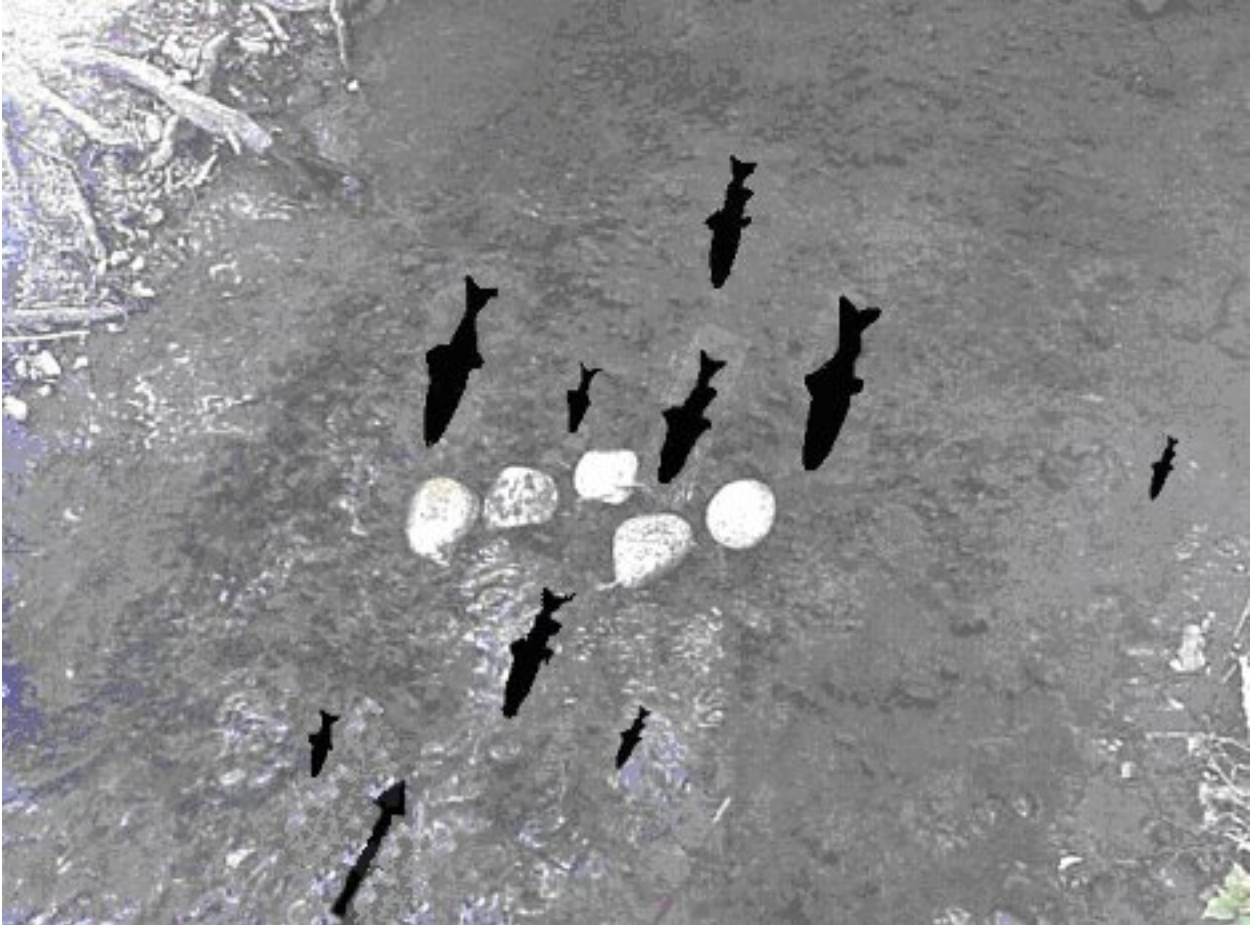
Figure D-5. "Old Mossback"

Five boulders, 2 to 5 tons each, placed close together.

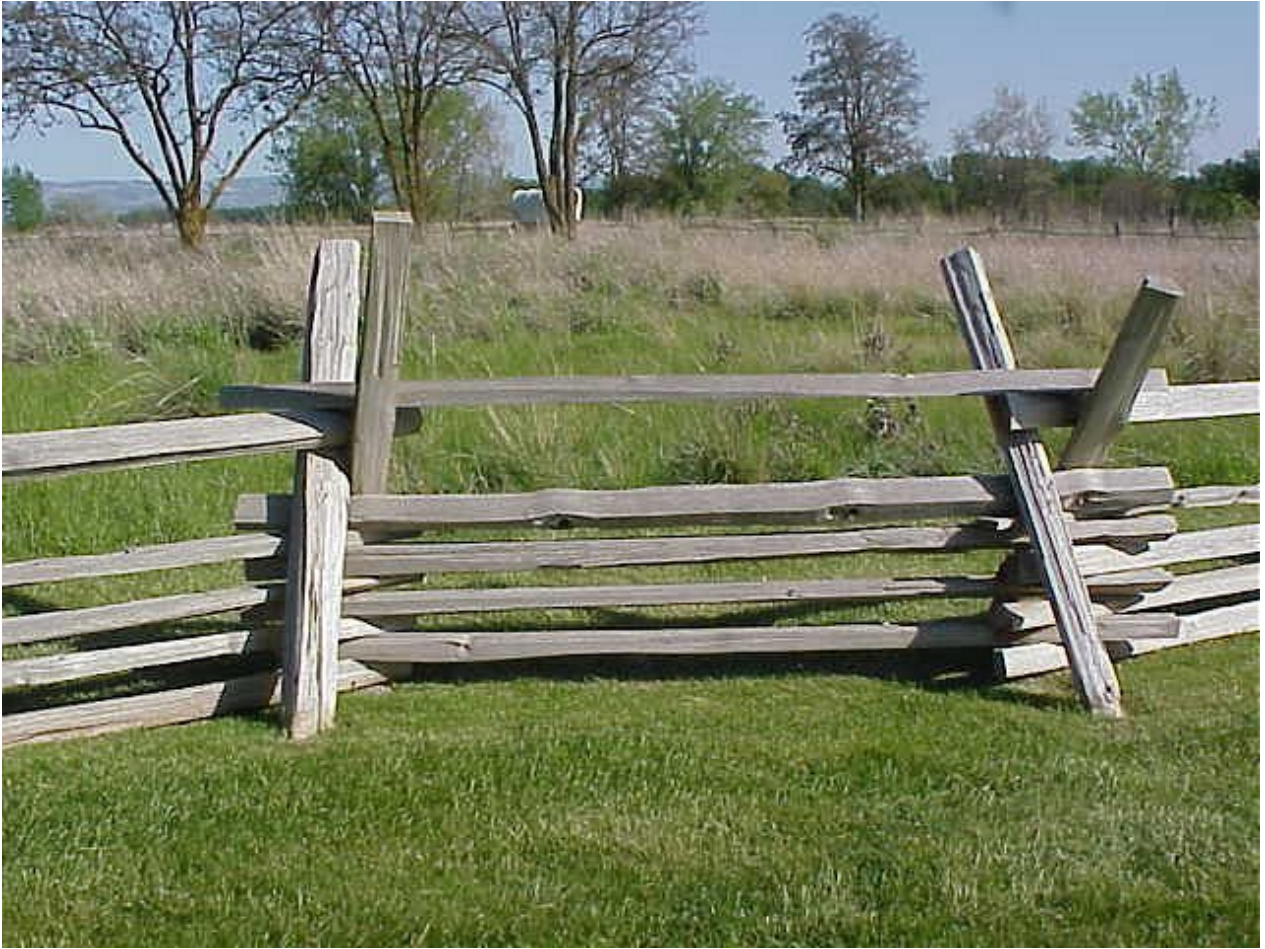
Photo E-1. Whitman Fence

Rails are 4" x 4" x 10'

Jacks are 4" 4" x 6' and are entrenched 12" in the ground.

The Marcus Whitman Mission was founded among the Cayuse Indians. For part of the year, the Indians traveled to buffalo country, the camas meadows, and the salmon fisheries in search of food. Whitman realized that the mission could not fulfill its purpose if the Indians remained nomadic. Therefore, he introduced the Indians to farming, which required that the fields be fenced to protect them from livestock and wildlife. The Whitman design is very simply to construct, yet is rigid in structure (see photos E-1 and E-2). This fencing requires no nails, and can be constructed by volunteer groups and Park staff. It can also be moved quite easily.
