City of Boise ADA  
Assessment

# Appendix A-Boise Depot

02/19/2021

Report #TO21-B020

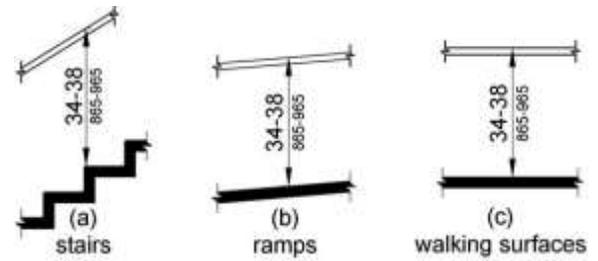
**2010 ADA Standards for Accessible Design Codes §505.4**  
Handrails are not located at a compliant height at 33" above the stair nosings.

Raise the handrails to a minimum height of 34" and a maximum of 38" above the stair nosings. Ensure that the handrails are at a consistent height along the stair treads.

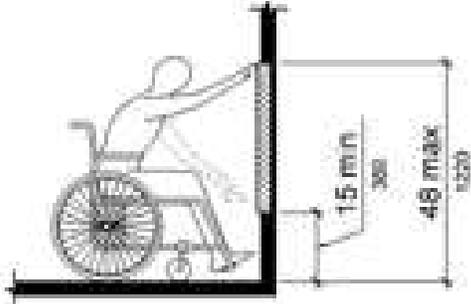
**2010 ADA Standards for Accessible Design Codes §308.2.1**  
The hooks are outside of the unobstructed forward reach range at 48.5" and 78" above the floor.

Lower the hooks by 0.5" to meet the accessible reach range of 48" maximum above the floor.

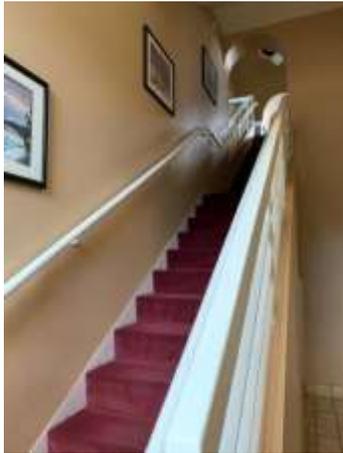
The Brides Room is only accessible via stairs.

Add vertical access to the amenity. An alternative to adding vertical access would be to ensure that a secondary bride's room is located on the first floor.

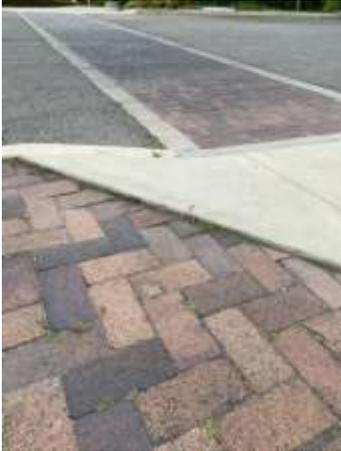
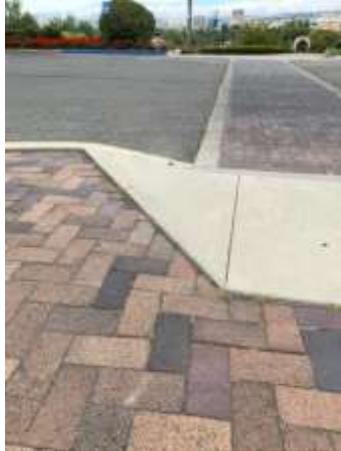
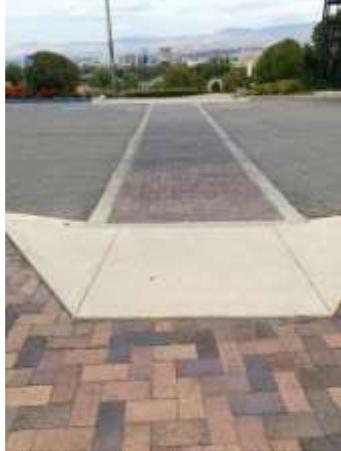
**2010 ADA Standards for Accessible Design Codes §705**  
The curb ramps do not have detectable warnings.

Install detectable warnings that contrast visually with the adjacent surface with either light-on-dark, or dark-on-light, are the width of the curb ramp, and have a depth of 24".

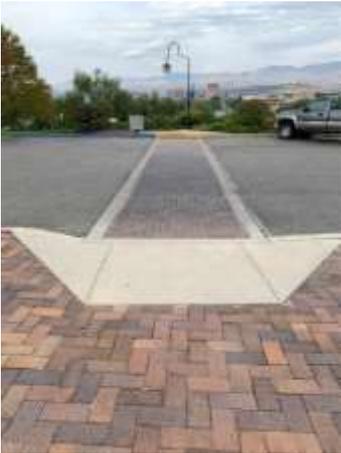
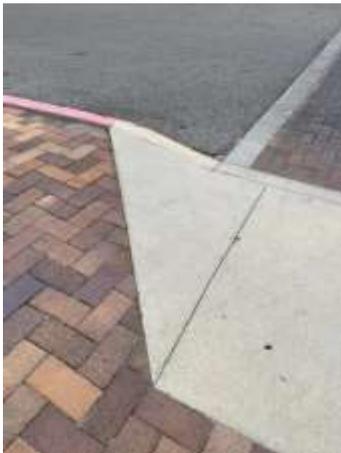
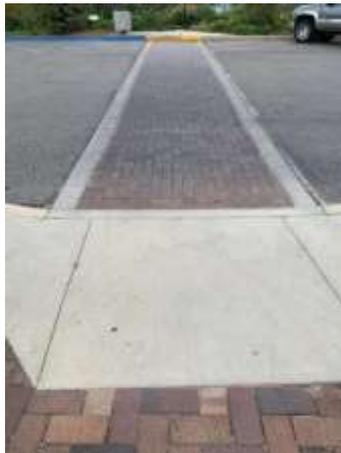
**2010 ADA Standards for Accessible Design Codes §705**  
The curb ramps do not have detectable warnings.

Install detectable warnings that contrast visually with the adjacent surface with either light-on-dark, or dark-on-light, are the width of the curb ramp, and have a depth of 24".

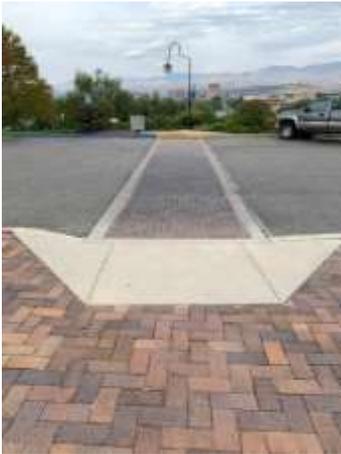
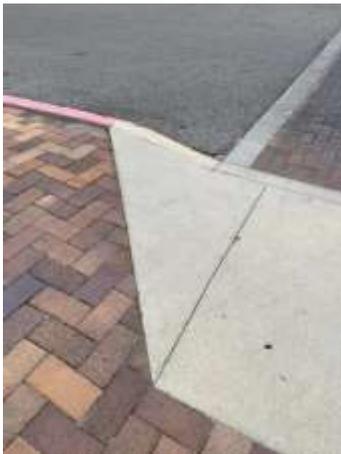
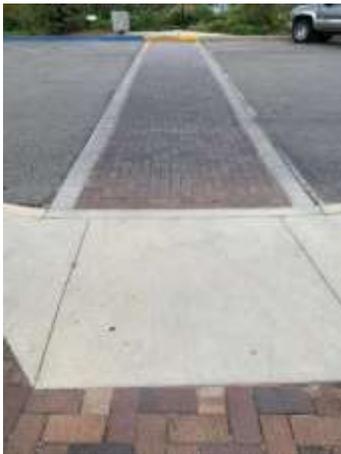
**2010 ADA Standards for Accessible Design Codes** §405.2  
The running slope of the curb ramp is 10.3%.

Reconstruct the curb ramp to reduce the running slope to a maximum of 8.3%.

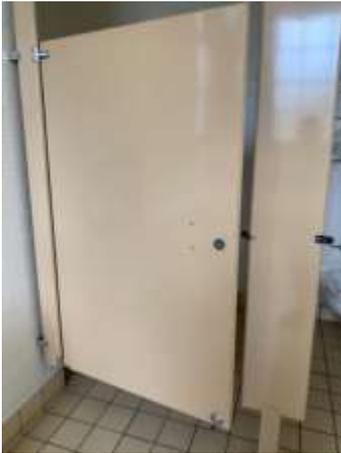
**2010 ADA Standards for Accessible Design Codes §604.8.1.2**  
The door to the accessible water closet is not self closing. Either self-closing hinges are not installed on the door or if installed, they are defective.

Install or reinstall self-closing hinges on the door to ensure that the door is self-closing per the ADA requirements.

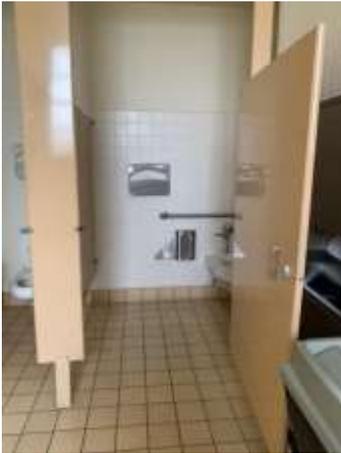
**2010 ADA Standards for Accessible Design Codes §604.8.1.2**  
The door to the accessible water closet is not self closing. Either self-closing hinges are not installed on the door or if installed, they are defective.

Install or reinstall self-closing hinges on the door to ensure that the door is self-closing per the ADA requirements.

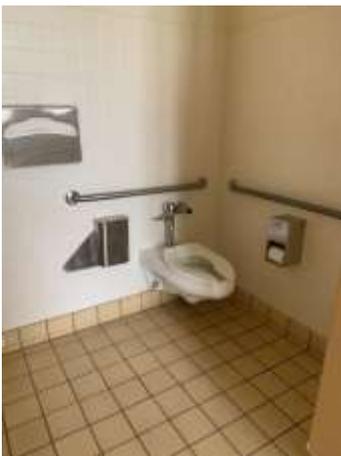
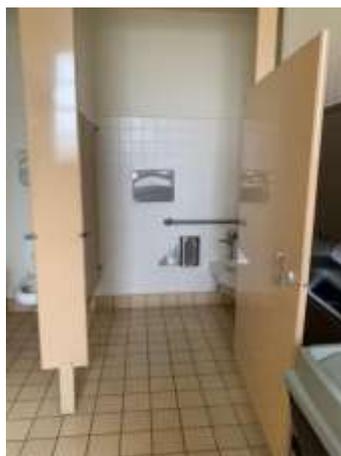
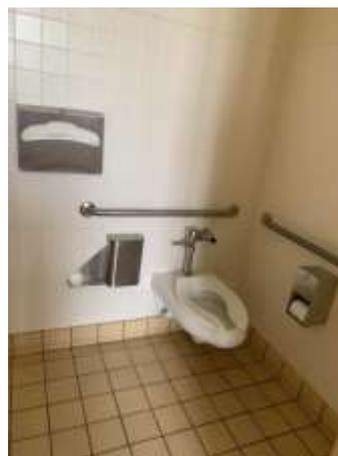
**Location:** Great Hall Women's Restroom

**2010 ADA Standards for Accessible Design Codes §604.7**

The toilet paper dispenser is located out of the accessible reach range.

Remount the toilet paper dispenser to 7" minimum and 9" maximum in front of the water closet measured to the centerline of the dispenser.

The outlet of the dispenser shall be 15" minimum and 48" maximum above the floor and shall not be located behind.

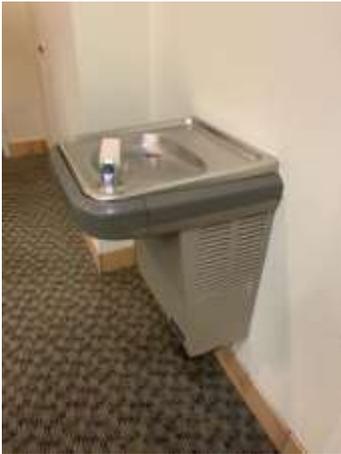
**Location:** Meeting Station  
**Schedule:** 2022  
**Estimated Cost:** \$1,000.00

**2010 ADA Standards for Accessible Design Codes** §211.2, §602.7  
There is only one drinking fountain provided at 33.5" above the floor.

Install an additional drinking fountain at a minimum spout height of 38" and maximum of 43" above the floor.

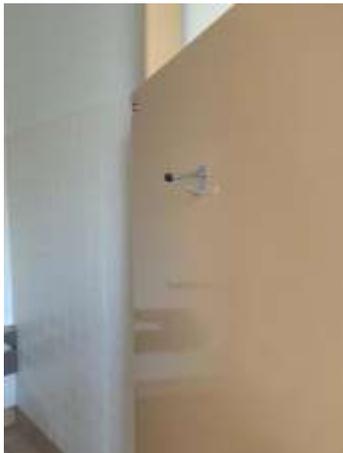
The door to the accessible water closet is not self closing. Either self-closing hinges are not installed on the door or if installed, they are defective.

Install or reinstall self-closing hinges on the door to ensure that the door is self-closing per the ADA requirements.
