City of Boise ADA
Assessment

Appendix A - Watershed Treatment Plant

05/05/2021

Report #TO21-B026

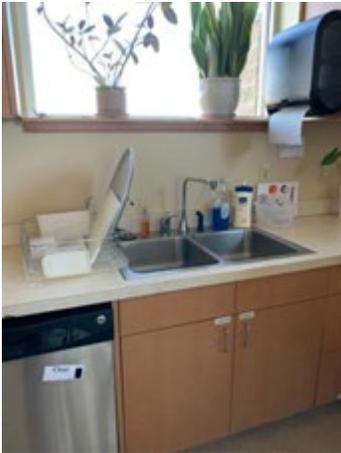
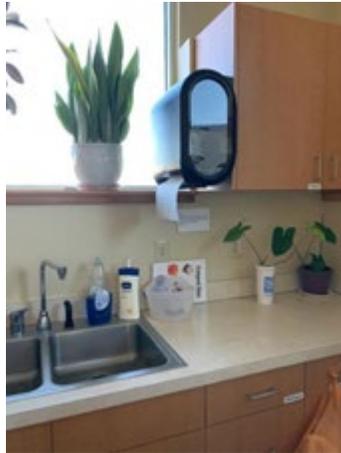
Location: Administration Break Room

2010 ADA Standards for Accessible Design Codes §308.2.1

The paper towel dispenser is outside of the obstructed forward reach range at 58" above the floor.

Lower the paper towel dispenser by 10" to meet the accessible reach range of 48" maximum above the floor.

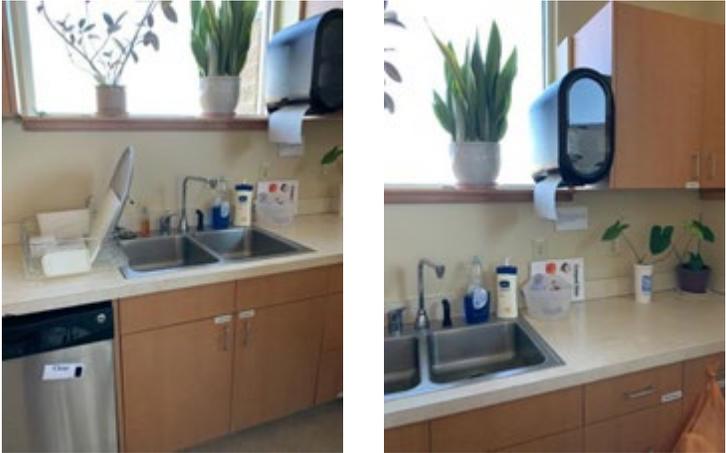
Location: Administration Break Room
Schedule: 2022
Estimated Cost: \$1,000.00

2010 ADA Standards for Accessible Design Codes §902.3, §306.3.3
There is no knee clearance underneath the sink.
The dining and work surface counter is 34.75" above the floor.

Provide knee clearance underneath the counter at the sink that is a minimum of 11" deep at 9" above the floor and 8" deep at 27" above the floor.
A portion of the dining and work surface must be no higher than 34" above the floor.

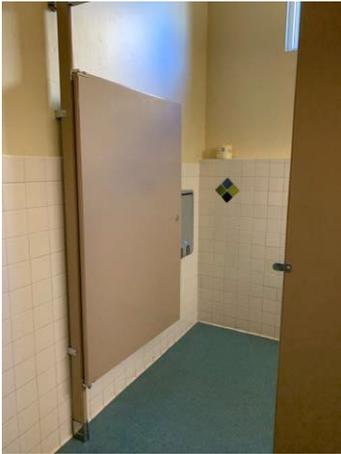
2010 ADA Standards for Accessible Design Codes §604.8.1.2
The door to the accessible water closet is not self closing. Either self-closing hinges are not installed on the door or if installed, they are defective.

Install or reinstall self-closing hinges on the door to ensure that the door is self-closing per the ADA requirements.

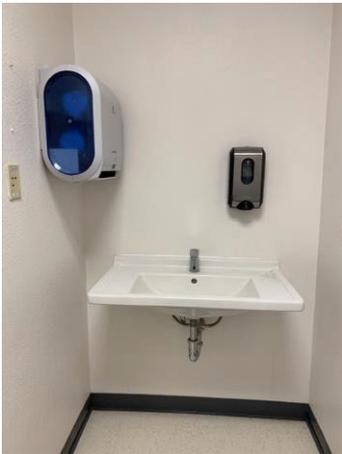
Location: Operations Building Laundry
Schedule: 2021
Estimated Cost: \$100.00

Wrap the pipes beneath the sink with soft protective wrap or plastic.

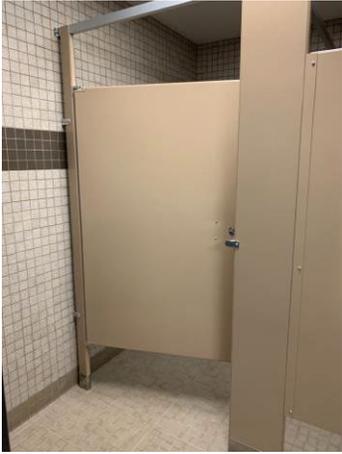
2010 ADA Standards for Accessible Design Codes §604.8.1.2
The door to the accessible water closet is not self closing. Either self-closing hinges are not installed on the door or if installed, they are defective.

Install or reinstall self-closing hinges on the door to ensure that the door is self-closing per the ADA requirements.
