City of Boise ADA  
Assessment

# Appendix A-Fairmont Pool House

12/4/2020

Report #TO20-B007

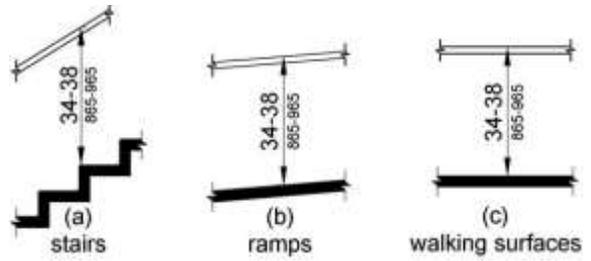
**2010 ADA Standards for Accessible Design Codes: §505.4**  
Handrails are not at a compliant height at 32" above the floor.

Raise the handrails to a minimum height of 34" and a maximum of 38" above the ground. Ensure that the handrails are at a consistent height along the walking surface.

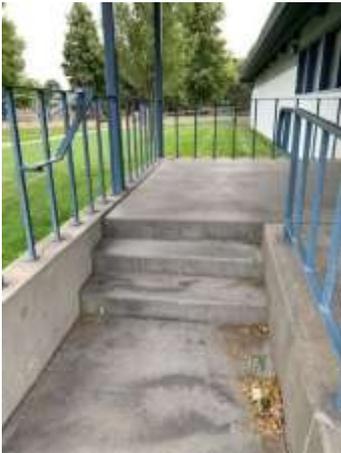
**2010 ADA Standards for Accessible Design Codes: §505.2**  
There are no handrails on one side of the stairwell.

Install handrails at a minimum height of 34” and maximum of 38” above the ground. Make sure there are adequate handrail extensions both at the top and bottom of the handrail.

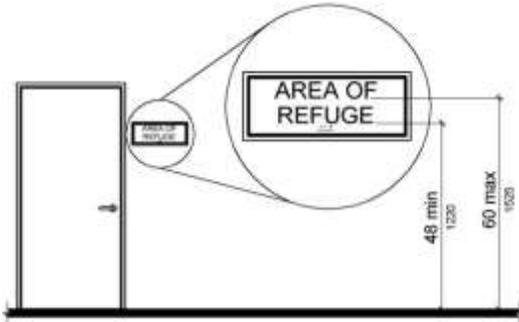
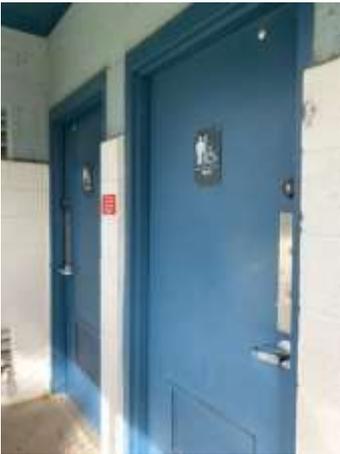
**2010 ADA Standards for Accessible Design Codes: §703.4**  
The tactile signs identifying the restrooms are not in the correct location.

Reinstall the signs on the latch side of the doors at 48" minimum above the floor measured from the baseline of the lowest character and 60" maximum measured from the baseline of the highest character.

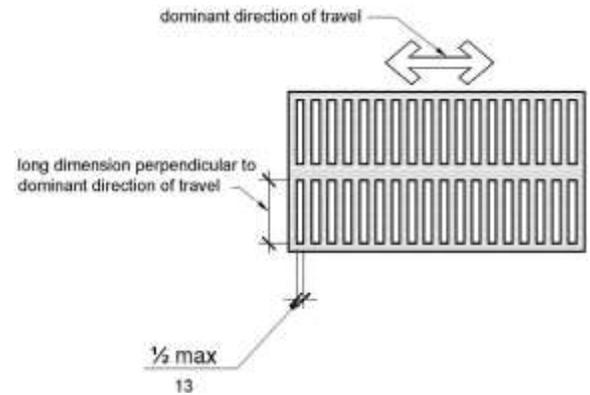
**2010 ADA Standards for Accessible Design Codes: §302.3**  
There is a 1.25" gap causing a tripping hazard and uneven surface.

Fill in the gap to ensure that openings in the accessible route does not exceed 1/2".

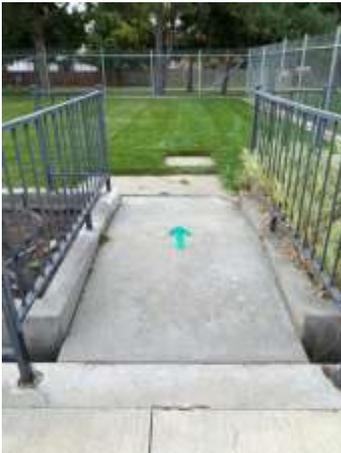
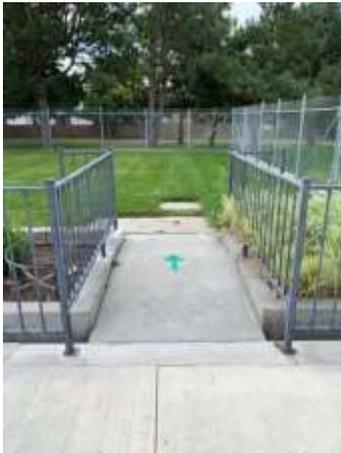
**2010 ADA Standards for Accessible Design Codes: §505.2**  
The ramp leading to the grass area has no handrails.

Install handrails at a minimum height of 34” and maximum of 38” above the ground. Make sure there are adequate handrail extensions both at the top and bottom of the handrail.

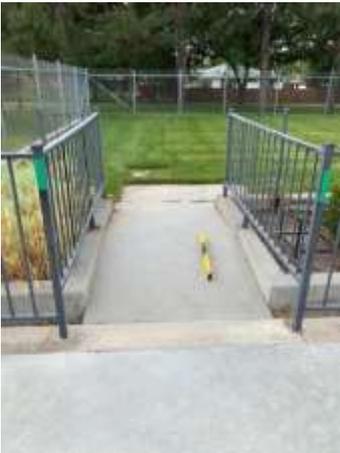
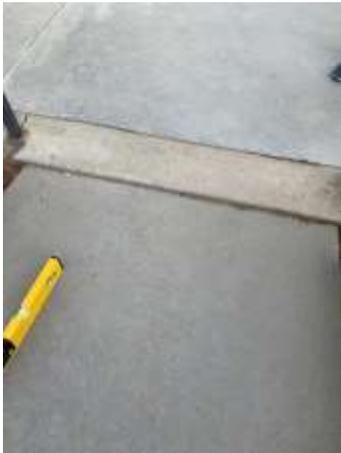
**2010 ADA Standards for Accessible Design Codes: §505.2**  
The ramp leading to the grass area has no handrails.

Install handrails at a minimum height of 34” and maximum of 38” above the ground. Make sure there are adequate handrail extensions both at the top and bottom of the handrail.

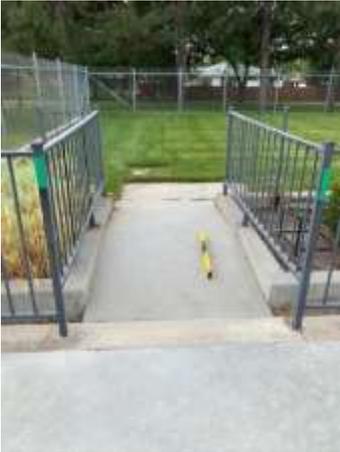
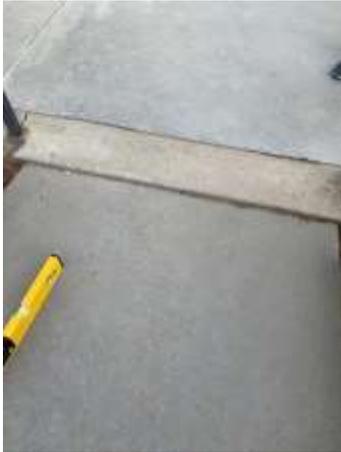
**2010 ADA Standards for Accessible Design Codes: §405.2**  
The running slope of the ramp is 11.4%.

Reconstruct the ramp to reduce the running slope to a maximum of 8.3%.

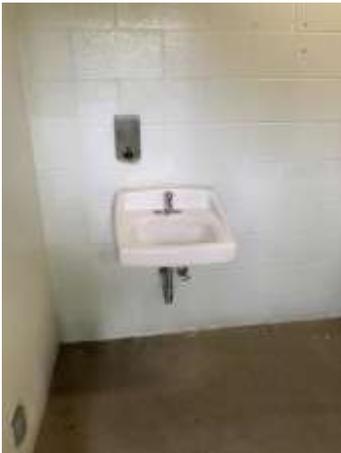
**2010 ADA Standards for Accessible Design Codes: §606.5**  
The pipes under the sink are not covered.

Wrap the pipes beneath the sink with soft protective wrap or plastic.

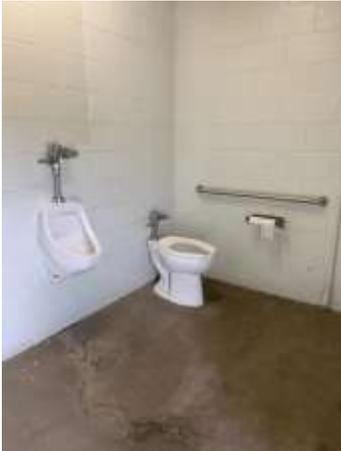
**2010 ADA Standards for Accessible Design Codes: §605.2**  
The urinal is 25" above the floor.

Lower the urinal to a maximum height of 17" above the floor.

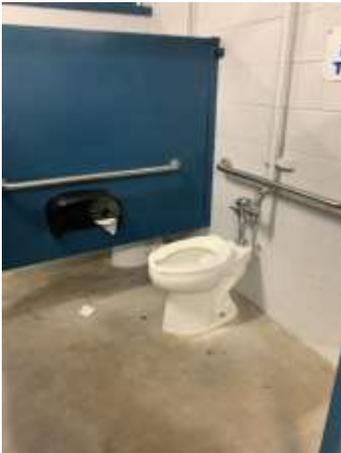
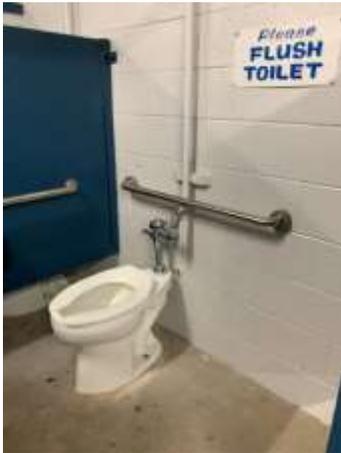
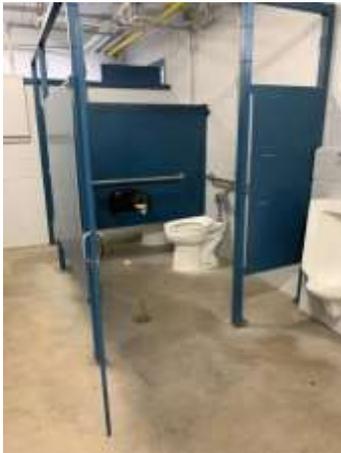
**2010 ADA Standards for Accessible Design Codes: §604.8.1.2**  
The door to the accessible water closet is not self closing. Either self-closing hinges are not installed on the door or if installed, they are defective.

Install or reinstall self-closing hinges on the door to ensure that the door is self-closing per the ADA requirements.

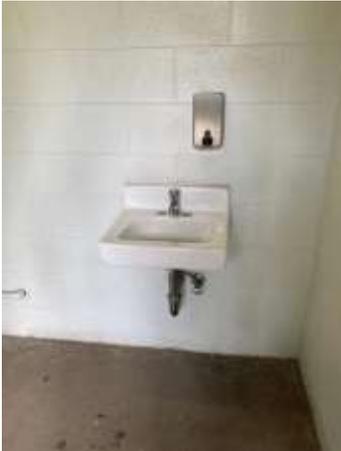
**2010 ADA Standards for Accessible Design Codes: §606.5**  
The pipes under the sink are not covered.

Wrap the pipes beneath the sink with soft protective wrap or plastic.

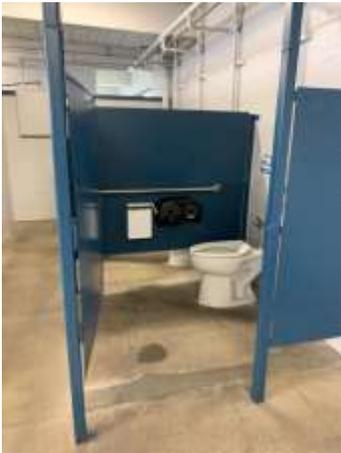
**2010 ADA Standards for Accessible Design Codes: §604.8.1.2**  
The door to the accessible water closet is not self closing. Either self-closing hinges are not installed on the door or if installed, they are defective.

Install or reinstall self-closing hinges on the door to ensure that the door is self-closing per the ADA requirements.
