City of Boise
ADA Assessment

Appendix A - Fire Training Center

03/26/2021

Report # TO21-B024

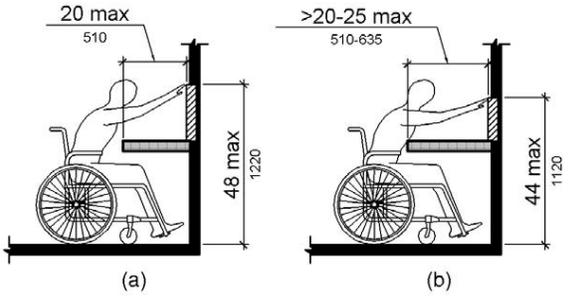
ID: 1359 **Facility:** Fire Training/Safety Building

2010 ADA Standards for Accessible Design Codes §308.2.2
The soap dispenser is outside of the obstructed forward reach range at 48.5" above the floor.

Lower the soap dispenser by 0.5" to meet the accessible reach range of 48" maximum above the floor.

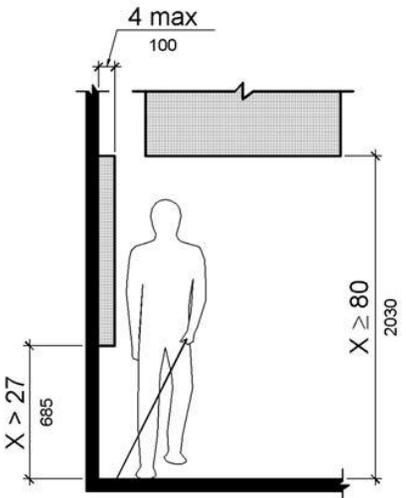
ID: 1360 **Facility:** Fire Training/Safety Building

2010 ADA Standards for Accessible Design Codes §307.2
The AED protrudes 6" into the circulation space at 34" above the floor.

Recess the AED so it protrudes a maximum of 4", lower it so the bottom edge is 27" maximum above the floor, or place a cane detectable object beneath it.

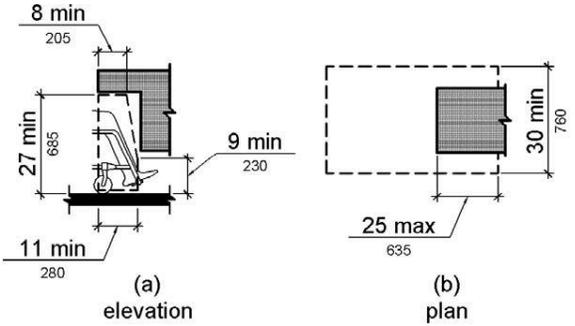
ID: 1357 **Facility:** Fire Training/Safety Building

2010 ADA Standards for Accessible Design Codes §306.3.3
There is no knee clearance underneath the sink.

Provide knee clearance underneath the counter at the sink that is a minimum of 11" deep at 9" above the floor and 8" deep at 27" above the floor.

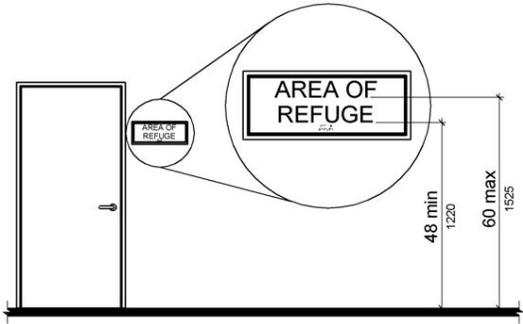
ID: 1361 **Facility:** Fire Training/Safety Building

2010 ADA Standards for Accessible Design Codes §216.4, §703
Doors serving as exits are not marked by tactile signage.

Place a tactile exit sign, that complies with §703.1, §703.2 and §703.5, identifying the exit doors.
Install missing signage at 48" minimum above the floor measured from the baseline of the lowest character and 60" maximum measured from the baseline of the highest character.

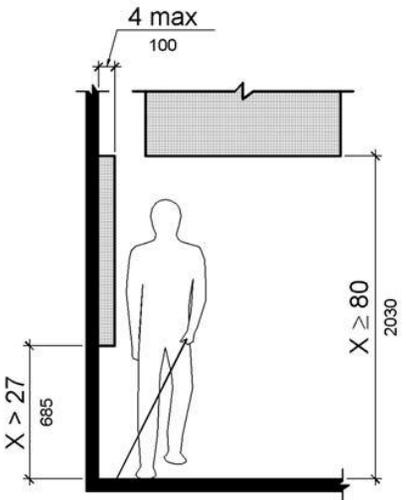
ID: 1300 **Facility:** Fire Training/Safety Building

2010 ADA Standards for Accessible Design Codes §307.2
The TV protrudes 6" into the circulation space at 45.5" above the floor.

Recess the TV so it protrudes a maximum of 4" or place a cane detectable object beneath it.

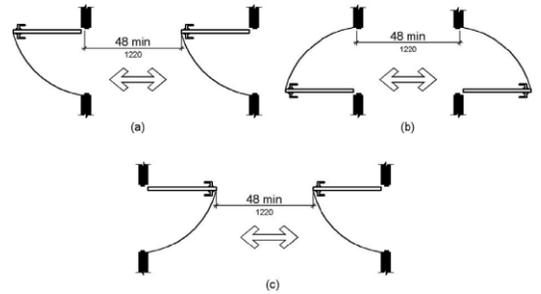
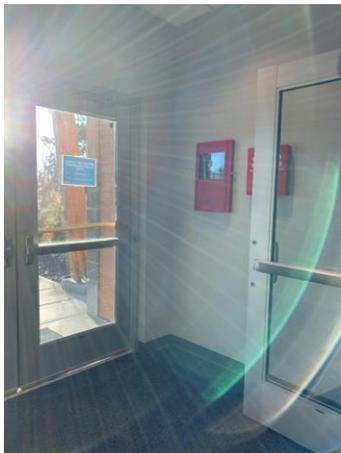
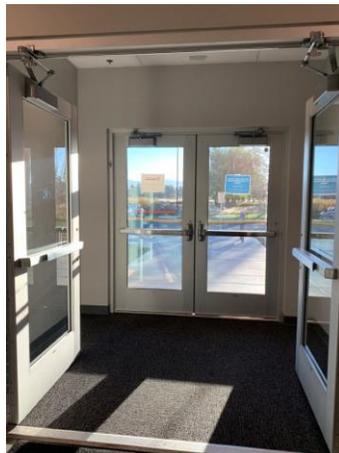
ID: 1295
Facility: Fire Training/Safety Building

2010 ADA Standards for Accessible Design Codes §404.2.6

Between the two hinged or pivoted doors, the width is 46".

Remove the inside set of doors or reverse the swing of the inside set of doors.
