City of Boise ADA  
Assessment

# Appendix A-Ivywild Pool House

12/4/2020

Report #TO20-B005

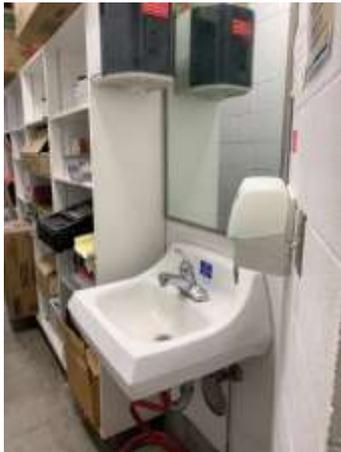
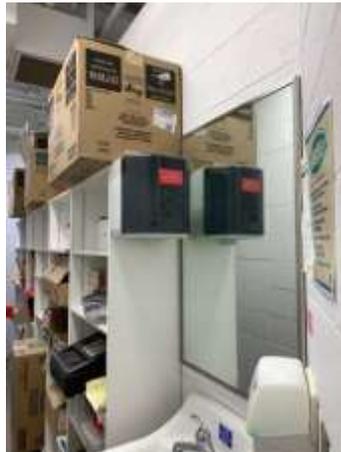
**2010 ADA Standards for Accessible Design Codes: §606.5**  
The pipes under the sink are not covered.

Wrap the pipes beneath the sink with soft protective wrap or plastic.

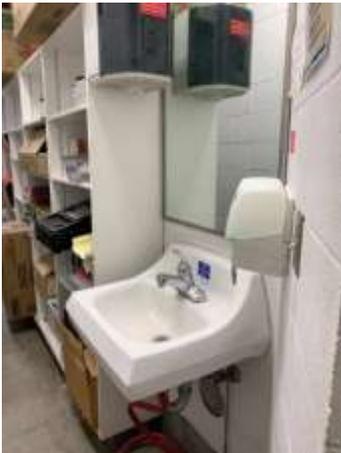
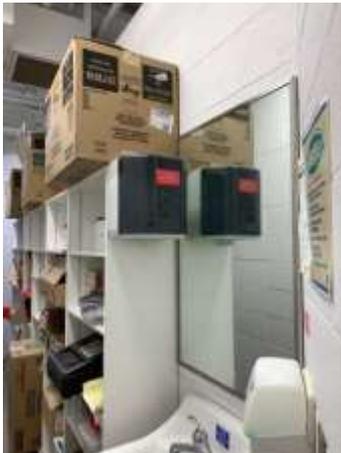
**2010 ADA Standards for Accessible Design Codes: §603.3**  
The mirror is too high to be accessible at 42" above the floor.

Lower the mirror its bottom edge is a maximum height of 40" above the floor.

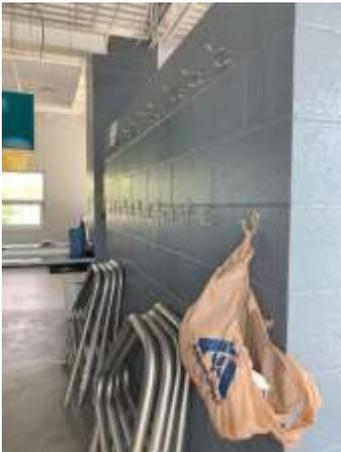
**2010 ADA Standards for Accessible Design Codes: §305.2**  
The clear floor space at the garbage can has a 2.2% slope.

Resurface the 30"x48" clear floor space to have a maximum slope of 2% slope.

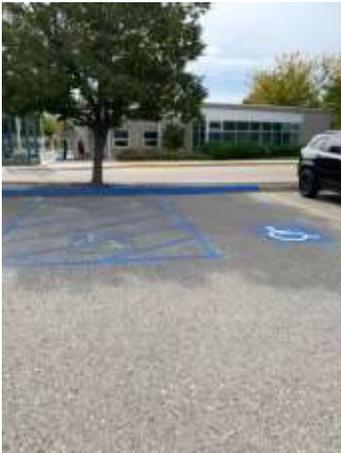
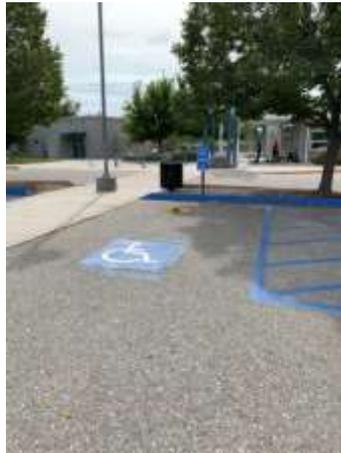
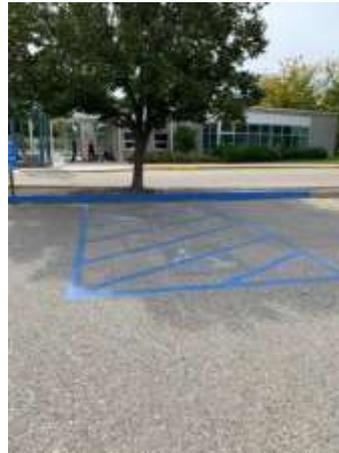
One accessible parking sign is missing and the existing accessible parking sign is 33.5" above the ground.

Install an accessible parking sign and remount the existing accessible sign to ensure that the sign is at a minimum height of 60" above the ground.

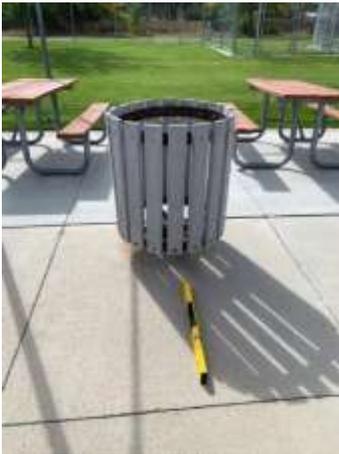
**PHOTOGRAPH(S) OF THIS LOCATION**

The clear floor space at the garbage can has a 2.3% slope.

Resurface the 30"x48" clear floor space to have a maximum slope of 2% slope.

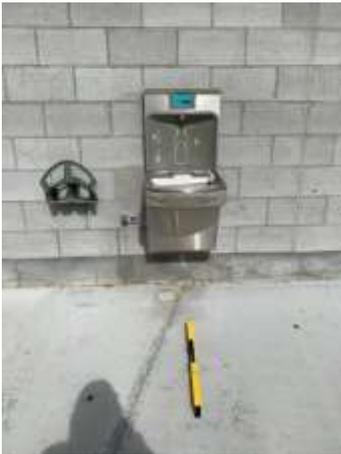
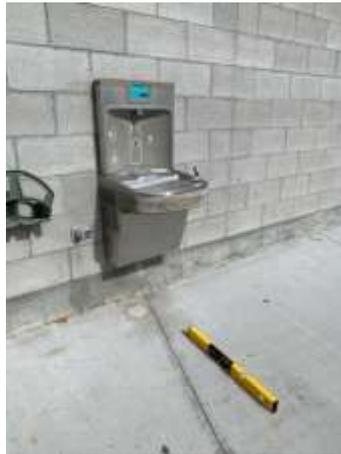
**PHOTOGRAPH(S) OF THIS LOCATION**

There is only one drinking fountain provided at 32" above the floor.

Install an additional drinking fountain at a minimum height of 38" and maximum of 43" above the floor.

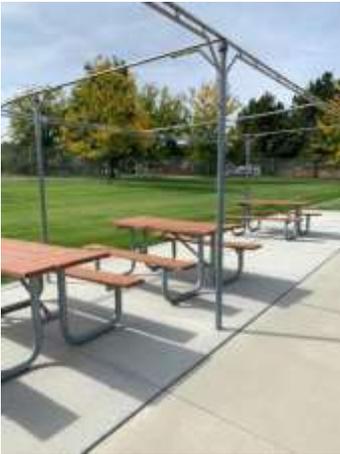
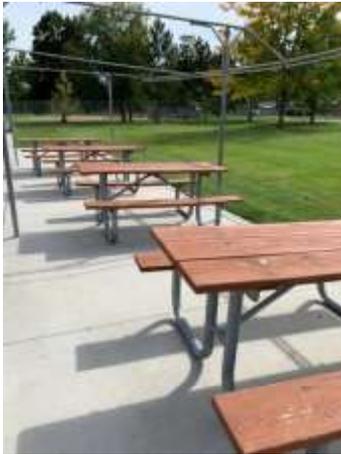
**PHOTOGRAPH(S) OF THIS LOCATION**

**2010 ADA Standards for Accessible Design Codes:** §226.1, §902, §305, §306  
The provided picnic table does not have an accessible clear space for a wheelchair user.

Add/replace picnic tables so that at least 5% of the seating is wheelchair accessible.  
Ensure that the wheelchair accessible seating has a clear floor space of 30" x 48" with a slope not steeper than 2% and that the tables have sufficient knee and toe clearance.

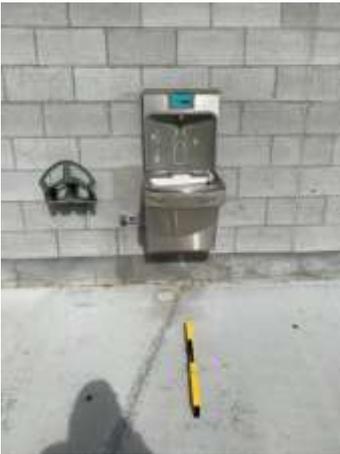
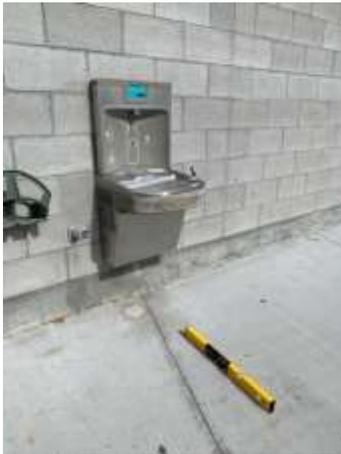
**PHOTOGRAPH(S) OF THIS LOCATION**

**2010 ADA Standards for Accessible Design Codes: §305.2**  
The clear floor space at the drinking fountain has a 6.1% slope.

Reconstruct the 30"x48" clear floor space to have a maximum slope of 2% slope.

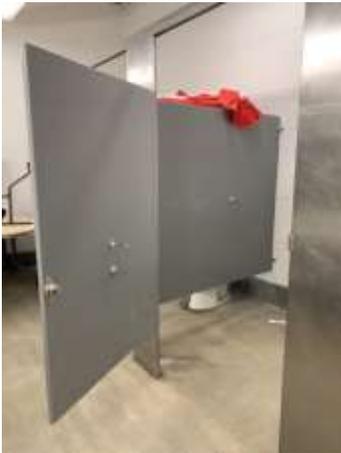
**PHOTOGRAPH(S) OF THIS LOCATION**

**2010 ADA Standards for Accessible Design Codes: §604.8.1.2**  
The door to the accessible water closet is not self closing.  
Either self-closing hinges are not installed on the door or if installed, they are defective.

Install or reinstall self-closing hinges on the door to ensure that the door is self-closing per the ADA requirements.
