City of Boise
ADA Assessment

Appendix A – Library! At Bown Crossing

01/27/2021

Report # TO21-B014

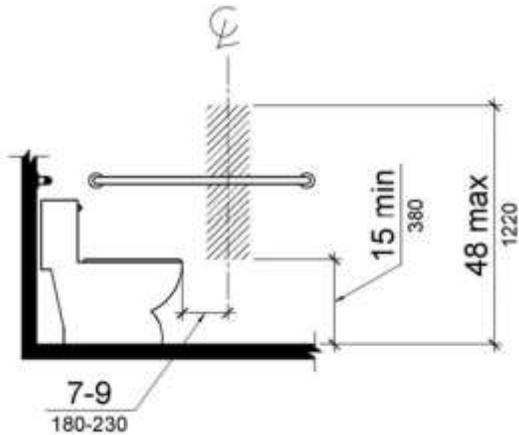
Location: Children's Area Family Restroom
Schedule: 2021
Estimated Cost: \$100.00

2010 ADA Standards for Accessible Design Codes §604.7
The toilet paper dispenser is located out of the accessible reach range.

Remount the toilet paper dispenser to 7" minimum and 9" maximum in front of the water closet measured to the centerline of the dispenser.
The outlet of the dispenser shall be 15" minimum and 48" maximum above the floor and shall not be located behind.

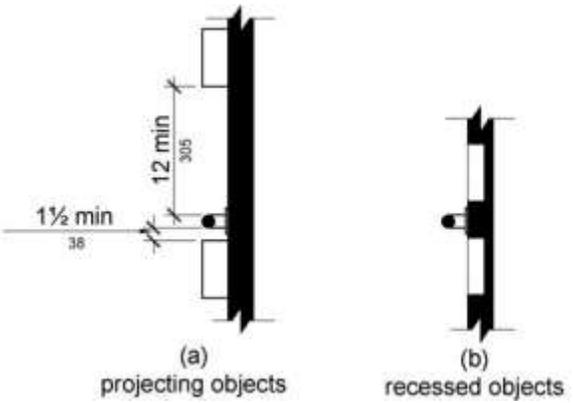
Location: Children's Area Family Restroom
Schedule: 2021
Estimated Cost: \$100.00

2010 ADA Standards for Accessible Design Codes §609.3
The space between the grab bar and the shelf is 9.5".

Relocate the shelf to a location that is at least a distance of 12" or greater above the grab bar. Ensure that the shelf is not greater than 48" above the floor.

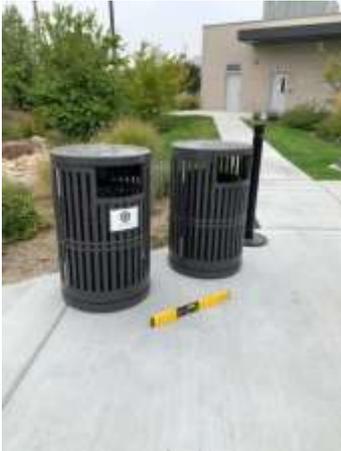
Location: Exterior
Schedule: 2023
Estimated Cost: \$1,000.00

2010 ADA Standards for Accessible Design Codes §305.2
The clear floor space has a 2.2% slope.

Resurface the 30"x48" clear floor space to have a maximum slope of 2% in all directions.

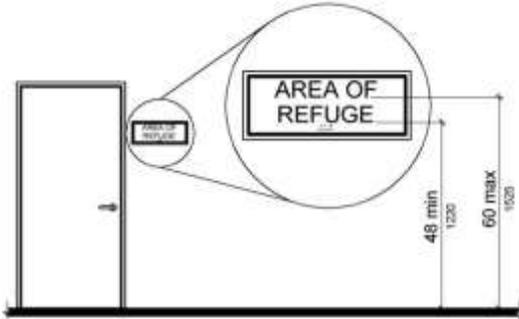
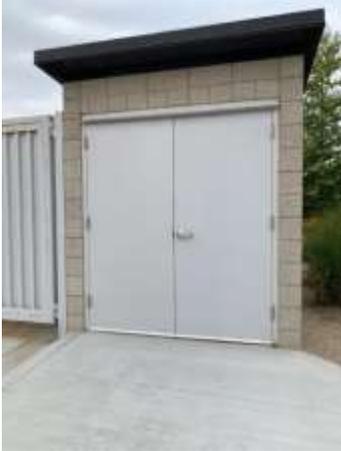
Location: Exterior at Curbside Pick Up
Schedule: 2021
Estimated Cost: \$100.00

2010 ADA Standards for Accessible Design Codes §216.2, §703
There is no tactile sign identifying the permanent room

Install tactile signage to the right of the right hand door at a height of 48" minimum to 60" maximum above the floor, identifying room by name or room number.
Signs shall be Braille with raised lettering and should be placed on the wall in the center of an 18"x18" clear floor space.

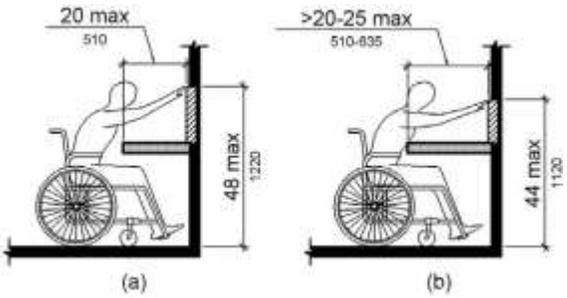
Location: Kitchen
Schedule: 2021
Estimated Cost: \$100.00

2010 ADA Standards for Accessible Design Codes §308.2.2
The paper towel dispenser is outside of the obstructed forward reach range at 46" above the floor.

Lower the paper towel dispenser by 2" to meet the accessible reach range of 44" maximum above the floor.

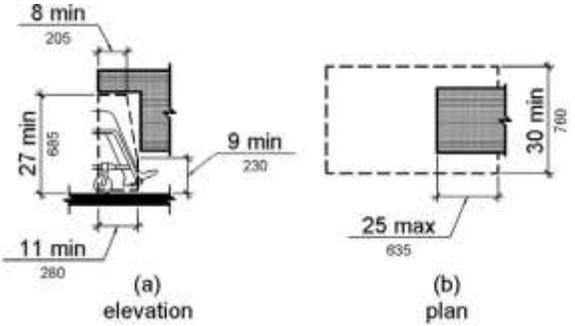
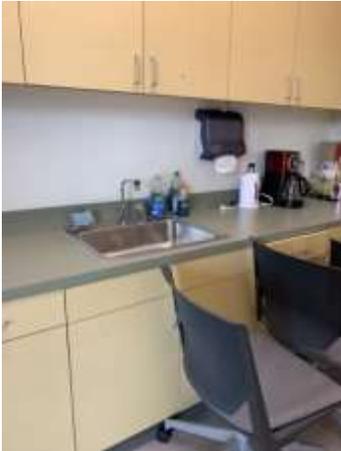
Location: Kitchen
Schedule: 2022
Estimated Cost: \$1,000.00

2010 ADA Standards for Accessible Design Codes §306.3.3
There is no knee clearance underneath the counter.

Provide knee clearance underneath the counter at the sink that is a minimum of 11" deep at 9" above the floor and 8" deep at 27" above the floor.

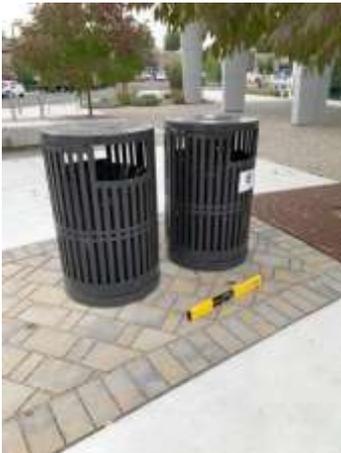
Location: Main Entrance
Schedule: 2023
Estimated Cost: \$1,000.00

2010 ADA Standards for Accessible Design Codes §305.2
The clear floor has a 2.4% slope.

Resurface the 30"x48" clear floor space to have a maximum slope of 2% in all directions.

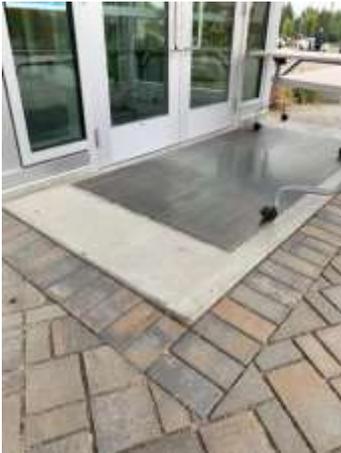
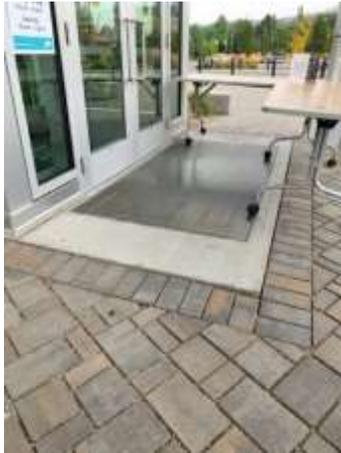
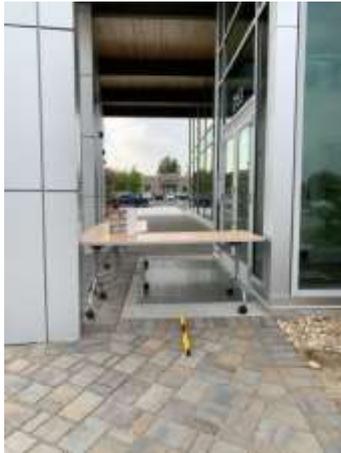
Location: Main Entrance
Schedule: 2021
Estimated Cost: \$2,500.00

2010 ADA Standards for Accessible Design Codes §403.3, §303.2

There is a 1" change in level. The running slope is 8.1%.

Reconstruct the bricks on the right side of the door to ensure that the slope does not exceed 5%.

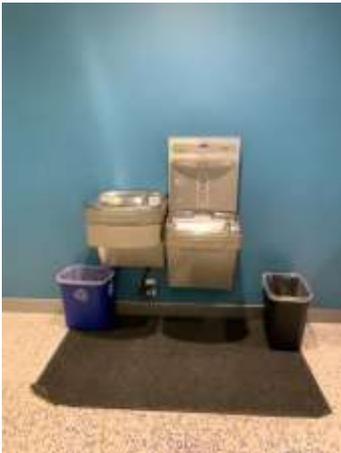
Location: Main Entrance Drinking Fountains
Schedule: 2022
Estimated Cost: \$1,000.00

2010 ADA Standards for Accessible Design Codes §602.4, §602.7
The spout heights of the drinking fountains are not compliant at 31" and 37" above the floor

Raise the existing tall drinking fountain in order to comply with the minimum spout height of 37" above the floor.

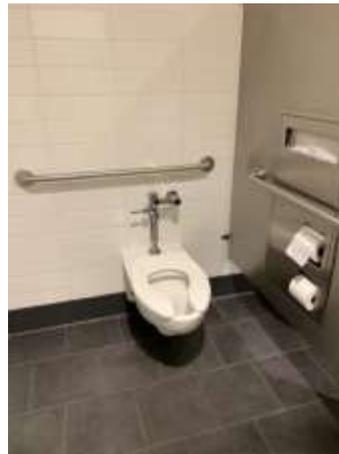
Location: Main Entrance Men's Restroom

2010 ADA Standards for Accessible Design Codes §604.8.1.2

The door to the accessible water closet is not self closing. Either self-closing hinges are not installed on the door or if installed, they are defective.

Install or reinstall self-closing hinges on the door to ensure that the door is self-closing per the ADA requirements.

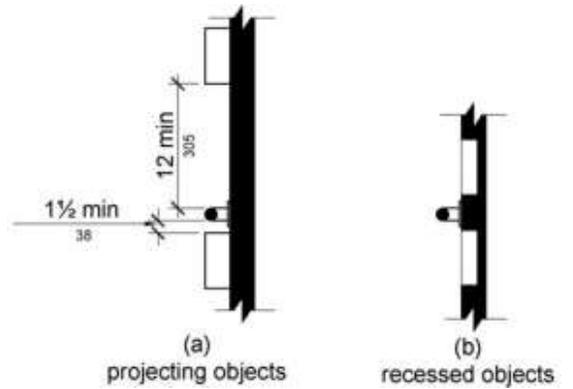
Location: Main Entrance Men's Restroom
Schedule: 2021
Estimated Cost: \$100.00

2010 ADA Standards for Accessible Design Codes §609.3
The space between the grab bar and the shelf is 9.5".

Relocate the shelf to a location that is at least a distance of 12" or greater above the grab bar. Ensure that the shelf is not greater than 48" above the floor.

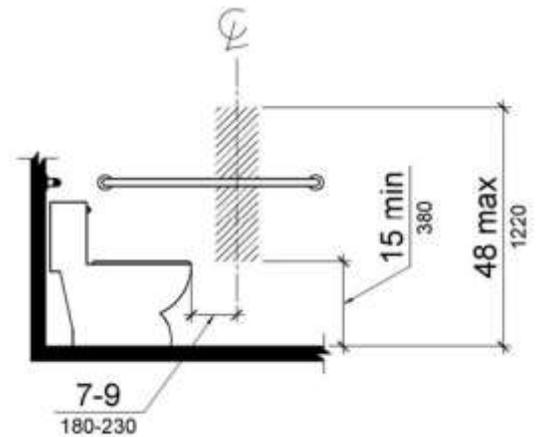
Location: Main Entrance Men's Restroom

2010 ADA Standards for Accessible Design Codes §604.7

The toilet paper dispenser is located out of the accessible reach range.

Remount the toilet paper dispenser to 7" minimum and 9" maximum in front of the water closet measured to the centerline of the dispenser.

The outlet of the dispenser shall be 15" minimum and 48" maximum above the floor and shall not be located behind.

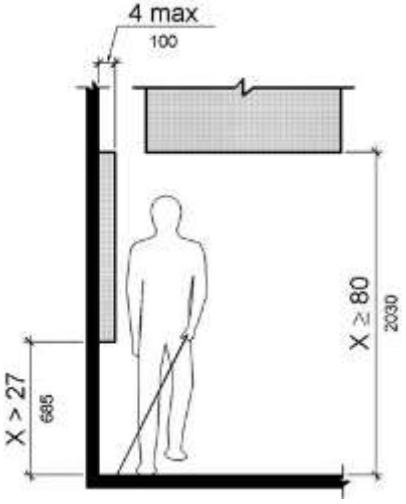
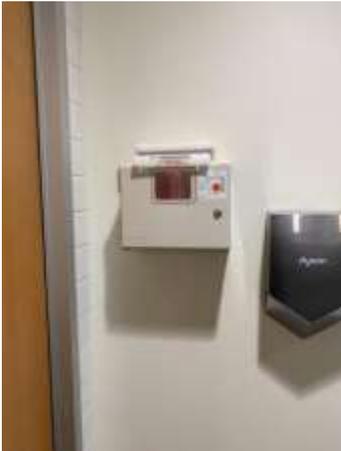
Location: Main Entrance Men's Restroom
Schedule: 2021
Estimated Cost: \$100.00

2010 ADA Standards for Accessible Design Codes §307.2, §308.2.1
The sharps container is outside of the unobstructed forward reach range at 49.5" above the floor. The sharps container protrudes 4.75" into the circulation space at 49.5" above the floor.

Lower the sharps container by 1.5" to meet the accessible reach range of 48" maximum above the floor.
Recess the sharps container so it protrudes a maximum of 4" or place a cane detectable object beneath it.

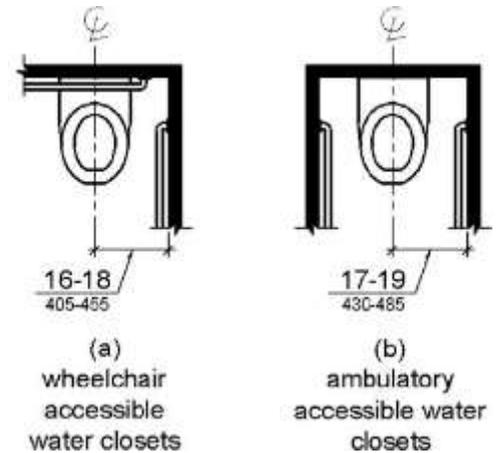
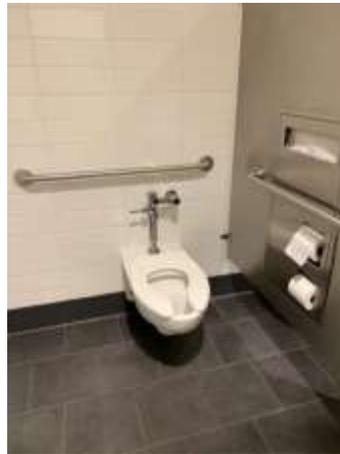
Location: Main Entrance Men's Restroom

2010 ADA Standards for Accessible Design Codes §604.2

The centerline of the toilet is located 19" from the sidewall

Reposition the centerline of the toilet to be within 16" minimum and 18" maximum from the sidewall.

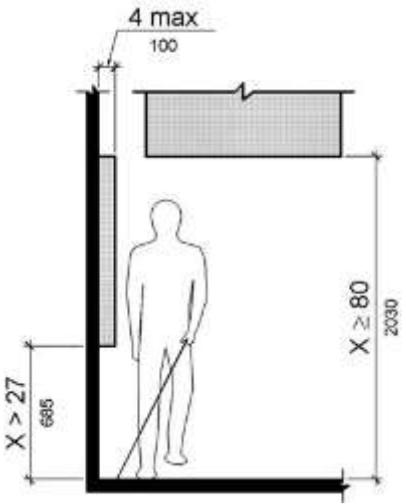
Location: Main Entrance Vox Poplar
Schedule: 2021
Estimated Cost: \$100.00

2010 ADA Standards for Accessible Design Codes §307.2
The Vox Poplar art protrudes 14" into the circulation space at 71.5" above the floor.

Recess the Vox Poplar art so it protrudes a maximum of 4", lower it so the bottom edge is 27" maximum above the floor, or place a cane detectable object beneath it.

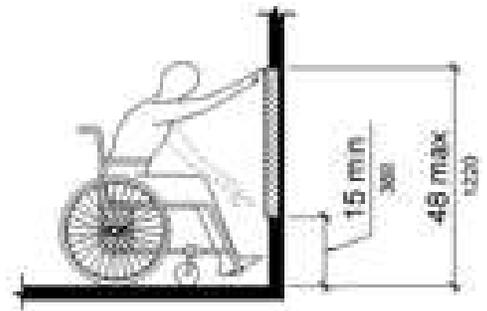
2010 ADA Standards for Accessible Design Codes §308.2.1

The top shelves are outside of the unobstructed forward reach range at 65" above the floor.

Ensure that the library has a policy that provides assistance to employees and volunteers reaching for shelves that are located beyond 48" above the floor.

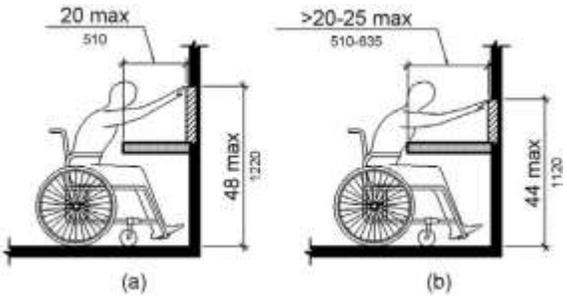
2010 ADA Standards for Accessible Design Codes §308.2.2
The paper towel dispenser is outside of the obstructed forward reach range at 47" above the floor however, the counter is 21" deep.

Lower the paper towel dispenser by 3" to meet the accessible reach range of 44" maximum above the floor.

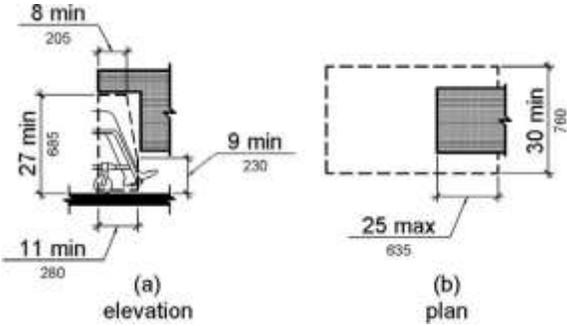
2010 ADA Standards for Accessible Design Codes §306.3.3
There is no knee clearance underneath the counter.

Provide knee clearance underneath the counter at the sink that is a minimum of 11" deep at 9" above the floor and 8" deep at 27" above the floor.

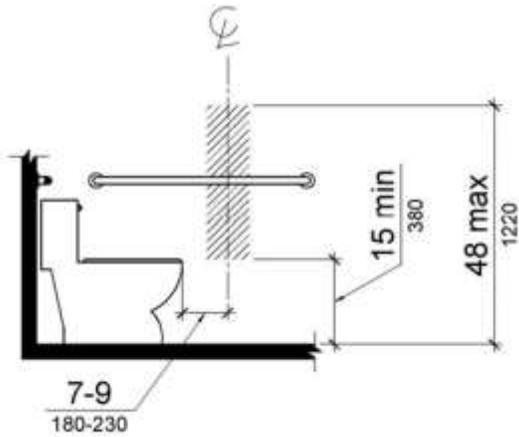
2010 ADA Standards for Accessible Design Codes §604.7
The toilet paper dispenser is located out of the accessible reach range.

Remount the toilet paper dispenser to 7" minimum and 9" maximum in front of the water closet measured to the centerline of the dispenser.
The outlet of the dispenser shall be 15" minimum and 48" maximum above the floor and shall not be located behind.
