City of Boise ADA  
Assessment

# Appendix A - Public Works Farm Office Shop Building

12/30/2020

Report #TO20-B010

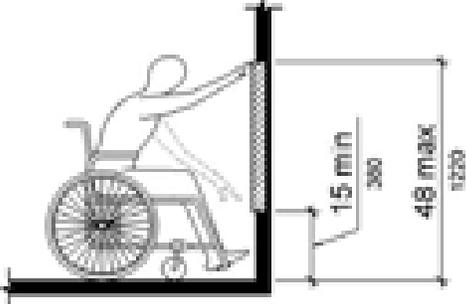
**Location:** Entrance  
**Schedule:** 2021  
**Estimated Cost:** \$100.00

**2010 ADA Standards for Accessible Design Codes: §308.2.1**  
The push button is outside of the unobstructed forward reach range at 50" above the floor.

Lower the push button by at least 2" to meet the accessible reach range of 15" minimum and 48" maximum above the floor.

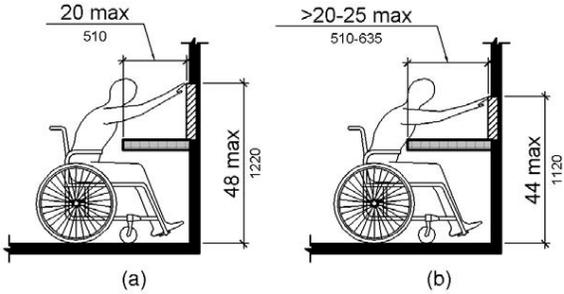
**Location:** Kestrel Conference Room  
**Schedule:** 2021  
**Estimated Cost:** \$100.00

**2010 ADA Standards for Accessible Design Codes: §308.2.2**  
The paper towel dispenser is outside of the obstructed forward reach range at 69" above the floor.

Lower the paper towel dispenser by 21" to meet the accessible reach range of 44" maximum above the floor.

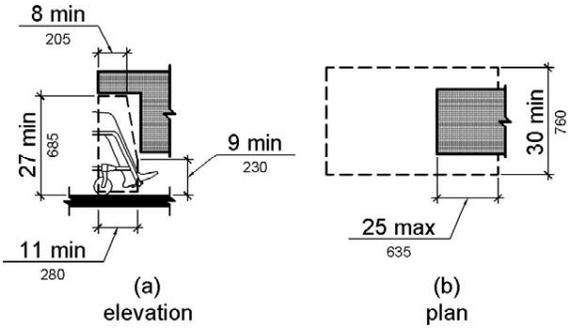
**Location:** Kestrel Conference Room  
**Schedule:** 2022  
**Estimated Cost:** \$1,000.00

**2010 ADA Standards for Accessible Design Codes: §306.3.3**  
There is no knee clearance underneath the counter.

Provide knee clearance underneath the counter at the sink that is a minimum of 11" deep at 9" above the floor and 8" deep at 27" above the floor.

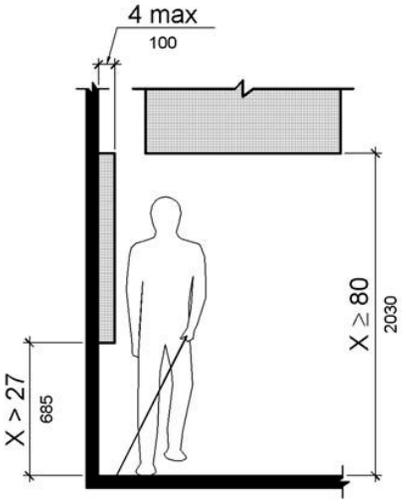
**Location:** Men's Locker Room  
**Schedule:** 2021  
**Estimated Cost:** \$100.00

**2010 ADA Standards for Accessible Design Codes: §307.2, §308.2.1**  
The paper towel dispenser is outside of the unobstructed forward reach range at 52" above the floor. The paper towel dispenser protrudes 8" into the circulation space at 52" above the floor.

Lower the paper towel dispenser by 4" to meet the accessible reach range of 48" maximum above the floor.  
Recess the paper towel dispenser so it protrudes a maximum of 4" or place a cane detectable object beneath it.

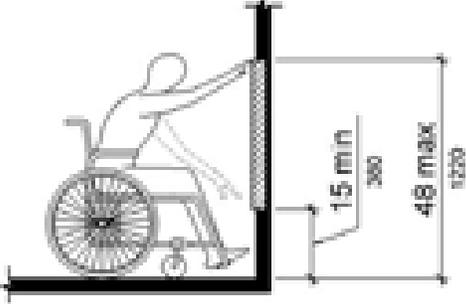
**Location:** Men's Locker Room  
**Schedule:** 2021  
**Estimated Cost:** \$200.00

**2010 ADA Standards for Accessible Design Codes: §308.2.1**  
The shelves are outside of the unobstructed forward reach range at 59.5" above the floor.

Lower the shelves by 11.5" to meet the accessible reach range of 48" maximum above the floor.

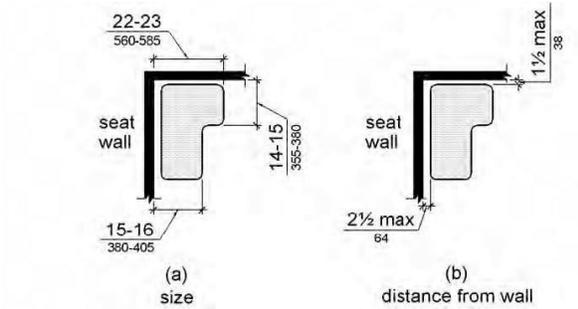
**Location:** Men's Locker Room  
**Schedule:** 2021  
**Estimated Cost:** \$500.00

**2010 ADA Standards for Accessible Design Codes: §610.3.2**  
The L-shaped shower seat does not meet the minimum requirements with a long side depth of 21" and a short side depth of 13.5".

Replace the L-shaped shower seat with one that has a long side depth from the seat wall to the front edge of 22" minimum and 23" maximum and a short side depth from the seat wall to the front edge 15" minimum and 16" maximum.

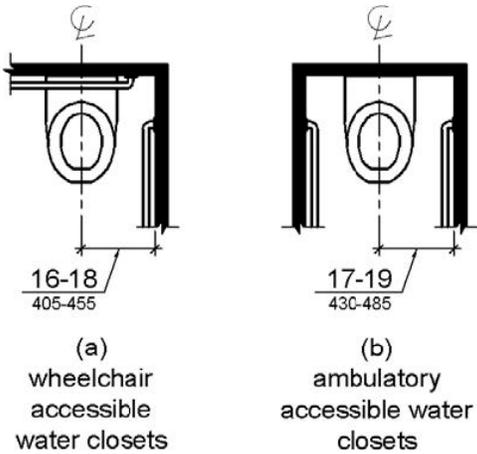
**Location:** Men's Locker Room  
**Schedule:** 2022  
**Estimated Cost:** \$1,000.00

**2010 ADA Standards for Accessible Design Codes: §604.2**  
The toilet is located 18.5" from the sidewall.

Reposition the toilet to be within 16" minimum and 18" maximum from the sidewall.
