City of Boise ADA
Assessment

Appendix A - Warm Springs Golf Course

2/19/2021

Report #TO21-B019

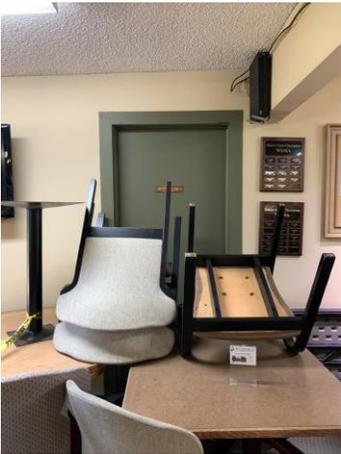
ID: 1492 **Facility:** Warm Springs Golf Course

2010 ADA Standards for Accessible Design Codes §216.2, §703
There is no tactile sign identifying the permanent room.

Install tactile signage on the latch side of the doorway at a height of 48” minimum to 60” maximum above the floor, identifying room by name or room number.

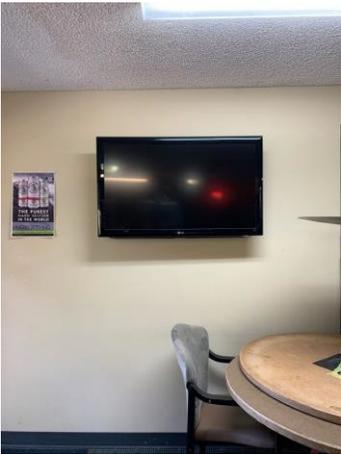
ID: 1493 **Facility:** Warm Springs Golf Course

2010 ADA Standards for Accessible Design Codes §307.2
The TV protrudes 6.75" into the circulation space at 55" above the floor.

Recess the TV so it protrudes a maximum of 4", raise it so the bottom edge is 80" maximum above the floor, or place a cane detectable object beneath it.

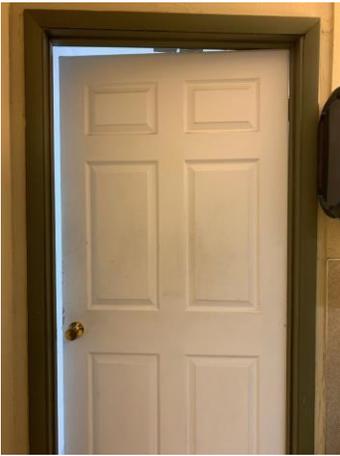
ID: 5
Facility: Warm Springs Golf Course

2010 ADA Standards for Accessible Design Codes §216.2, §703
 There is no tactile sign identifying the permanent room.

Install tactile signage on the latch side of the doorway at a height of 48” minimum to 60” maximum above the floor, identifying room by name or room number.
 Signs shall be Braille with raised lettering and should be placed on the wall in the center of an 18"x18" clear floor space.

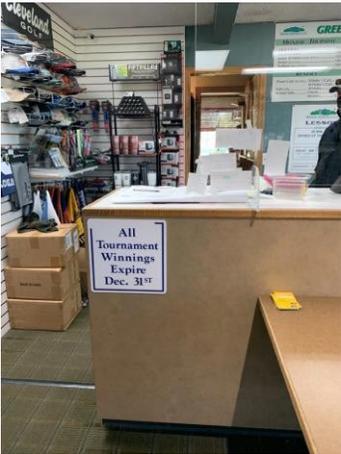
ID: 1489 **Facility:** Warm Springs Golf Course

2010 ADA Standards for Accessible Design Codes §904.4.1
The counter is 42" above the floor.

A portion of the service counter must be no higher than 36" above the floor for a horizontal distance of 36".

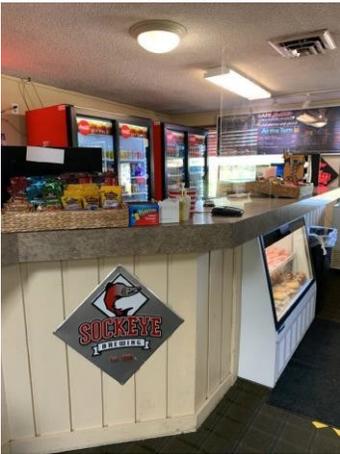
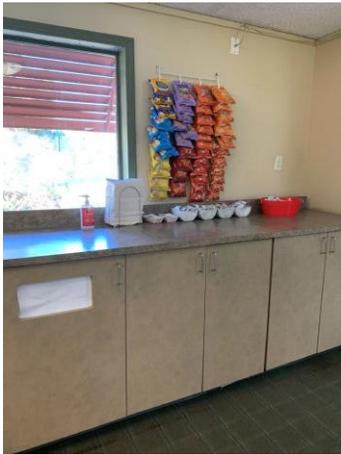
ID: 1494 **Facility:** Warm Springs Golf Course

2010 ADA Standards for Accessible Design Codes §904.4.1
The counter is 44.5" above the floor. The side condiment counter is 38" above the floor.

A portion of the service counter must be no higher than 36" above the floor for a horizontal distance of 36".

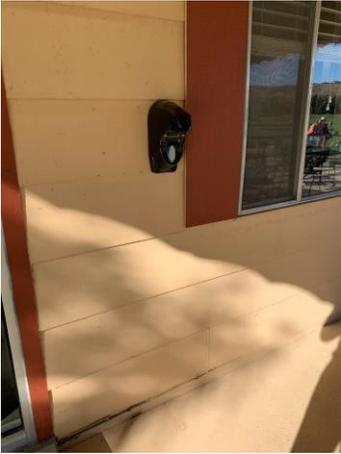
ID: 1471 **Facility:** Warm Springs Golf Course

2010 ADA Standards for Accessible Design Codes §308.2.1
The hand sanitizer is outside of the unobstructed forward reach range at 55" above the floor.

Lower the hand sanitizer by 7" to meet the accessible reach range of 48" maximum above the floor.

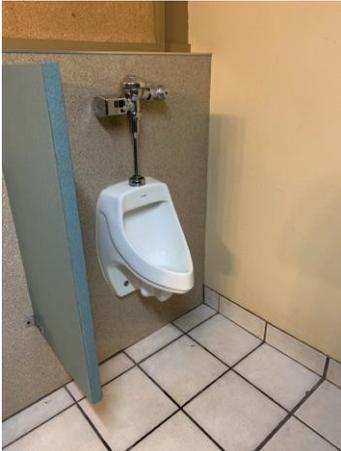
ID: 1507 **Facility:** Warm Springs Golf Course

2010 ADA Standards for Accessible Design Codes §605.2
The urinal is 22.5" above the floor.

Lower the urinal to a maximum height of 17" above the floor.

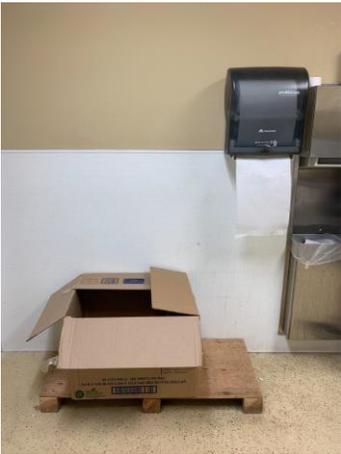
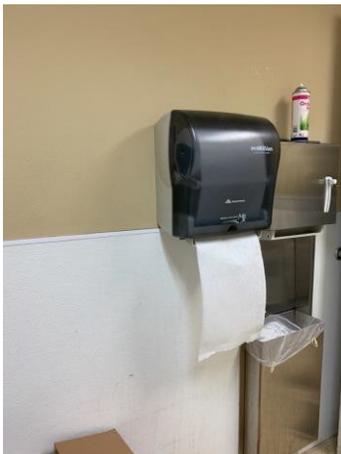
ID: 1533 **Facility:** Warm Springs Golf Course

2010 ADA Standards for Accessible Design Codes §307.2
The paper towel dispenser protrudes 7.5" into the circulation space at 48" above the floor.

Remove the protruding paper towel dispenser.
Remove the pallet and cardboard box from underneath the paper towel dispenser to provide a 30"x48" clear floor space.

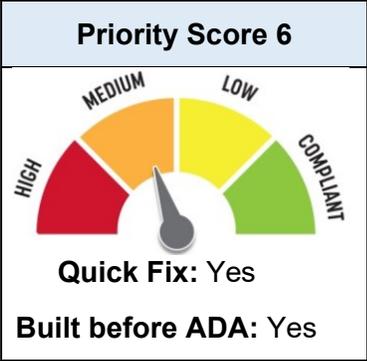
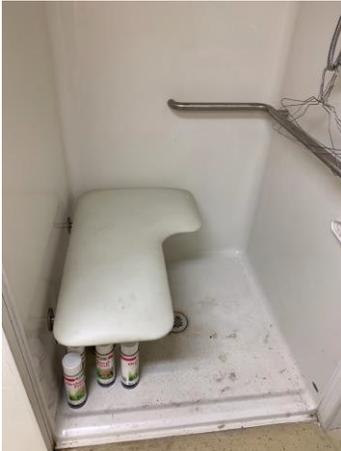
ID: 1536 **Facility:** Warm Springs Golf Course

2010 ADA Standards for Accessible Design Codes §302.3, §608.7
 There is a lip at the entry of the shower is 1" tall.

Remove the rubber lip to create a flat surface.

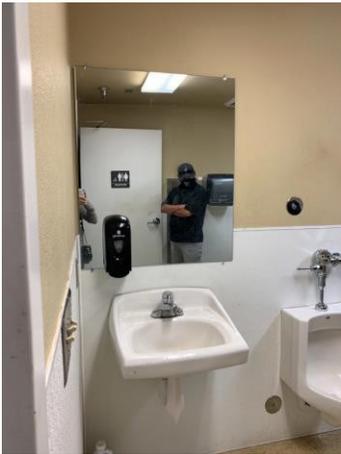
ID: 1543 **Facility:** Warm Springs Golf Course

2010 ADA Standards for Accessible Design Codes §603.3
 The mirror is too high to be accessible at 42" above the floor.

Lower the mirror so its bottom edge is a maximum height of 40" above the floor.

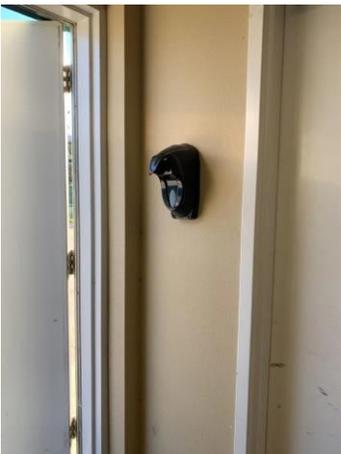
ID: 1544 **Facility:** Warm Springs Golf Course

2010 ADA Standards for Accessible Design Codes §308.2.1
The hand sanitizer is outside of the unobstructed forward reach range at 59" above the floor.

Lower the hand sanitizer by 11" to meet the accessible reach range of 48" maximum above the floor.

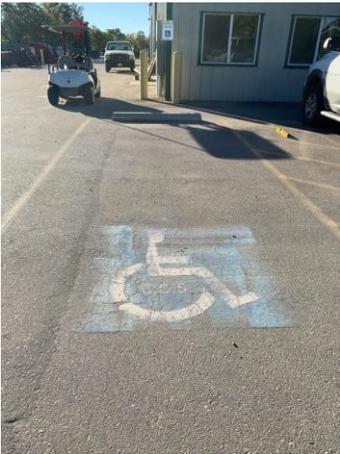
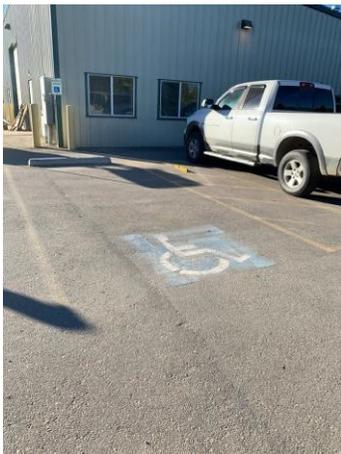
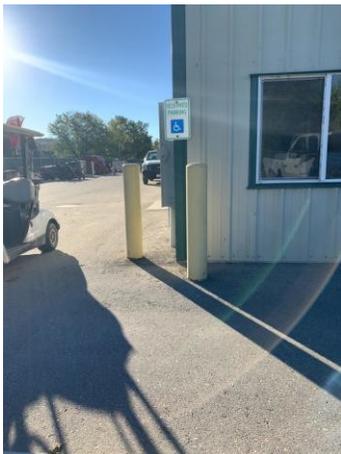
ID: 1550 **Facility:** Warm Springs Golf Course

2010 ADA Standards for Accessible Design Codes §502.6
The sign at the accessible parking space is 59.5" above the ground.

Remount the accessible parking sign at a minimum height of 60" above the ground.

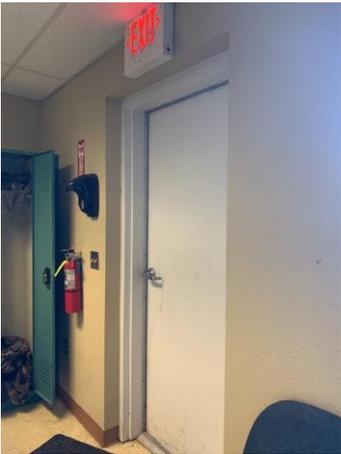
ID: 1527 **Facility:** Warm Springs Golf Course

2010 ADA Standards for Accessible Design Codes §216.4, §703
Doors serving as exits are not marked by tactile signage.

Place a tactile exit sign, that complies with §703.1, §703.2 and §703.5, identifying the exit doors.
Install missing signage at 48" minimum above the floor measured from the baseline of the lowest character and 60" maximum measured from the baseline of the highest character.
