City of Boise ADA  
Assessment

# Appendix A-City of Boise Zoo

03/12/2021

Report #TO21-B023

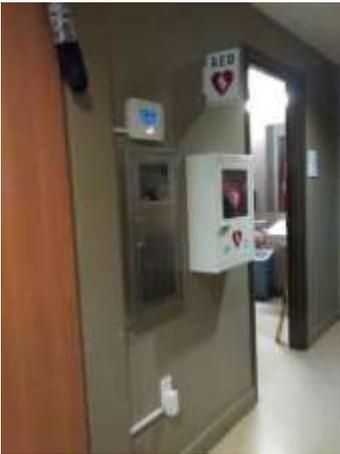
**PHOTOGRAPH(S) OF THIS LOCATION**

**2010 ADA Standards for Accessible Design Codes §307.2**  
The AED protrudes 6.5" into the circulation space at 38" above the floor.

Recess the AED so it protrudes a maximum of 4" or place a cane detectable object beneath it.

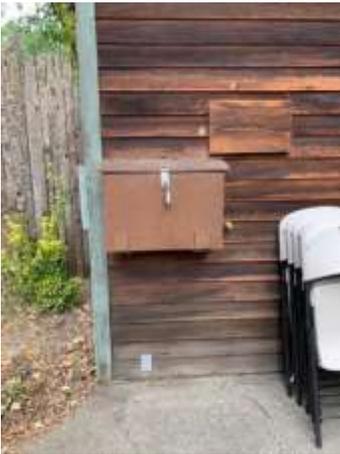
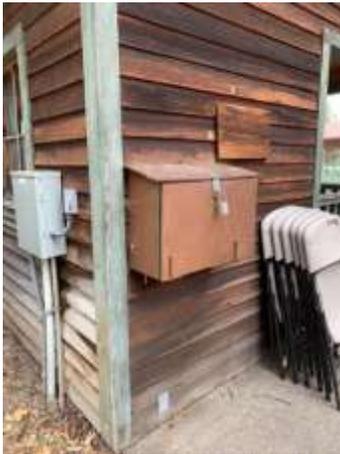
**PHOTOGRAPH(S) OF THIS LOCATION**

**2010 ADA Standards for Accessible Design Codes §307.2**  
The box protrudes 9" into the circulation space at 36" above the floor.

Recess the box so it protrudes a maximum of 4" or place a cane detectable object beneath it.

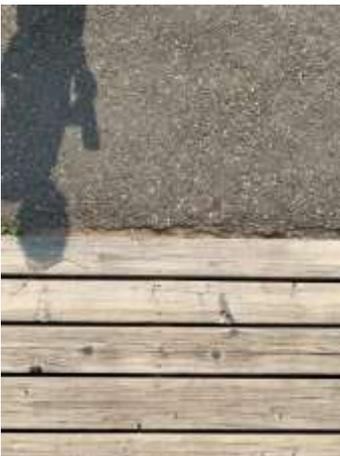
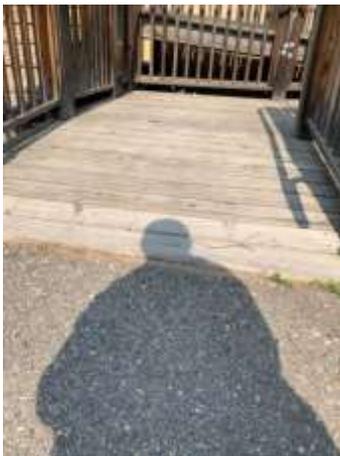
**PHOTOGRAPH(S) OF THIS LOCATION**

**2010 ADA Standards for Accessible Design Codes** §302.3  
There is a 1" in the pathway posing a tripping hazard.

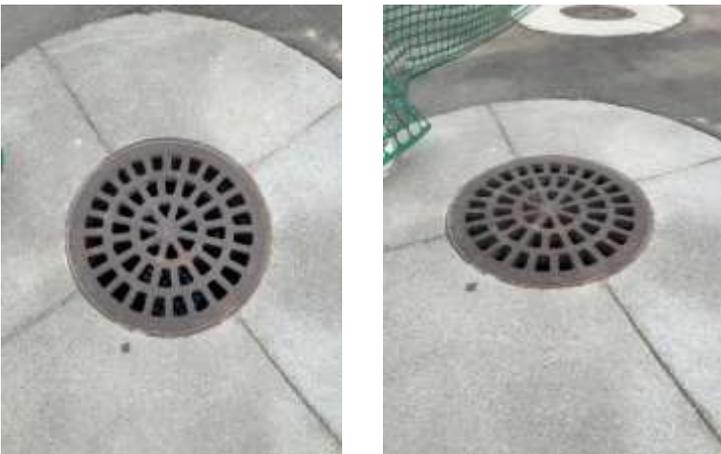
**ID:** 2891      **Facility:** City of Boise Zoo

**2010 ADA Standards for Accessible Design Codes §302.3**  
There are open grates in the pathway posing a tripping hazard.

Replace the grate with one that has gaps that are a maximum of 0.5".

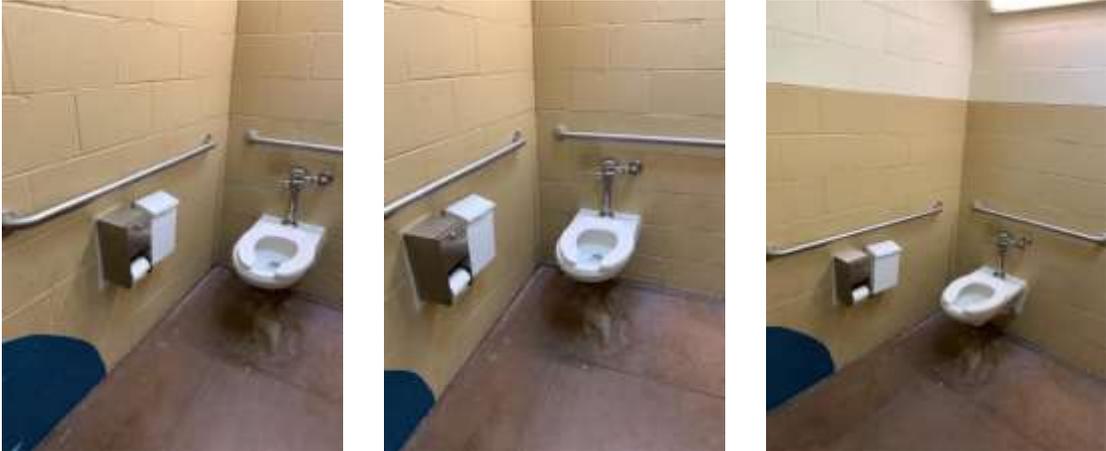
**ID:** 2857      **Facility:** City of Boise Zoo

**2010 ADA Standards for Accessible Design Codes** §604.8.1.2  
The door to the accessible water closet is not self closing. Either self-closing hinges are not installed on the door or if installed, they are defective.

Install or reinstall self-closing hinges on the door to ensure that the door is self-closing per the ADA requirements.

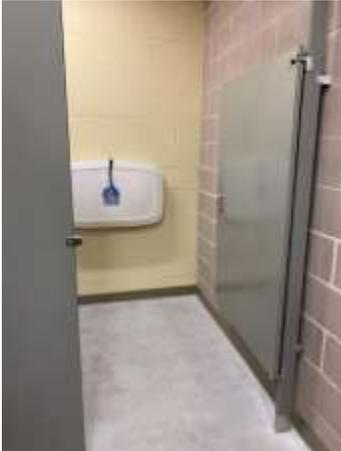
**ID:** 3521      **Facility:** City of Boise Zoo

**2010 ADA Standards for Accessible Design Codes** §604.8.1.2  
The door to the accessible water closet is not self closing. Either self-closing hinges are not installed on the door or if installed, they are defective.

Install or reinstall self-closing hinges on the door to ensure that the door is self-closing per the ADA requirements.

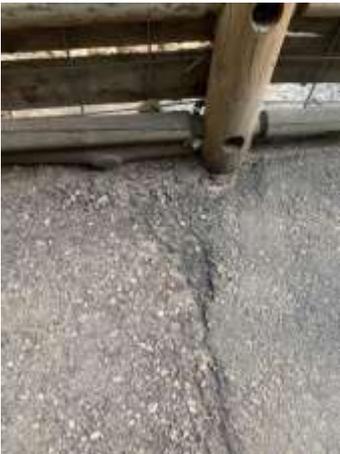
**ID:** 3130      **Facility:** City of Boise Zoo

**2010 ADA Standards for Accessible Design Codes** §302.1  
There is a change in level that pose tripping hazards in the accessible route.

Repave the area of the sidewalk to remove the change in level.

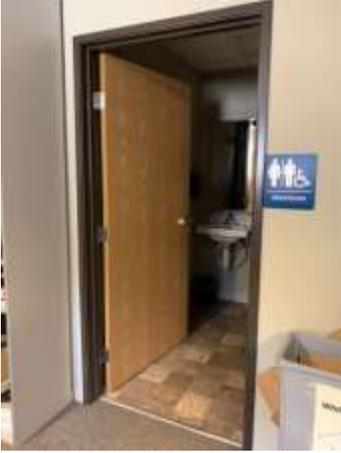
**ID:** 3329      **Facility:** City of Boise Zoo

**2010 ADA Standards for Accessible Design Codes** §604.8.1.2  
The door to the accessible water closet is not self closing. Either self-closing hinges are not installed on the door or if installed, they are defective.

Install or reinstall self-closing hinges on the door to ensure that the door is self-closing per the ADA requirements.

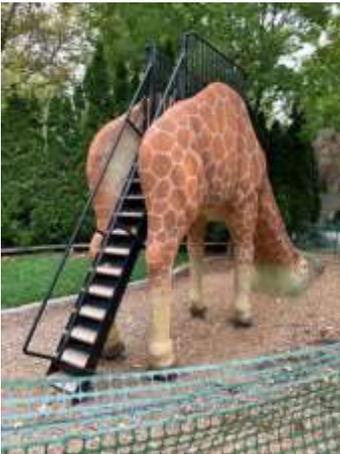
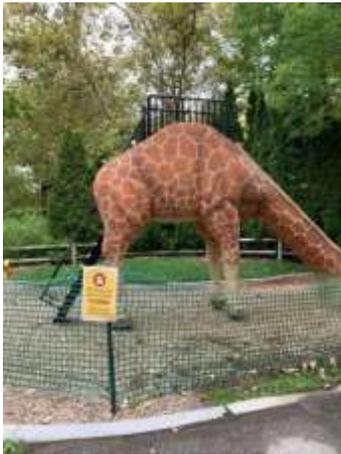
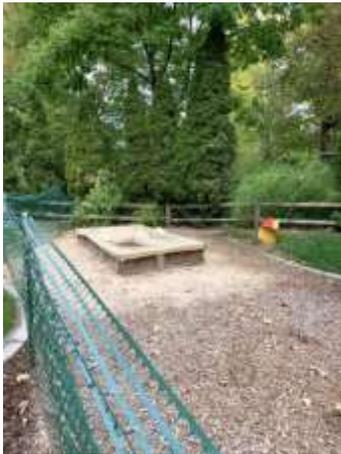
**2010 ADA Standards for Accessible Design Codes** §302.1, ASTM F1951-99  
The giraffe slide is not accessible. There are changes in level that pose tripping hazards on the route to the giraffe slide.  
The playground surface is not stable, firm, and slip resistant.

Install an accessible play element in addition to the giraffe slide.  
Repave the area of the sidewalk to remove the change in level.  
Replace the mulch with an accessible playground surface material such as pour-in-place rubber, rubber tiles, artificial grass, and engineered wood fiber.

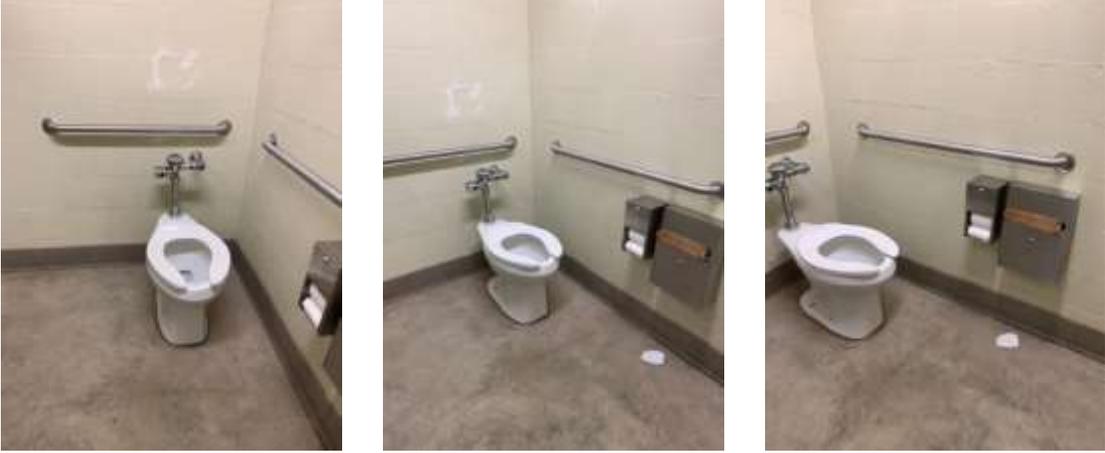
**ID:** 3083      **Facility:** City of Boise Zoo

**2010 ADA Standards for Accessible Design Codes** §604.8.1.2  
The door to the accessible water closet is not self closing. Either self-closing hinges are not installed on the door or if installed, they are defective.

Install or reinstall self-closing hinges on the door to ensure that the door is self-closing per the ADA requirements.

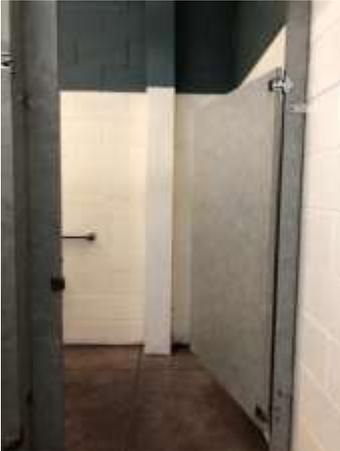
**2010 ADA Standards for Accessible Design Codes** §604.8.1.2  
 The door to the accessible water closet is not self closing. Either self-closing hinges are not installed on the door or if installed, they are defective.

Install or reinstall self-closing hinges on the door to ensure that the door is self-closing per the ADA requirements.

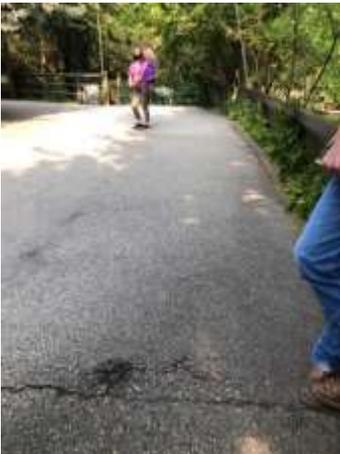
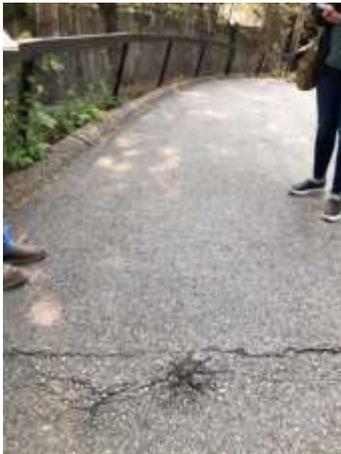
**2010 ADA Standards for Accessible Design Codes** §302.1  
There are tripping hazards in the accessible route causing changes in level.

Repave the area of the sidewalk to remove the bump.

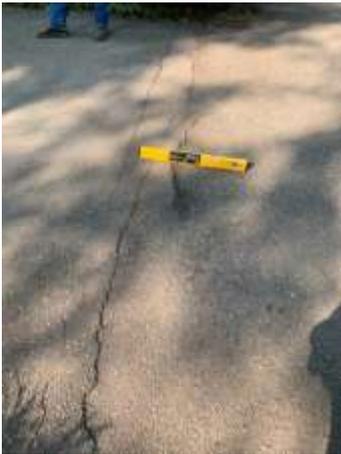
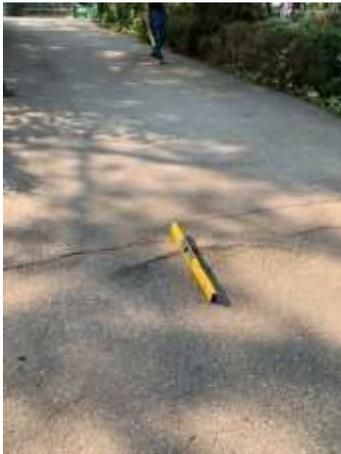
**2010 ADA Standards for Accessible Design Codes** §403.3, §302.1  
 A section of the pavement is uneven posing a tripping hazard and causing a running slope of 12.3%.

Reconstruct the pathway to ensure that the uneven section of asphalt is level, with vertical changes in elevation not exceeding 0.25".

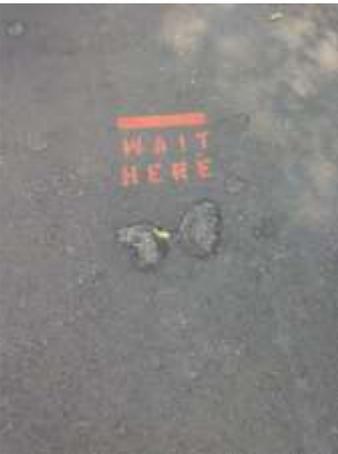
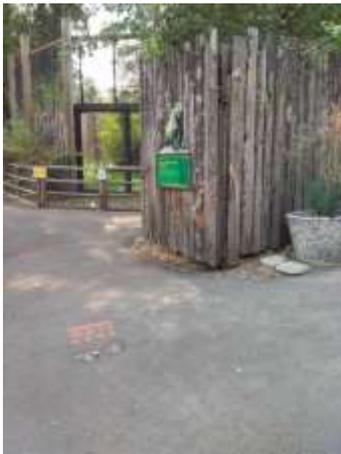
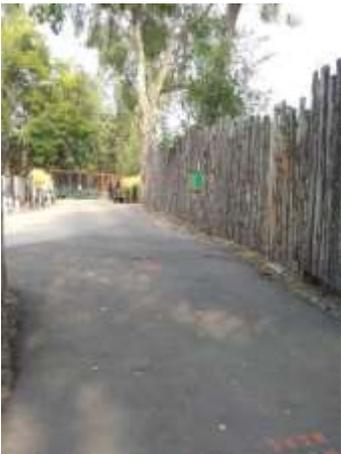
**2010 ADA Standards for Accessible Design Codes** §403.3, §303.3  
The recessed paw prints are a tripping hazard due to them being recessed up to 0.5". The running slope is 8%.

Fill in the paw prints as to not exceed 0.25" in depth.  
Reconstruct the route to reduce the running slope to a maximum of 5%.

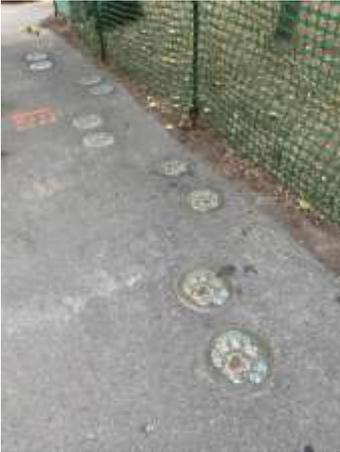
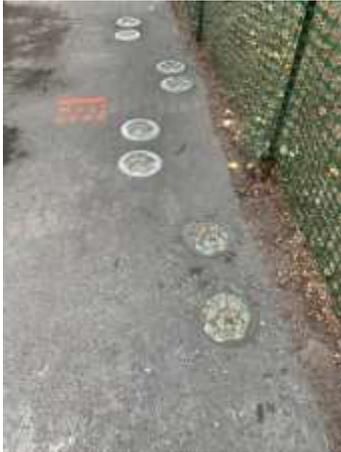
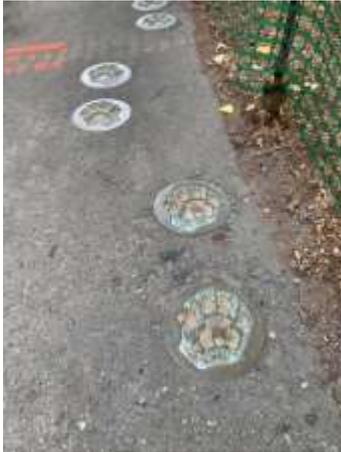
**2010 ADA Standards for Accessible Design Codes** §303.2  
The paw prints cause a 0.75" change in level.

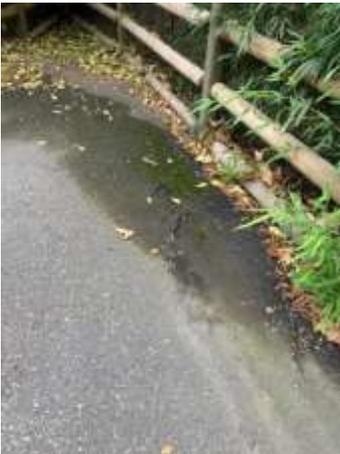
**2010 ADA Standards for Accessible Design Codes §302.1**  
There is a change in level that pose tripping hazards in the accessible route.

Repave the area of the sidewalk to remove the change in level.
